Hells Canyon Complex Aesthetic Resource Inventory and Evaluation

TECHNICAL REPORT

**Technical Report
Appendix E.6-3**

Hells Canyon Complex
FERC No. 1971

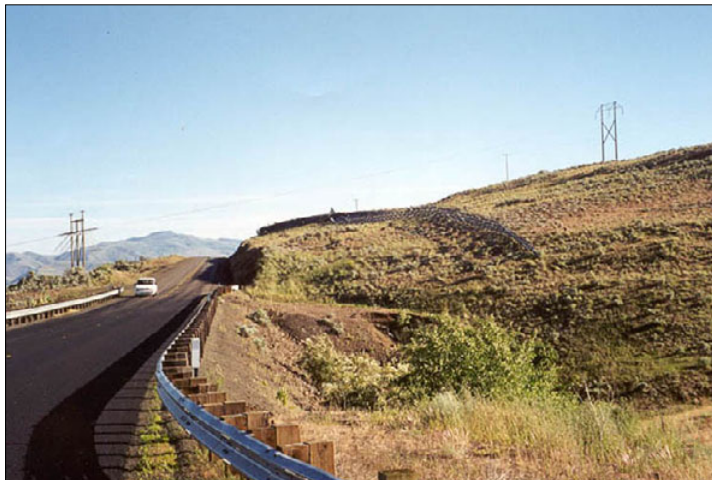
Fig. 9. Transmission lines and conductors silhouetted against the horizon (VP#30).

and texture were moderate to weak. Conductors (i.e., transmission lines) were highly reflective in sunny conditions and were also visible in overcast conditions. Safety balls, used to help aircraft see conductors, were present at only a few sites and increased the contrast of the conductors. Safety balls, however, are required by the Federal Aviation Administration (FAA) and cannot be removed.

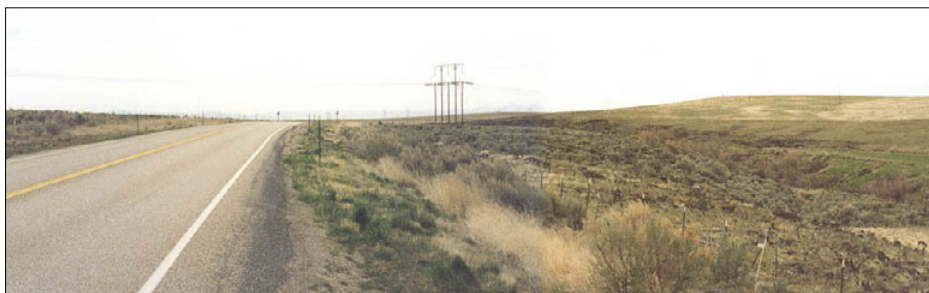
Transmission structures intersecting or adjacent to travel corridor. Transmission lines, towers, and access and service roads also commonly crossed or paralleled travel corridors (**Fig. 10**). Similar to the previous effect, distance from viewpoint to structure and the number of towers

Fig. 10. Transmission lines crossing the travel corridor (VP#19).

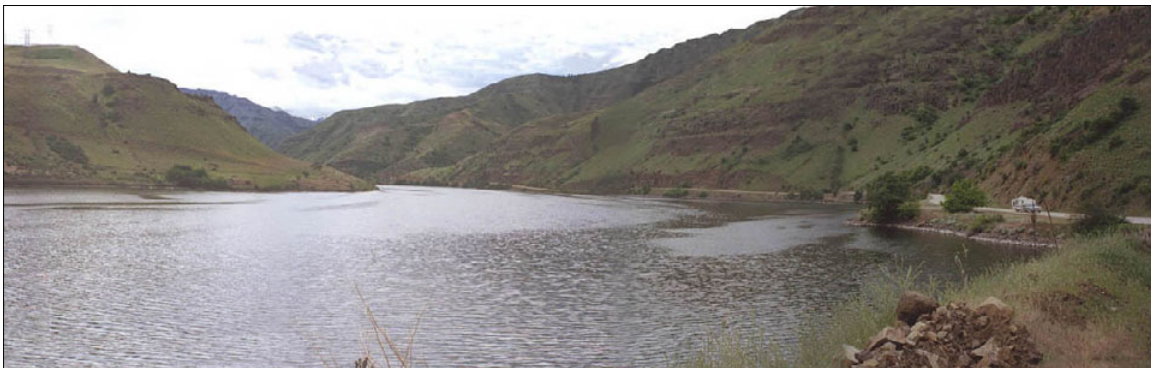
Reservoir (**Fig. 15**), where fluctuations typically range between three feet (summer weekends) and four feet (spring weekends). At Brownlee Reservoir, the drawdown effect typically results in weak contrasts in form and line, strong contrast in color, and moderate contrast in texture. At Oxbow Reservoir, the drawdown effect typically results in weak contrast in form, line, and texture, and moderate contrast in color.

Fig. 15. Drawdown effect at Dead Man's Spot at Oxbow Reservoir (VP #49).

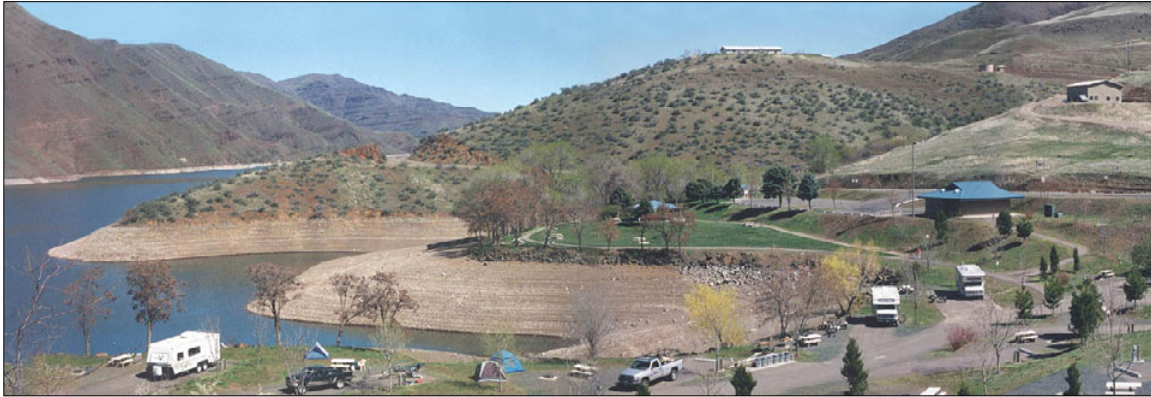
Alterations to vegetation. Deviations from native vegetation created visual contrast and were generally limited to the Brownlee/Oxbow Unit. Two types of deviations were noted. The first appeared limited and occurred where fluctuating water levels created opportunities for annual weed species to colonize bare soil as reservoir water levels receded. In this case, the contrast ratings were typically low because the vegetation, thought to be non-native and potentially noxious, had no or weak contrast in form, line, color, and texture when viewed from the KOPs. The second deviation occurred where non-native plants were incorporated into the landscape at IPC facilities such as Woodhead Park (**Fig. 16**). In this case, the use of non-native plants and their placement in the landscape resulted in strong to moderate contrasts in form and line, moderate contrast in color, and weak contrast in texture.

Fig. 16. Non-native vegetation at Woodhead Park (VP #44).

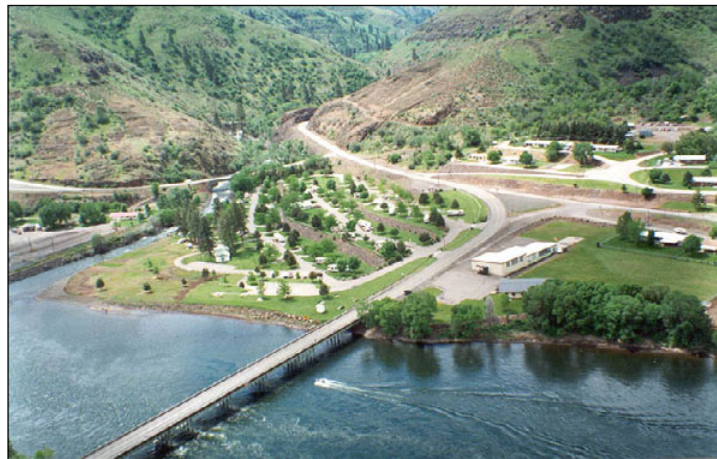
Hardscape elements. Hardscape elements include items such as site furnishings, parking areas, boat ramps, road, picnic shelters, and toilet facilities. These items are common at developed recreational sites such as Copperfield Park (**Fig. 17**) and at dispersed recreational sites throughout the Study Area. Hardscape elements generally created strong contrasts in form, line, and color, and moderate contrasts in texture. Exceptions to contrasting materials include the use of sun-bleached logs to direct vehicular traffic and parking at Spring Recreation Site (VP #37) and gravel, rather than concrete, for access roads and parking at McCormick Park (VP #47).

Fig. 17. Hardscape elements at Copperfield Park (VP #53).

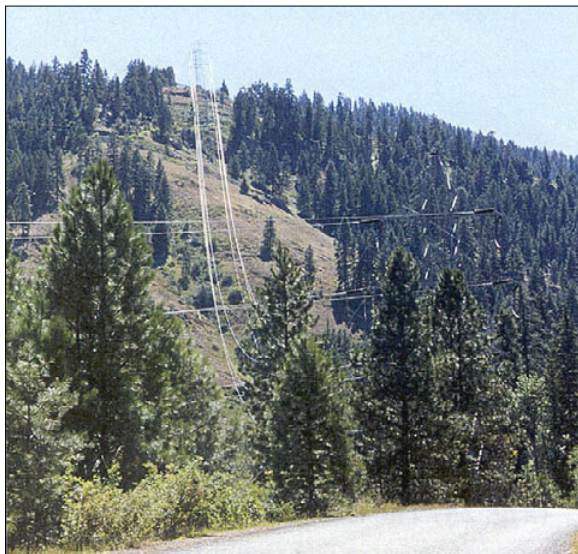
Wallowa Mountain Loop Road, a designated Scenic Byway. Several steel lattice towers and wooden poles were silhouetted against the skyline. Conductors (i.e., transmission lines) were highly reflective in sunny conditions and were also visible in overcast conditions. Safety balls, used to help aircraft see conductors, were present at only a few sites and increased the contrast of the conductor; however, since these are required by the FAA, they cannot be removed. Service roads created contrast in line and color as well as opportunities for erosion.

Fig. 25. Transmission lines through the Imnaha River valley.

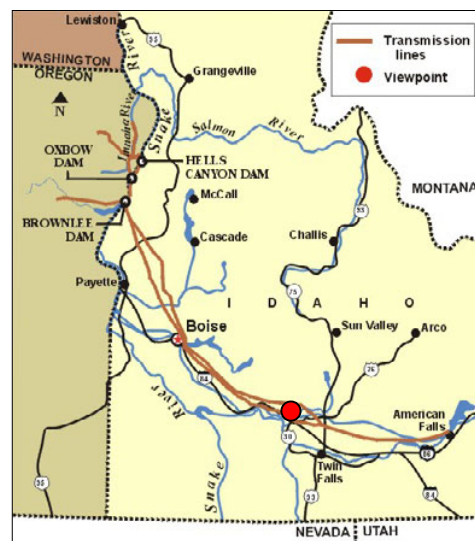
Viewpoint #11: ID SR 46 and Old Highway 46 (KOP)

Visual Contrast Rating	Existing VRM Class	Is contrast rating acceptable for VRM Class?	Proposed VRI Class	Is contrast rating acceptable for proposed VRI Class?
17	II	No	N/A	N/A
IPC Facilities/ Operations	Current / Proposed Operations		Full Pool/ Run-of-River	
	Effects	Suggested PM&E	Effects	
Line 912 (H-frame wood/laminate)	DF: Six towers silhouetted from southern approach	Replace lines with non-specular wire in normal maintenance cycle.	N/A	
Comments	Effect is visible for very short time period as motorists approach and pass under line. Relocating towers is not reasonable.

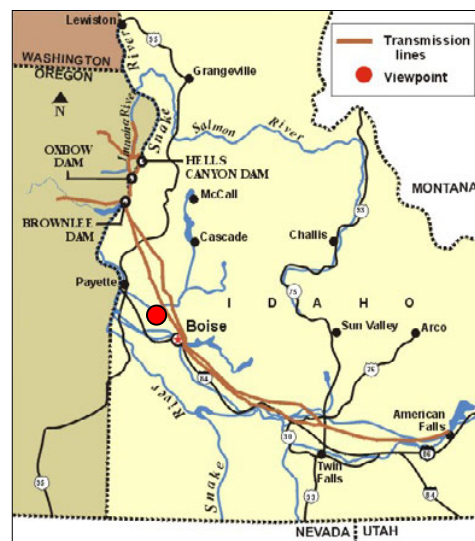
Viewpoint #23: Payette River and ID SR 52 (KOP)

Visual Contrast Rating	Existing VRM Class	Is contrast rating acceptable for VRM Class?	Proposed VRI Class	Is contrast rating acceptable for proposed VRI Class?
21	II	No	N/A	N/A
IPC Facilities/ Operations	Current / Proposed Operations		Full Pool/ Run-of-River	
	Effects	Suggested PM&E	Effects	
Line 911 (steel lattice)	DF: Steel lattice tower transmission line crosses Payette River and ID SR 52; towers silhouetted to south middle-ground/background.	Replace lines with non-specular wire in normal maintenance cycle.	N/A	
Comments	Effect is visible for very short time period as motorists approach and pass under line. Relocating towers is not reasonable.
