Effects of Constructing and Operating the Hells Canyon Complex on Wildlife Habitat

Charles Blair, CH2M HILL
Jeff Braatne, University of Washington
Robert Simons, Simons & Associates
Stewart Rood, University of Lethbridge
and
Brandy Wilson, CH2M HILL

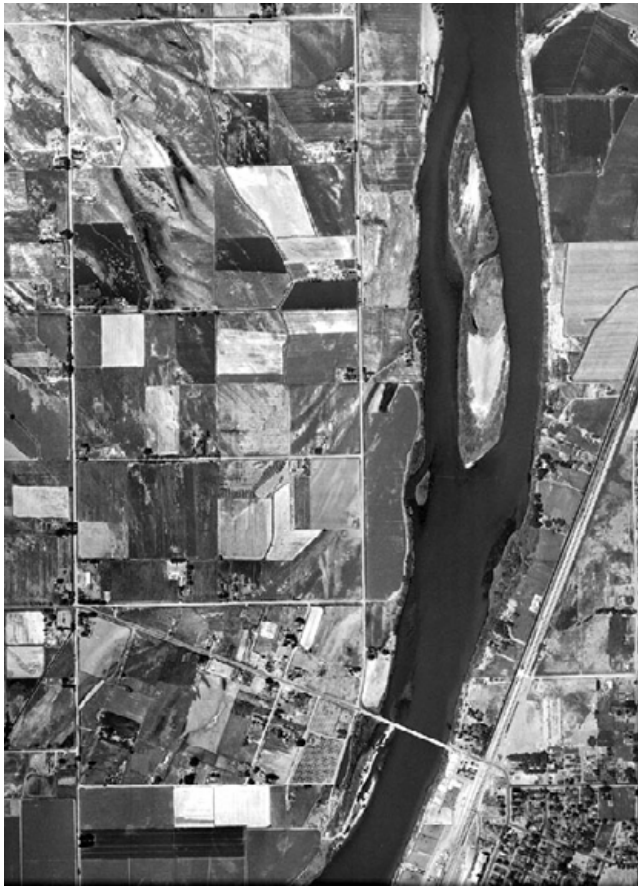
August 23, 1955. Aerial view of irrigated crops and pastures on the Weiser Flats floodplain. Only a few areas support woody riparian plants. Patterns of former channel migration (that is, paleo-channels) are visible within cultivated fields on Weiser Flats as variation in surface substrate conditions. The extent of paleo-channels suggests that this area was dominated by dense stands of sandbar willows prior to clearing and cultivation.

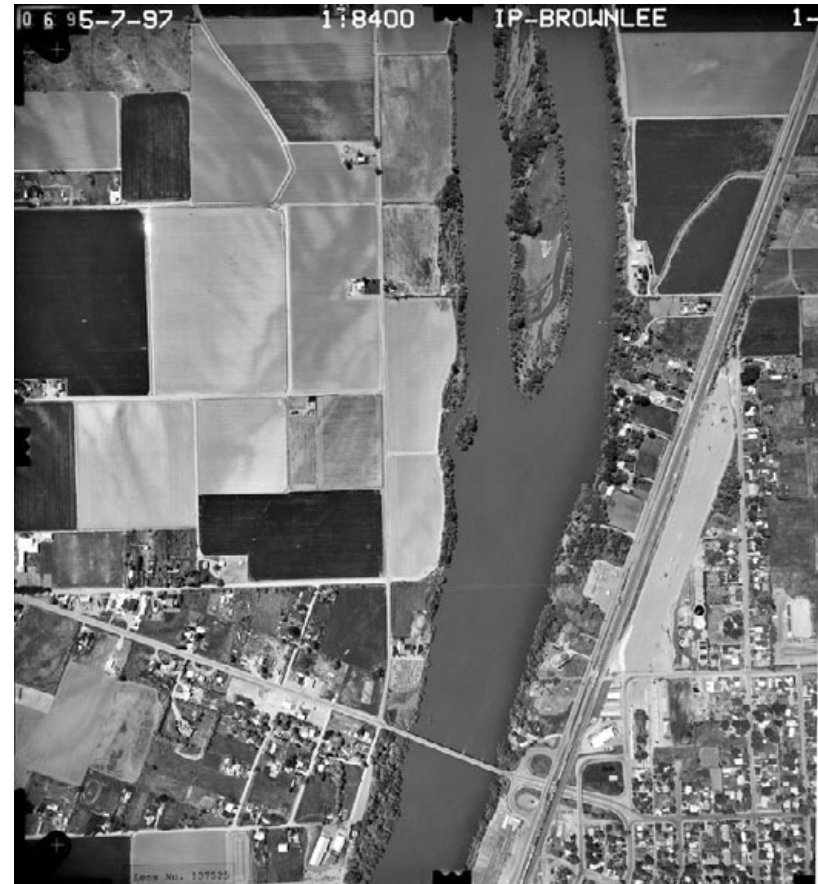
May 7, 1997. Aerial view of irrigated fields near Weiser, Idaho. A narrow fringe of dense woody vegetation is visible along the main river channel. The large island in the center of the channel is no longer farmed and has become partially bisected by shallow cross-channels. Channel morphology is comparable with historic photo, although patterns of past channel migration are less evident in recent aerial photos.

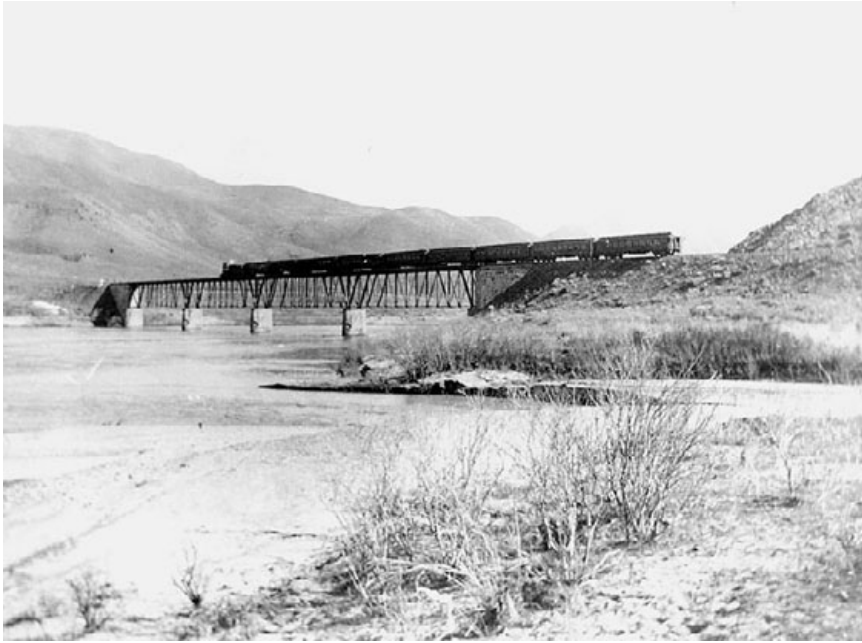
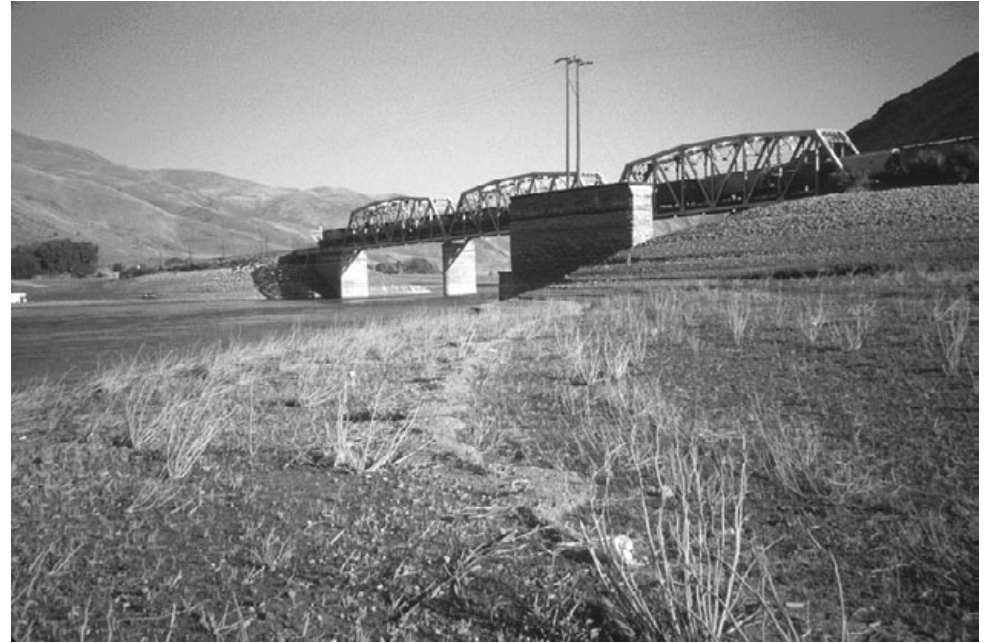
1899. View of a sparse riparian zone of sandbar willow and herbaceous plants (Idaho Historical Society: Rodenbaugh collection). The abundance of fine substrates, particularly along the opposite bank, is related to the alluvial deposits typically found near the confluence of two rivers.

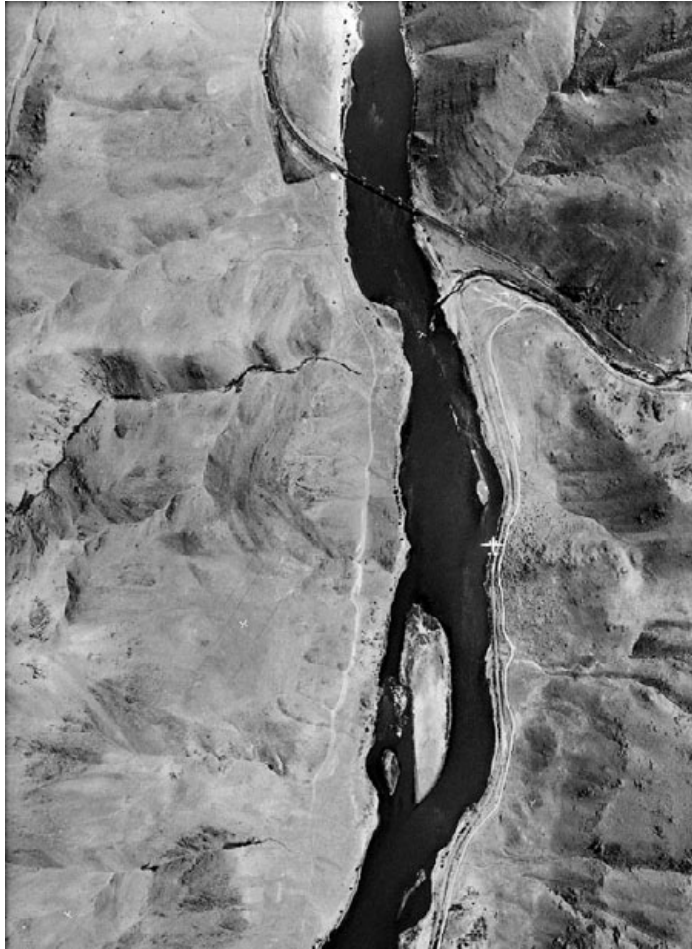
August 23, 1955. Aerial view of the confluence of the Burnt and Snake Rivers. Upland sagebrush steppe vegetation dominates the landscape, with woody plants limited to a scattered fringe of hackberry. Islands and sandbars are common geomorphic features.

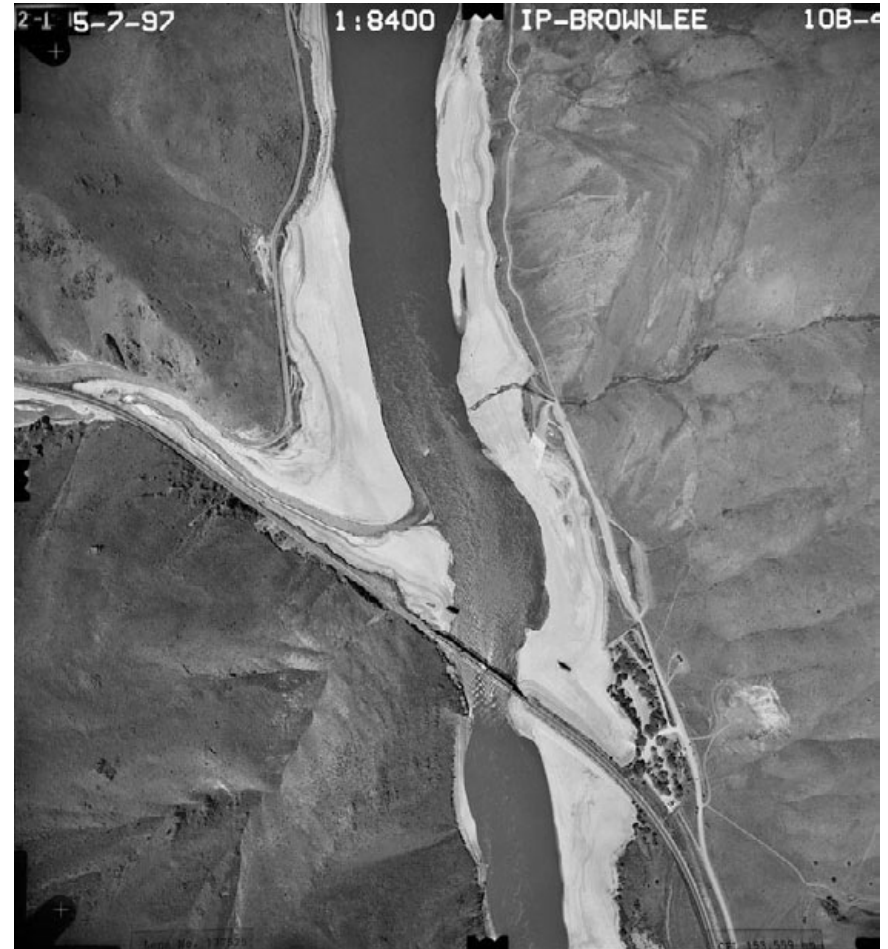
May 7, 1997. Aerial view of the confluence of the Burnt River with the upper Brownlee Reservoir corridor. Extensive barren zones are visible along reservoir shorelines. Upland sagebrush steppe vegetation extends down the slope to the reservoir high-water mark. Former islands and sandbars are inundated in the recent aerial photograph.

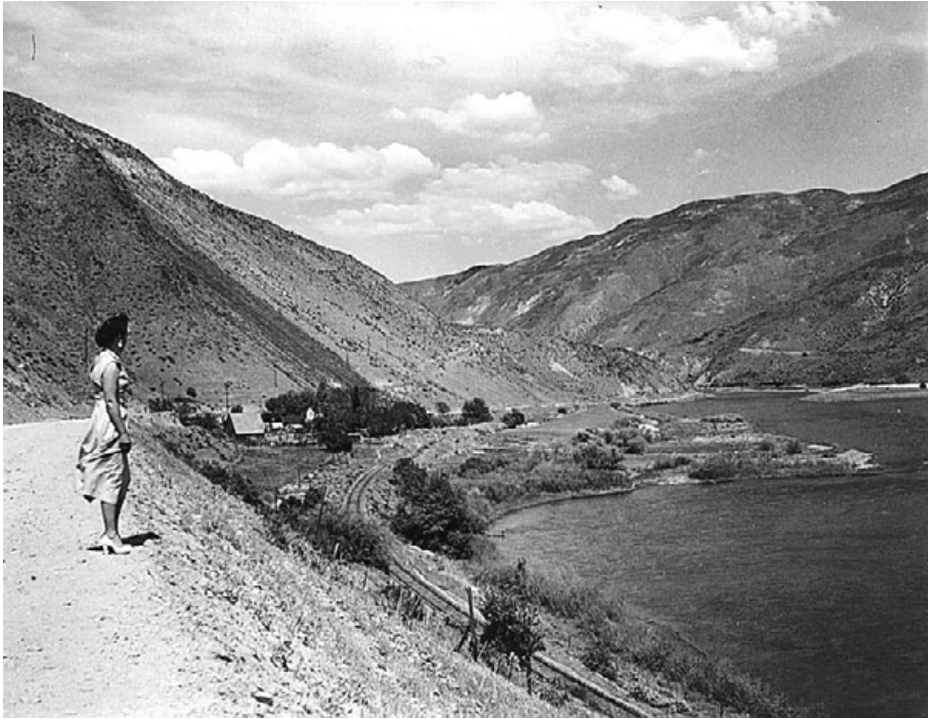
1952. Photograph of the alluvial fan associated with the confluence of Morgan Creek with the Snake River (photograph by P. Basche). A narrow fringe of sandbar willow with scattered hackberry grows along the riverbank. Steep upland habitats extend downslope to an open river valley with scattered sandbar deposits and channel islands.

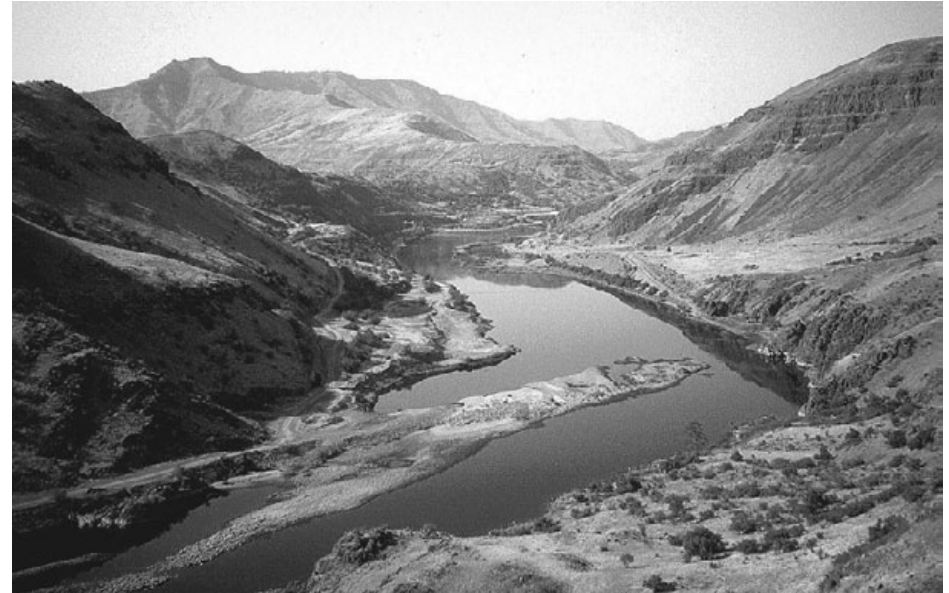
September 1999. Photograph showing partial inundation of the oxbow by Hells Canyon Reservoir (photograph by J.H. Braatne). Upland and riparian habitats appear similar to pre-dam conditions, alternating cycles of inundation and drawdown have armored the channel bed; shoreline consists of cobble and bedrock.

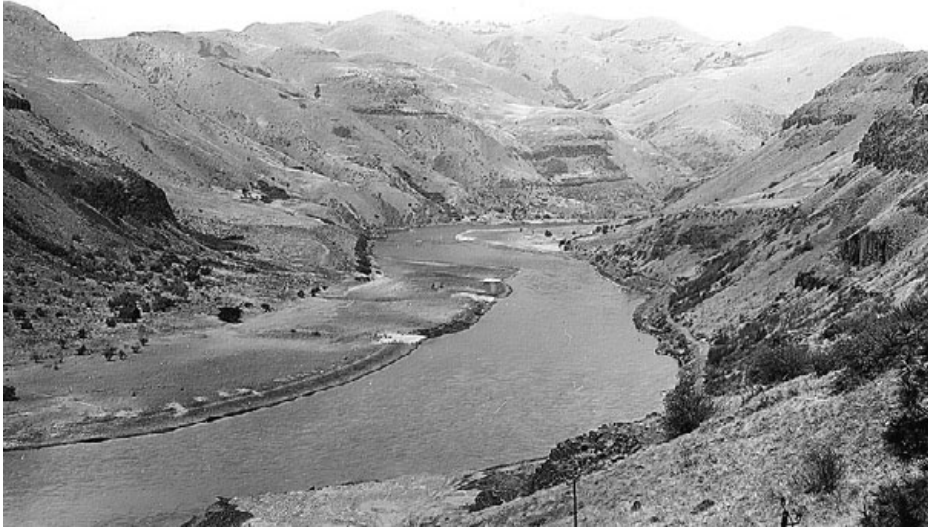
August 1953. Photograph of the river flowing through the lower half of the oxbow (photograph by F.R. McCormick). Upland habitats of sagebrush steppe with a fragmented fringe of hackberry are present along the river. The broad river terraces are composed of fine to fine-cobble and bedrock, and a browse line is evident on tall shrubs (hackberry and possibly serviceberry).

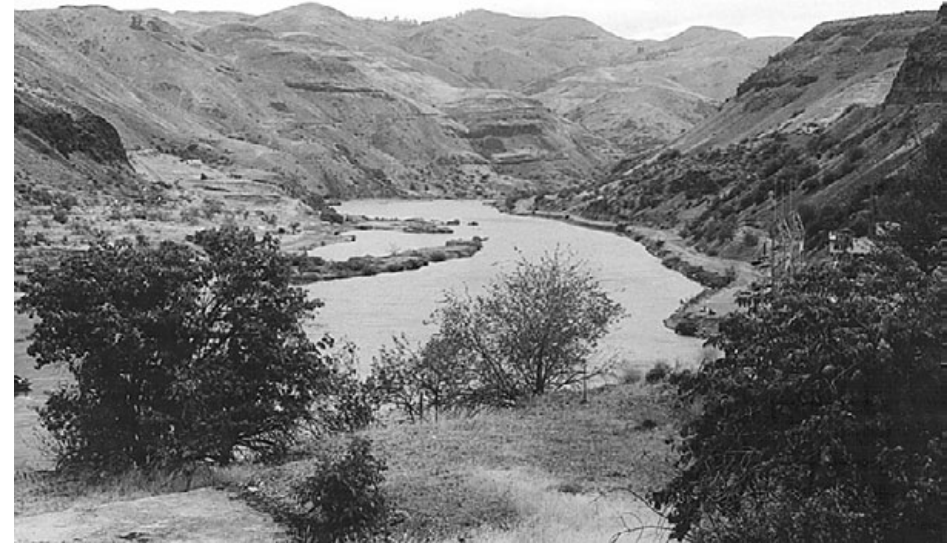
August 1999. Photograph of the inundation of river terraces near Hells Canyon Reservoir (photograph by J.H. Braatne). Upland and riparian habitats appear similar to pre-dam conditions, although the areal extent of hackberry, thornberry, and serviceberry (*Amelanchier alnifolia*) have increased significantly. The road on the upper right side of the 1999 photograph was not present in 1953.

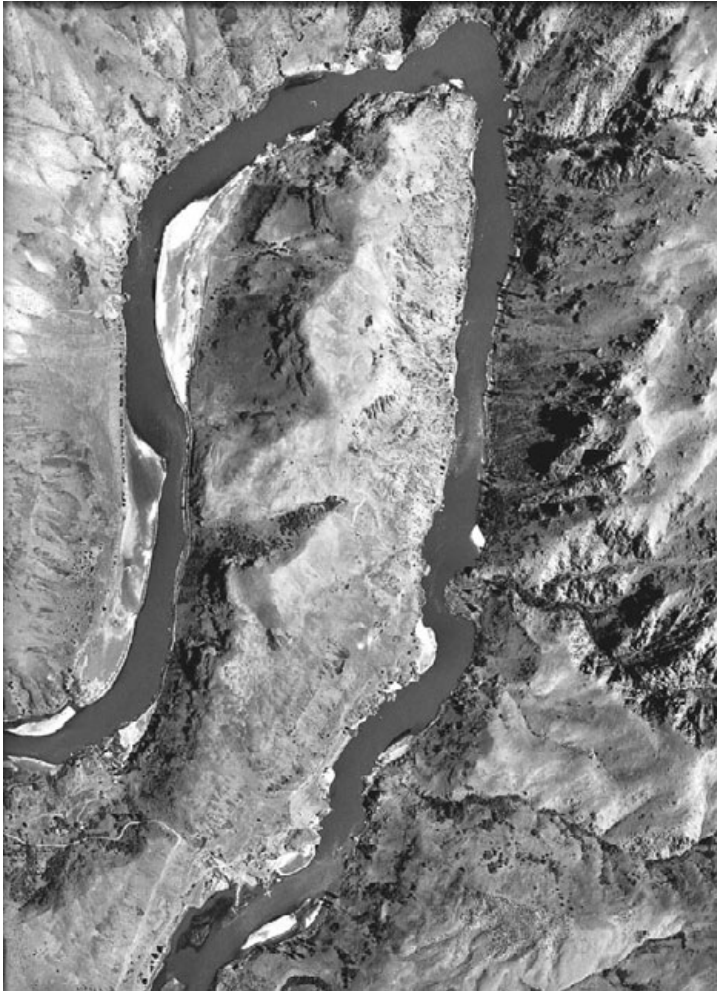
August 22, 1955. Aerial view of the oxbow. As the river flows through the oxbow, sandbars, islands, and low-elevation river terraces are common. Riparian habitats consist of a scattered fringe of hackberry and sandbar willow. Islands and sandbars appear to be barren.

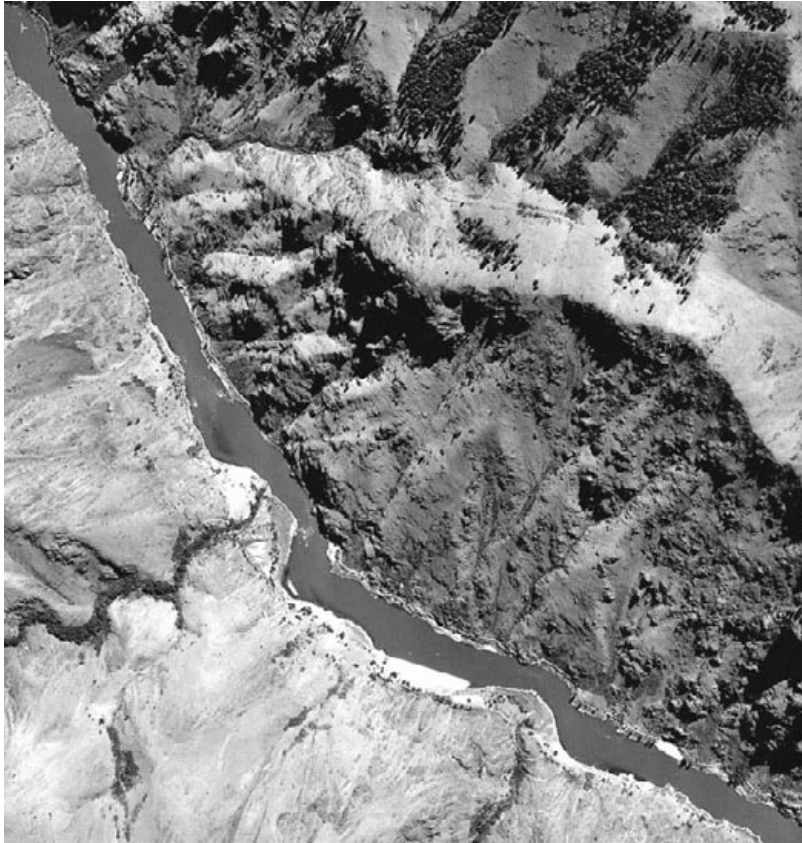
August 22, 1955. Aerial view of the Snake River corridor near McGraw and Spring Creeks. This corridor is noted for steep canyon walls with scattered sandbars and alluvial fans. The riparian zone is limited to scattered fragments of hackberry. Riparian stands of white alder along Spring Creek are much more extensive than those along McGraw Creek.

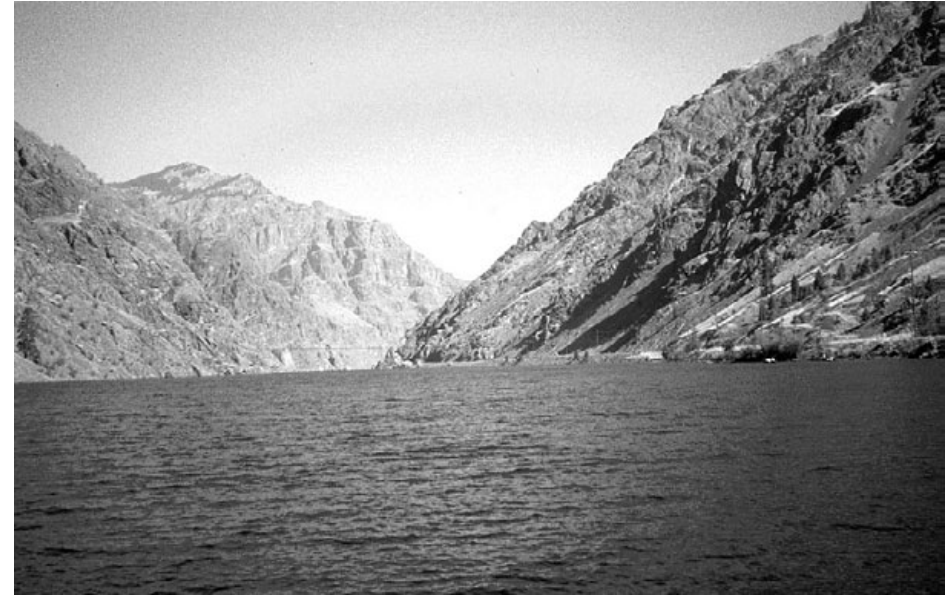
September 1999. Photograph showing inundation of low-elevation bedrock formations. Sparsely vegetated slopes appear similar to pre-dam conditions (photograph by J.H. Braatne).

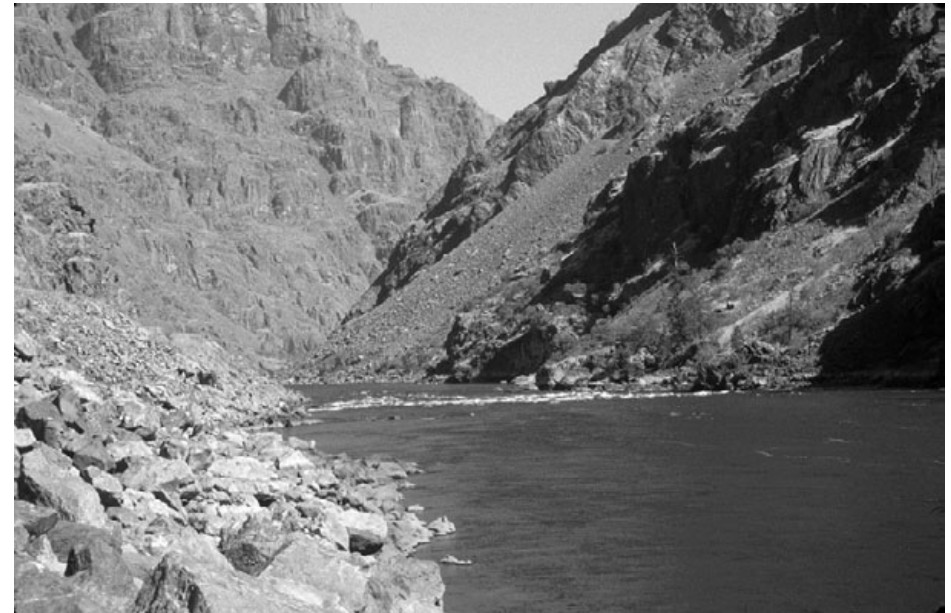
September 1999. Photograph of the Snake River corridor between Deep and Hells Canyon Creeks (photograph by J.H. Braatne). This reach is now directly below Hells Canyon Dam. The banks on the Oregon side of the river have been heavily armored with revetments, whereas the Idaho side of the river does not differ from pre-dam conditions and features a riverbank composed of cobbles, boulder, and bedrock.

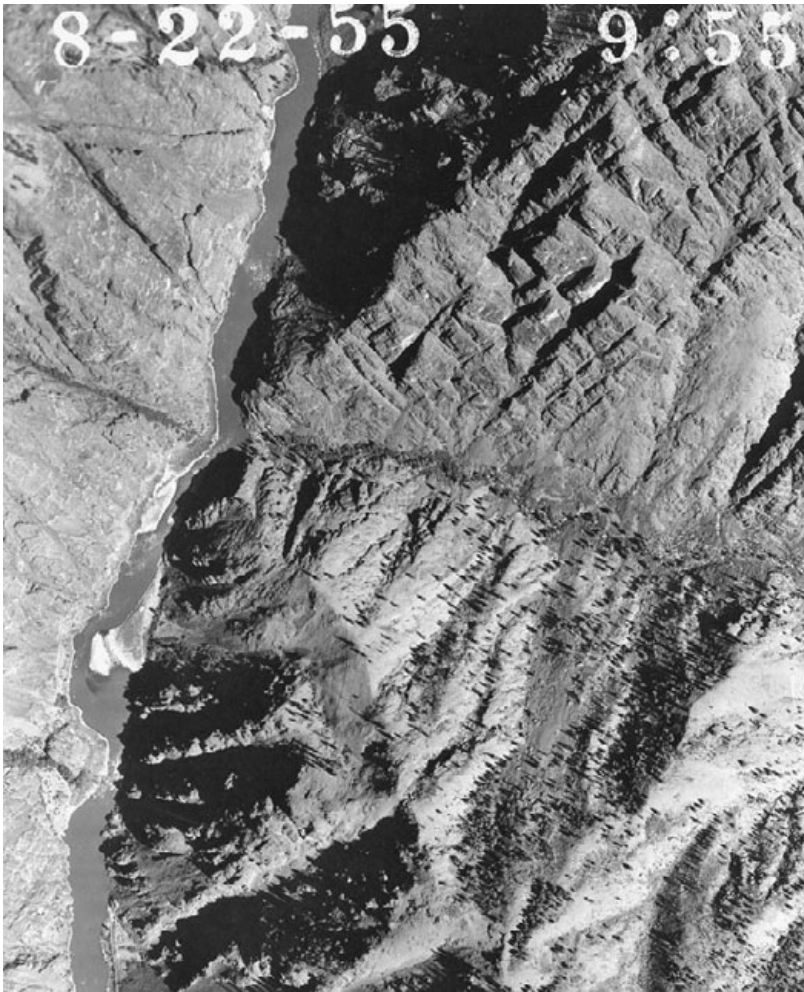
August 22, 1955. Aerial view of the deep confined canyon between Deep and Hells Canyon Creeks. Steep, rocky canyon walls and talus slopes limit sediment deposition and riparian habitats along this reach.

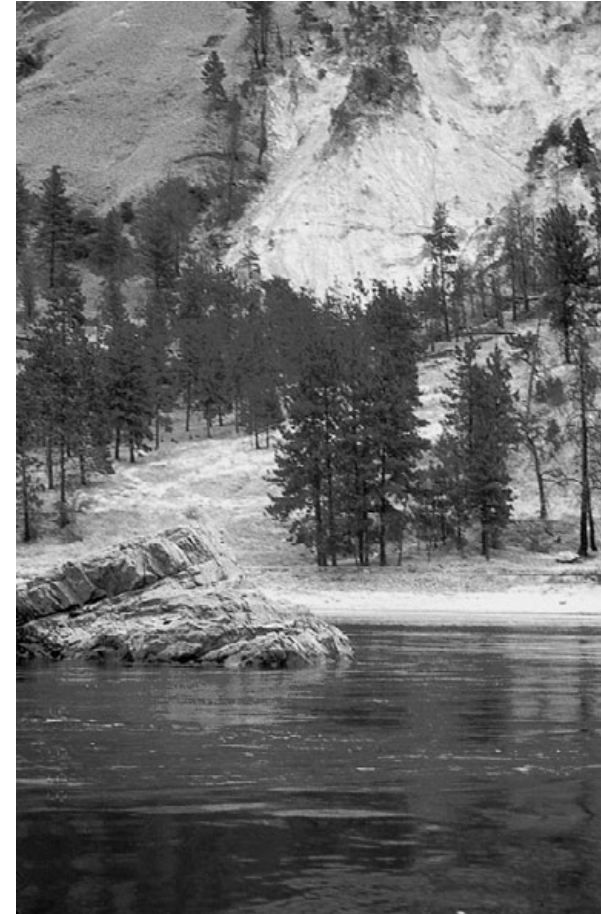
September 1999. Photograph of Sturgeon Rock and Alum/Pine Bar showing sandbar erosion and the loss of sandbar willow and hackberry. The riverbank consists of fine sands (photograph by J.H. Braatne). A recent fire appears to have burned through some of the pines growing along the canyon walls.

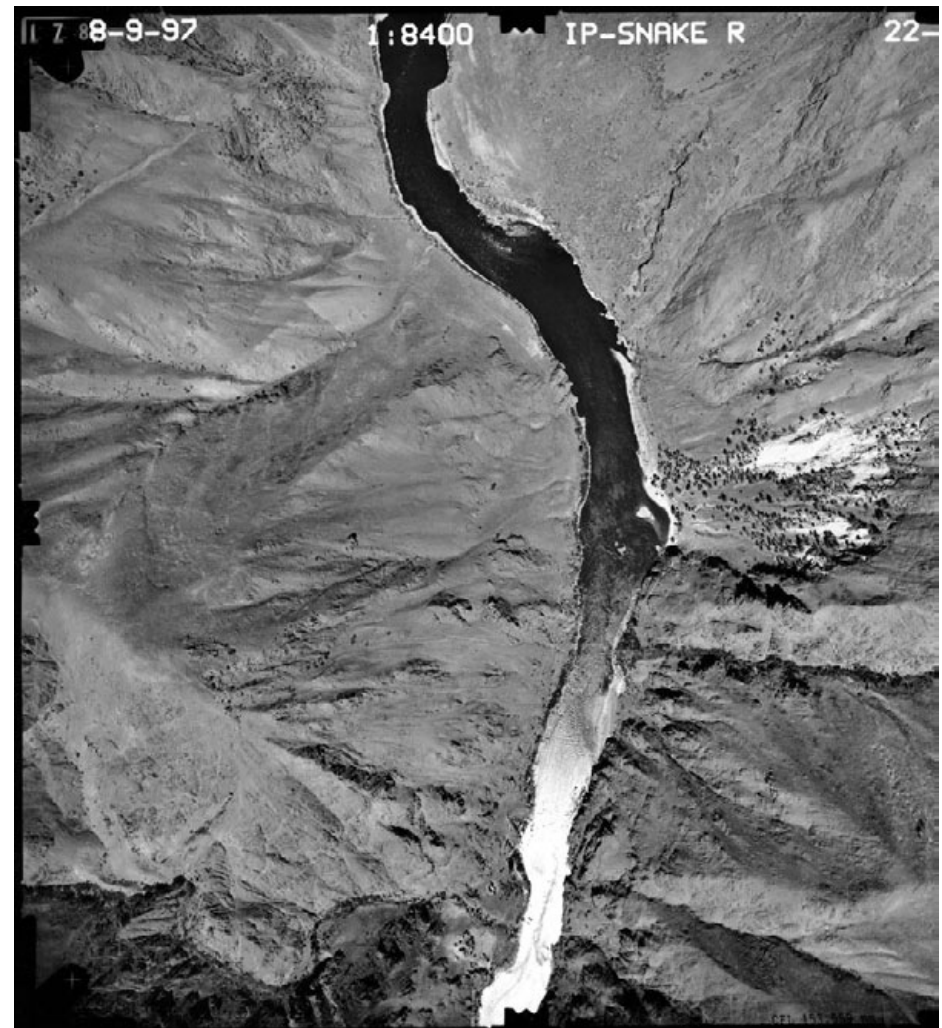
No pre-dam aerial photograph is available at this time.

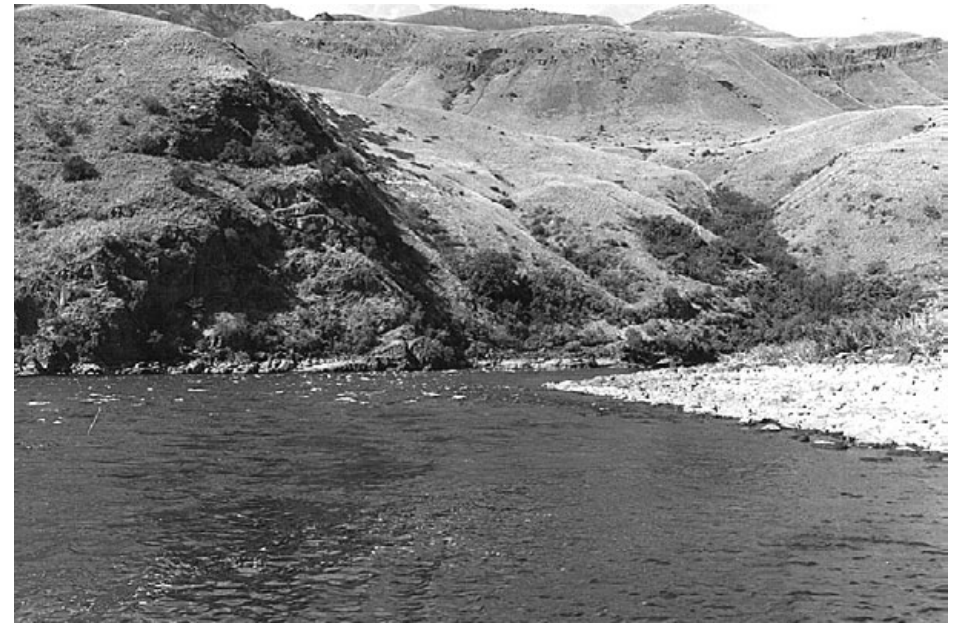
1999. Photograph of the riverbank opposite from Pittsburg Landing (photograph by J.H. Braatne). No apparent changes are visible in vegetation or shoreline conditions. The high-water mark appears at a similar river stage. A moderate increase in shrub coverage is associated with seeps and draws; much of this expansion by shrubs is related to the colonization and growth of Himalayan blackberry.

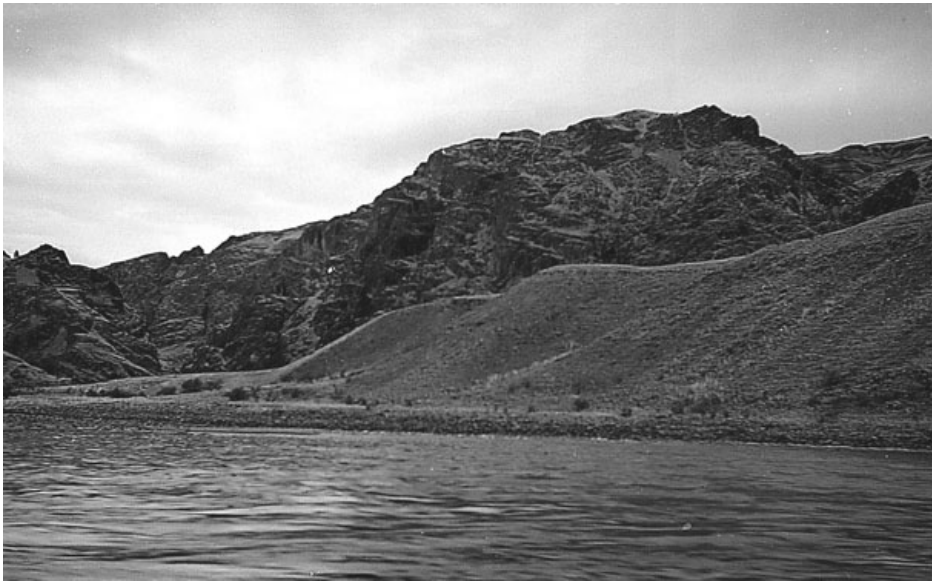
December 1953. Photograph of the riverbank adjacent to lower Pittsburg Landing (photograph by F.R. McCormick). The riparian zone is limited to a few hackberry growing at the toe slope of Bonneville Flood depositions (14,500 years ago). Riverbanks consist of cobble substrates

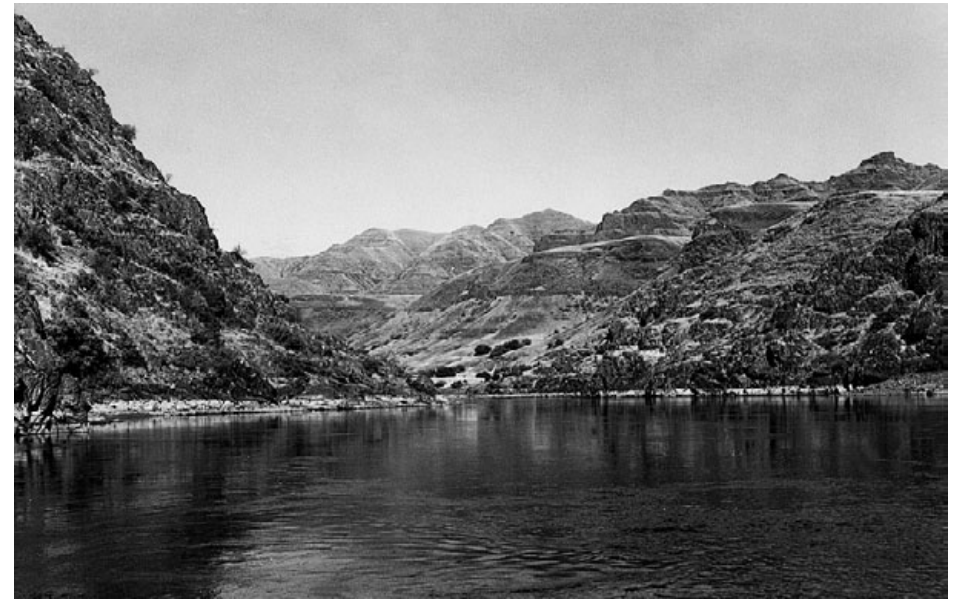
September 1999. Photograph of the Snake River looking downriver toward High Range and Getta Creeks (photograph by J.H. Braatne). No significant differences in vegetation or shoreline conditions are apparent from the historic photograph. The high-water marks appear at a similar river stage.

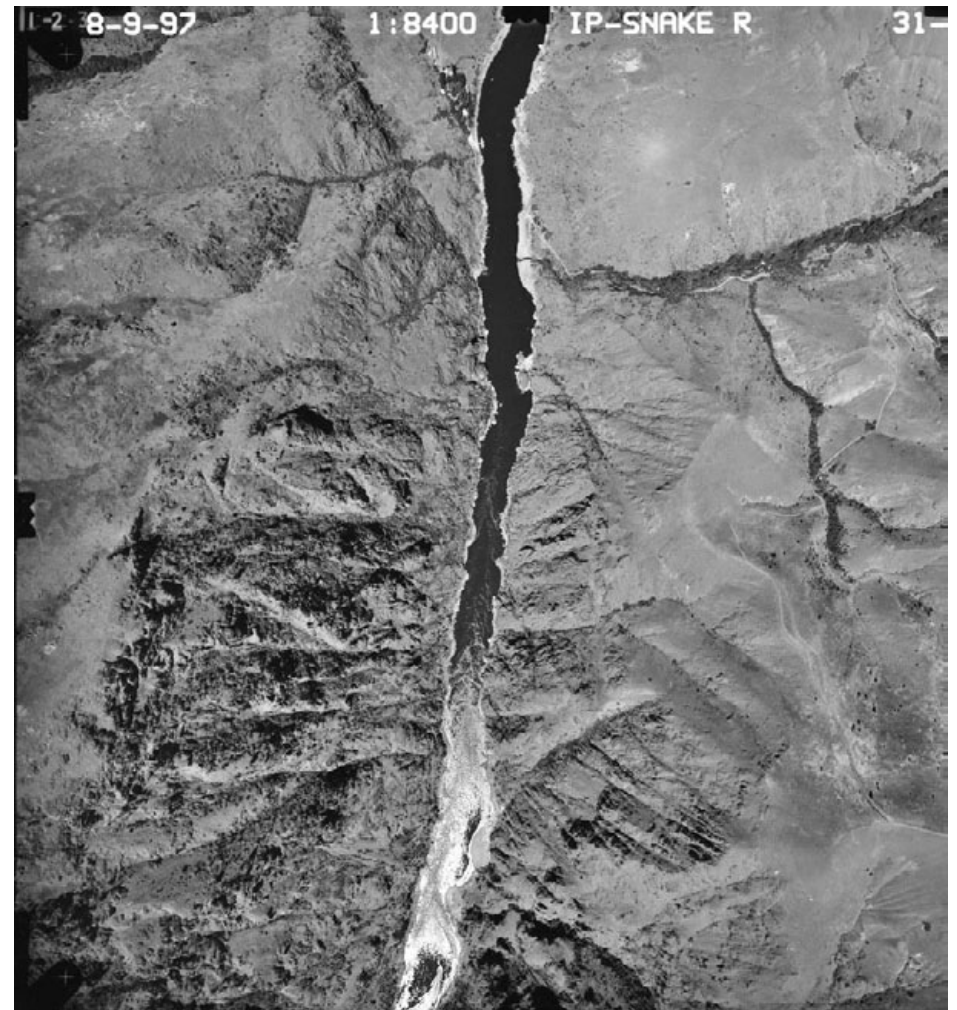
No pre-dam aerial photograph is available at this time.

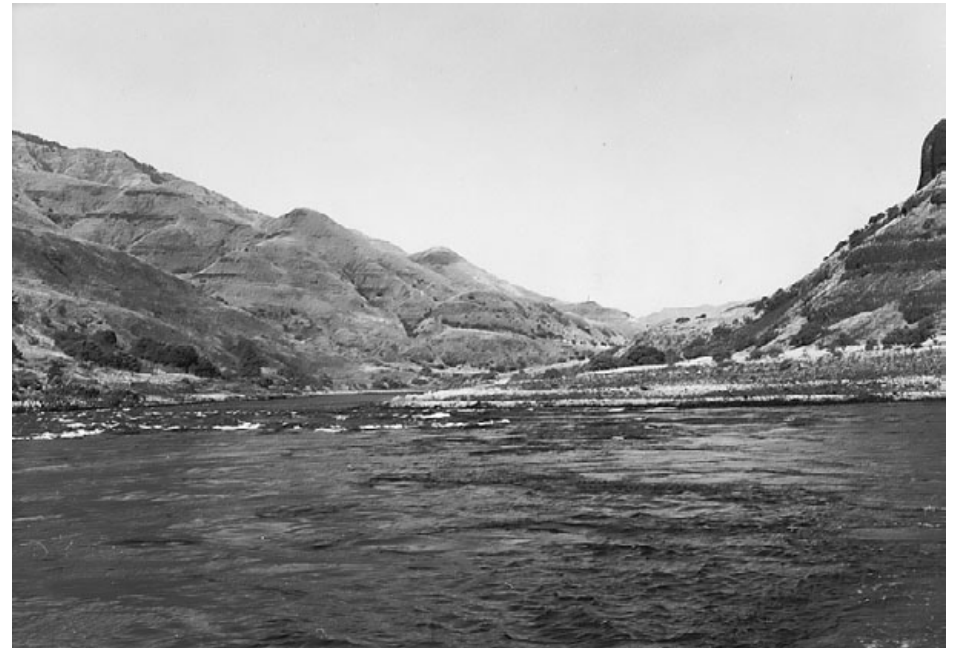
September 1999. Photograph looking downriver toward Ragtown Bar (photograph by J.H. Braatne). There are no significant differences in vegetation or shoreline conditions. Riverbanks consist of cobble and bedrock. Hackberry appears to have grown somewhat larger during the last 70 years.

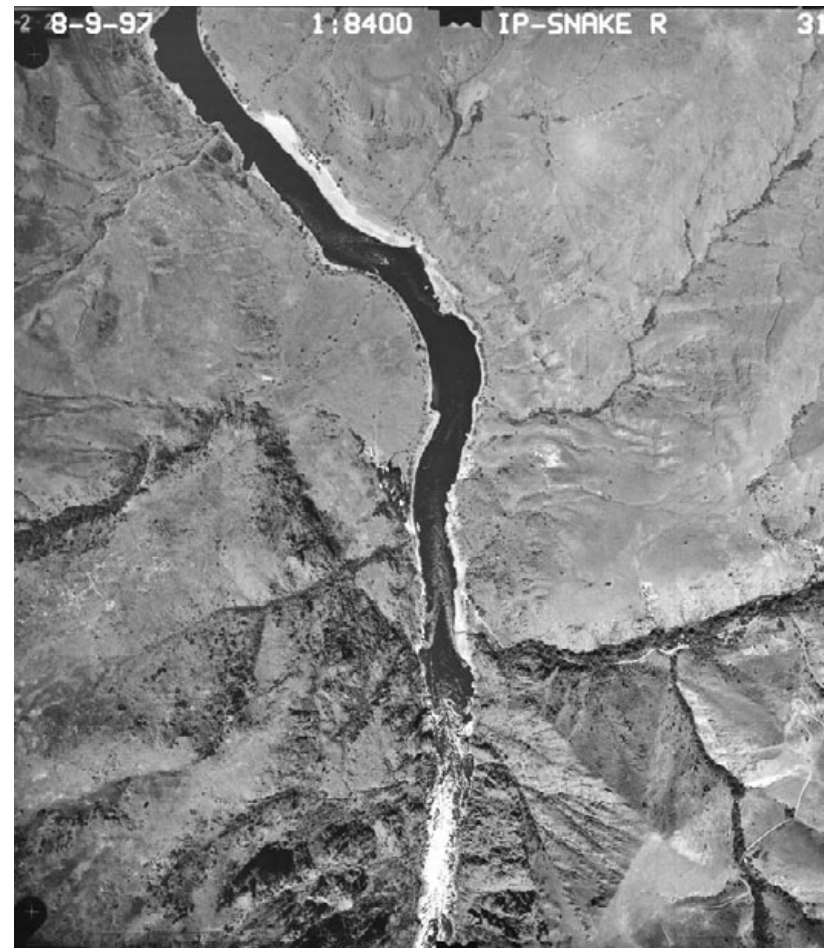
No pre-dam aerial photograph is available at this time.

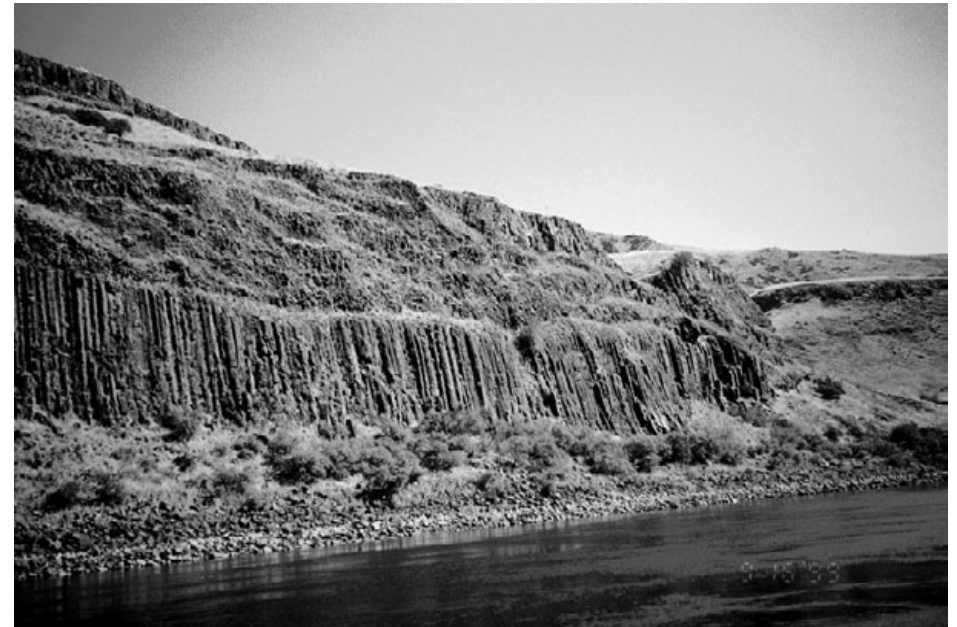
September 1999. Photograph of the Dug Bar basalt columns (photograph by J.H. Braatne). Vegetation and shoreline conditions are comparable to those in the earlier photograph. Riverbanks consist of cobble substrate.

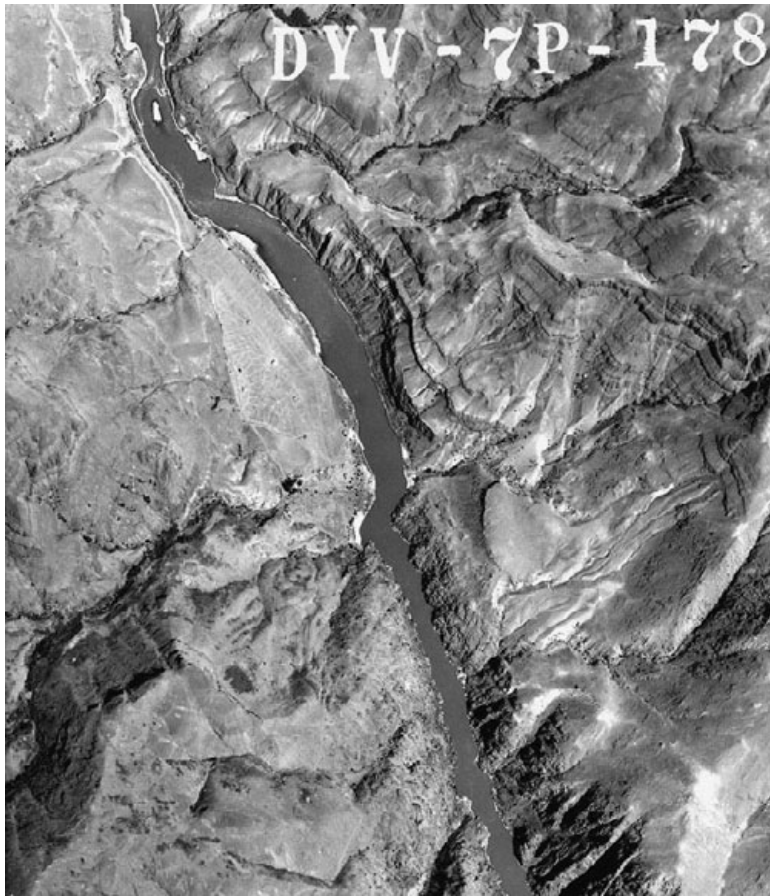
August 3, 1955. Aerial view of Dug Bar. The reach just upriver from Dug Bar is highly constrained by steep canyon walls. The canyon opens as the river flows by Dug Bar, a broad terrace derived from Bonneville Flood deposits (14,500 years ago). Channel-margin sandbars appear common along the Dug Bar corridor. Woody riparian vegetation is limited to a few scattered hackberry.

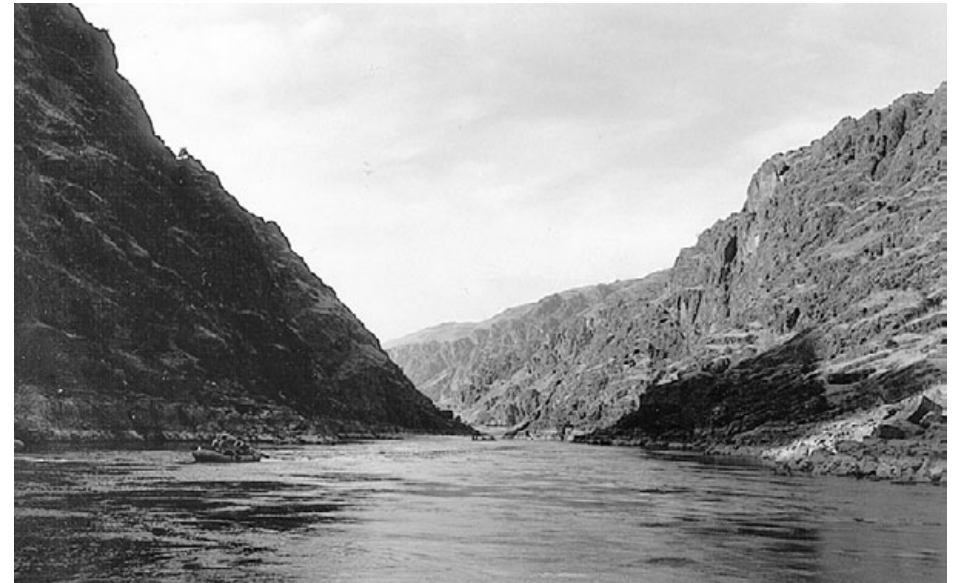
September 1999. Photograph of the corridor just upriver from the confluence of the Snake and Salmon Rivers (photograph by J.H. Braatne). There are no apparent differences in vegetation or shoreline conditions from the earlier photograph. Riverbanks consist of boulders and bedrock. High-water marks appear at a similar river stage.
