Hells Canyon Complex Aesthetic Resource Inventory and Evaluation

TECHNICAL REPORT

**Technical Report
Appendix E.6-3**

Hells Canyon Complex
FERC No. 1971

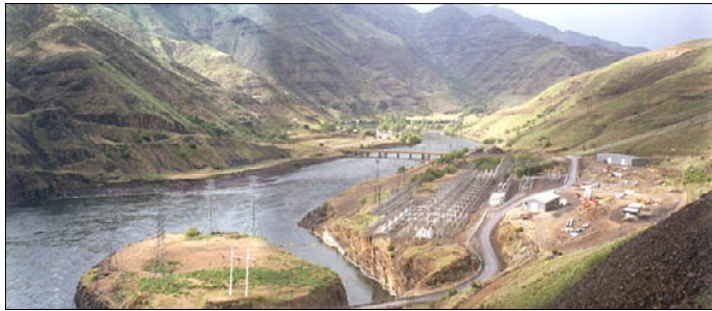
Power-generating and substation facilities. Power-generating facilities that are visible from KOPs include the Brownlee and Oxbow dams, powerhouses, access roads, and appurtenant facilities, including substations (**Figs. 11**

Fig. 11. Substation facilities at Brownlee Dam.

and **12**). These facilities typically dominate views and create strong to moderate degrees of contrast in form, line, color, and texture.

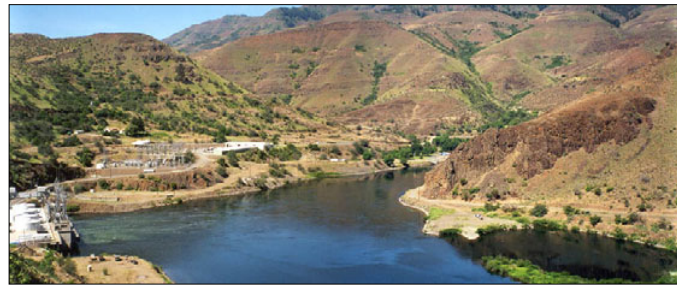
Fig. 12. Power-generating facilities at Oxbow Dam (lower left).

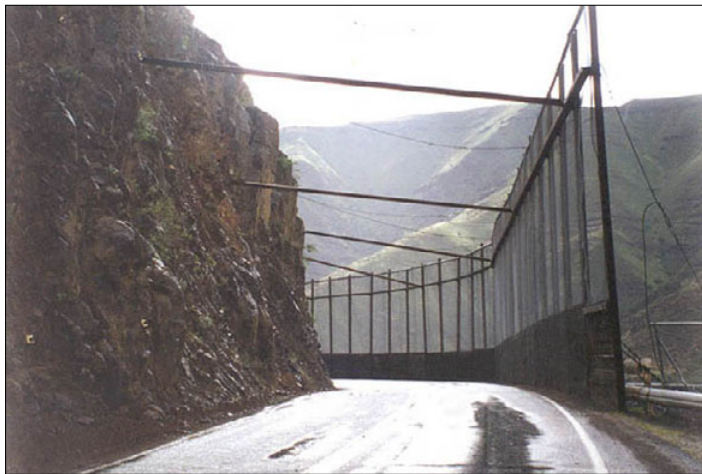
Fig. 13. The Brownlee Cage protects Project facilities on the approach to Brownlee Dam.

The Brownlee Cage protects Project facilities from falling rocks on the approach to Brownlee Dam along Idaho State Route 71 (**Fig. 13**). The cage is constructed of steel beams, wire mesh, and support cables. The cage and road cut are visible from VP #46 and contribute to the Brownlee power-generating facility's strong contrast in form, line, color, and texture.

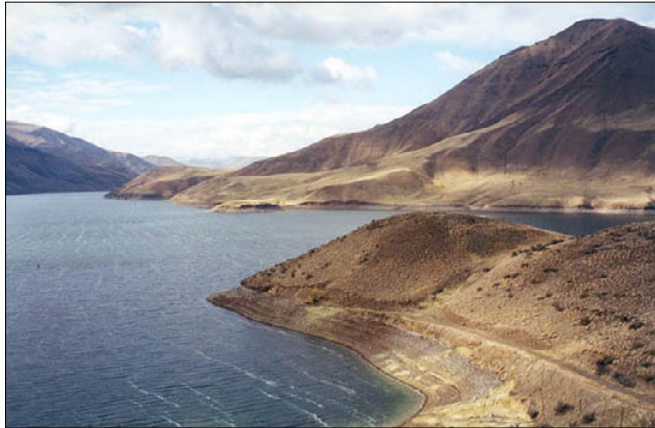
Reservoir drawdown. The drawdown effect is a result of the water-level fluctuations in the reservoirs and appears in the landscape as a distinct white- to buff-colored band along the perimeter of the reservoirs. The drawdown effect can be dramatic at Brownlee Reservoir (**Fig. 14**), where water levels can fluctuate as much as 101 feet in a season, although the reservoir has been fully drawn down only three times in the past 30 years. The effect is much less noticeable at Oxbow

Fig. 14. Drawdown effect at Brownlee Reservoir.

Reservoir (**Fig. 15**), where fluctuations typically range between three feet (summer weekends) and four feet (spring weekends). At Brownlee Reservoir, the drawdown effect typically results in weak contrasts in form and line, strong contrast in color, and moderate contrast in texture. At Oxbow Reservoir, the drawdown effect typically results in weak contrast in form, line, and texture, and moderate contrast in color.

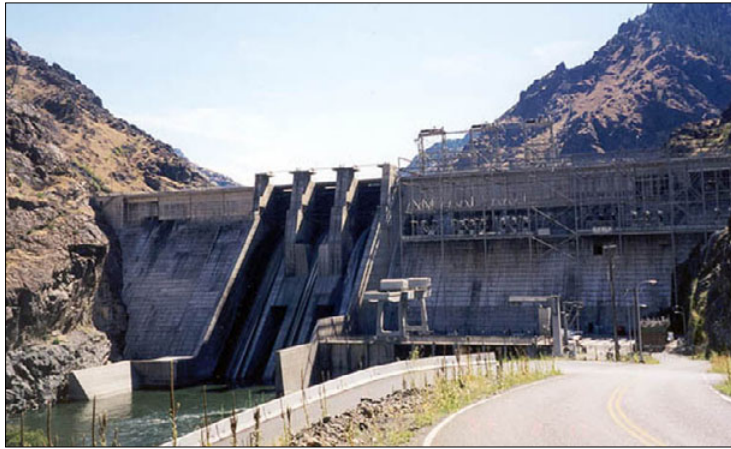
Fig. 26. Hells Canyon Dam, viewed from the north.

tunnel structure and concrete pads also detract from scenic integrity. The transmission line, although visible at one point, is not obvious along the drive from the dam to the Hells Canyon Visitor Information Center. Nevertheless, the design of the entry sequence is lackluster and does not adequately reflect the importance of the HCNRA.

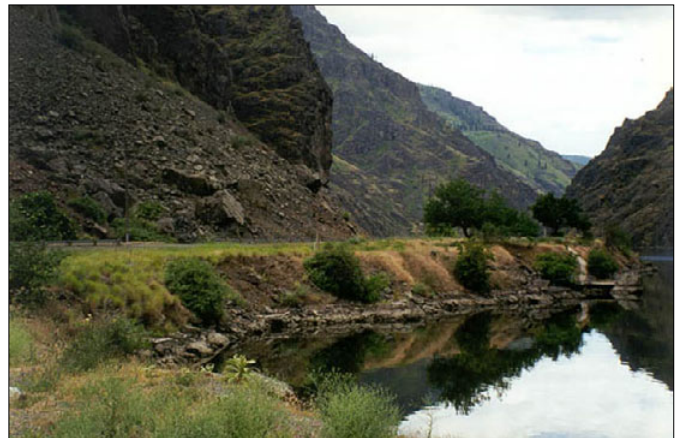
Reservoir drawdown effect. The reservoir drawdown effect is a result of the water-level fluctuations in Hells Canyon Reservoir and appears in the landscape as a distinct white-to buff-colored band along the perimeter of the reservoir (**Fig. 27**). The band is typically no wider than three feet during spring and summer weekends. It results in weak contrast in form, line, and texture, and moderate contrast in color.

Fig. 27. Drawdown effect at Hells Canyon Reservoir.

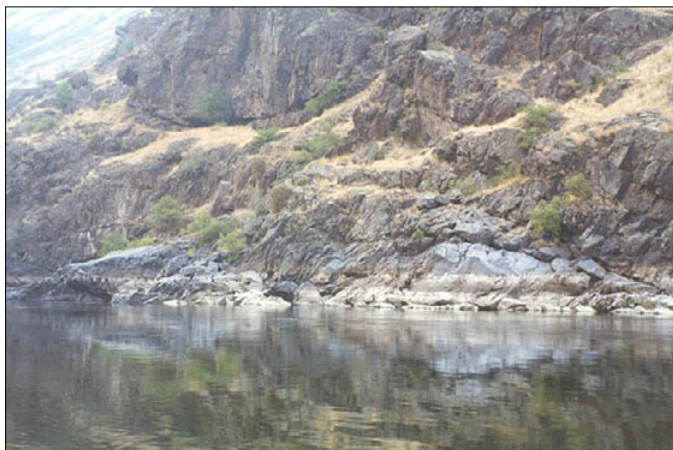
River water-level fluctuation effect.

Fluctuations in water level may result in a prominent white-to-buff band along the river's edge, which can vary from several inches to several feet in width (**Fig. 28**). The river fluctuation effect is categorized as a DH rather than a DF because the cause has not been conclusively determined to be Project-

Fig. 28. Water-level fluctuation effect on the Snake River.

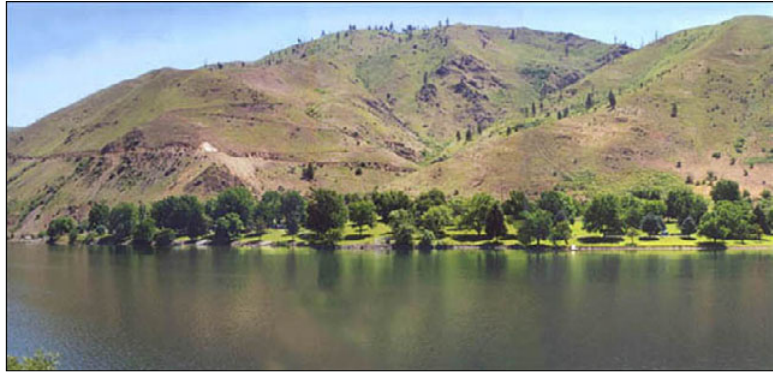
Fig. 29. Hells Canyon Park.

Project facilities and operations affect the aesthetic quality of vegetation in three significant ways. First, ornamental landscaping and irrigated lawn deviate substantially from the surrounding landscape context and compete with native vegetation. Changes in color and form are very noticeable and inconsistent with the historical

landscape character. However, many users identify the non-native shade trees and irrigated lawn as a welcome oasis from the heat of Hells Canyon. Examples include Hells Canyon Park (Viewpoint #101) (**Fig. 29**) and Kirkwood Ranch (Viewpoint #134). Second, maintenance of transmission line rights-of-way has resulted in a substantial edge effect and substantial deviations in form, line, color and texture; however, this typically occurs only in the HCNRA Uplands Unit and the effect is geographically limited. Third, recreational use below Hells Canyon Dam has resulted in trampled vegetation at many sites (assumed to be an IF).

- Modify landscaping (e.g., ornamental landscaping at Hells Canyon Park) to mimic an indigenous condition using native species wherever possible. Modifications will reduce contrast in form, line, color, and texture. Plantings should be functional, i.e., should provide shade, windbreaks, direct views, and circulation, and should screen undesirable views.
- Modify vegetation management in transmission line rights-of-way to achieve screening of lines and softening of edge effect to reduce contrast in form, line, color, and texture.

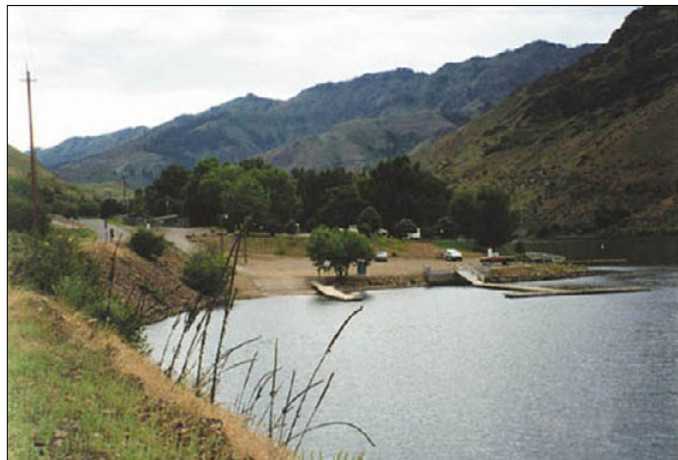
Fig. 30. Hardscape elements at Hells Canyon Park boat ramp.

Hardscape elements include items such as site furnishings, parking areas, boat ramps, roads, picnic shelters, and toilet facilities. These items were typically seen at developed sites, such as Hells Canyon Park (Viewpoint #101) (**Fig. 30**) and Dug Bar Landing (Viewpoint #144) throughout the SMS Study Area. Detractors from scenic integrity include the contrasting color and reflective qualities of materials used in docks, structures, and buildings; contrasting materials, colors, and form of handrails, chairs and tables, and fencing; use of Jersey barriers; unattractive signage; and poorly functioning parking areas. Hardscape elements generally create strong contrasts in form, line, and color, and moderate contrasts in texture. Typically, these elements are not consistent with the historical context of the landscape.

- Modify and/or dull the color of hardscape elements to match the surrounding landscape and reduce contrast in color and line.
- Replace unnatural elements (e.g., Jersey barriers) with materials more consistent with the surrounding landscape to reduce contrast in form, line, color, and texture.
- Utilize materials that are consistent with the historical landscape character (e.g., rough-sawn lumber).
- Incorporate compliance with visual standards (i.e., proposed aesthetic and design standards and guidelines discussed in **Chapter 4**) into IPC permit system for private facilities.

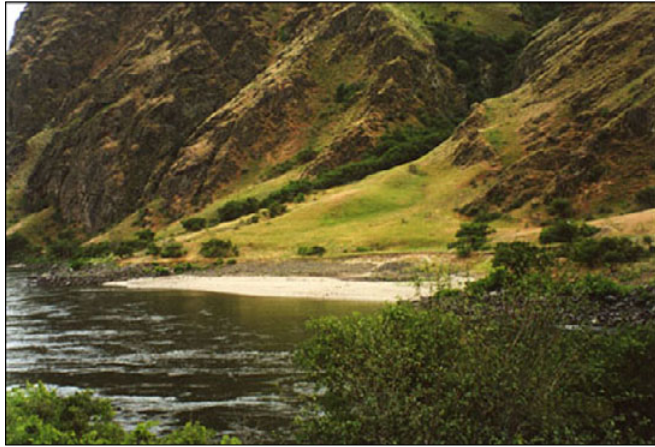
Fig. 31. Sandy beach below Hells Canyon.

Possible loss of sandy beaches. Sandy beaches occur at several sites below Hells Canyon Dam (**Fig. 31**). Observations by members of the Subgroup and others suggest the extent of sandy beaches has been reduced, in some cases significantly. However, adequate documentation does not exist to determine if Project facilities and operations have resulted in the loss of sandy beaches below Hells Canyon Dam.

Mitigating the loss of sandy beaches by replacing the sand and using erosion control techniques to retain it could be problematic. The river's designation as Wild and Scenic may limit the disturbance that is allowed, and the limit may restrict the work required to replace the sand and install erosion-control measures. Traditional engineering approaches, such as riprap would significantly detract from scenic integrity, and bioengineering approaches, such as coir lifts, livestaking, and revegetating, could disturb the open nature of the beach because developed root systems are required to hold unstable materials in place. Furthermore, the cost of importing and maintaining sand may not be reasonable.

Additional investigation beyond the scope of this report would be required to determine the feasibility of replacing and maintaining sandy beaches if IPC decides the measure is justified. If the PM&E is determined not to be feasible, mitigation may include pursuing other opportunities in coordination with USFS or improving USFS facilities in the SMS Study Area. These opportunities are discussed in **Chapter 4** and noted in the Viewpoint Summaries.

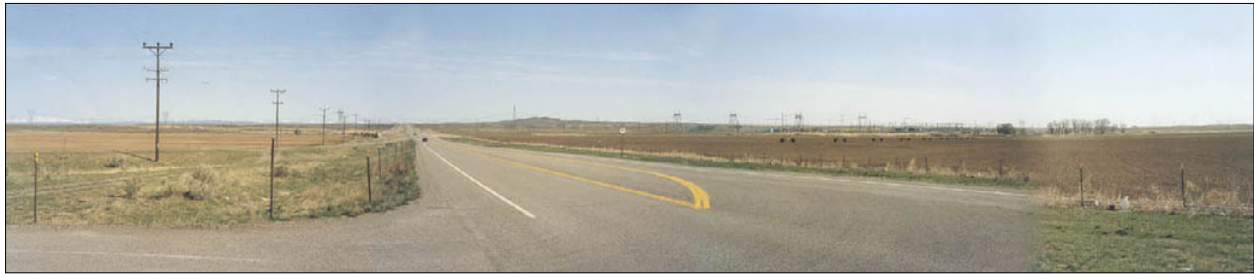
Viewpoint #5: US 93 near Midpoint Substation (KOP)

Visual Contrast Rating	Existing VRM Class	Is contrast rating acceptable for VRM Class?	Proposed VRI Class	Is contrast rating acceptable for proposed VRI Class?
10	III	Yes	N/A	N/A

Comments	NP: Multiple non-Project transmission lines visible and augment transmission line effect. Midpoint substation creates contrast in line and form. Substation most noticeable from southern approach.
-----------------	--

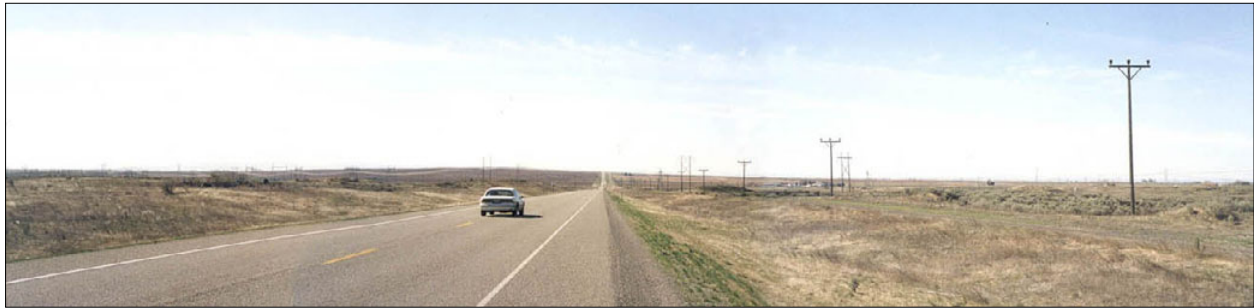
Viewpoint #6: US 93 near Midpoint Substation (KOP)

Visual Contrast Rating	Existing VRM Class	Is contrast rating acceptable for VRM Class?	Proposed VRI Class	Is contrast rating acceptable for proposed VRI Class?
10	III	Yes	N/A	N/A

Comments	NP: Multiple non-Project transmission lines visible and augment transmission line effect. Midpoint substation creates contrast in line and form. Substation most noticeable from southern approach.
-----------------	--

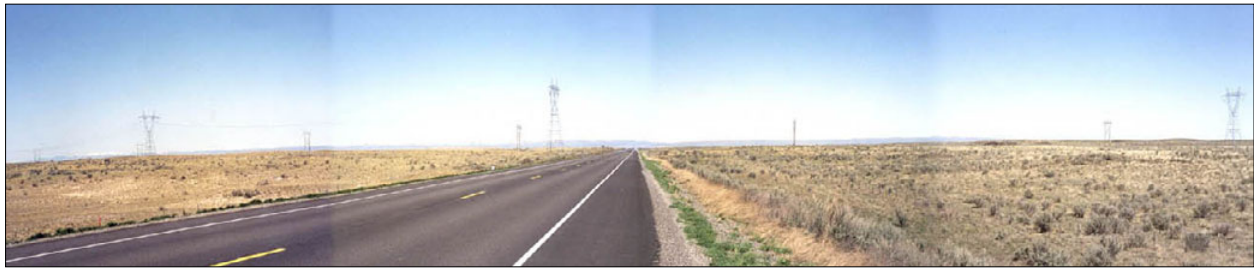
Viewpoint #7: ID SR 46 near Gooding, Idaho (KOP)

Visual Contrast Rating	Existing VRM Class	Is contrast rating acceptable for VRM Class?	Proposed VRI Class	Is contrast rating acceptable for proposed VRI Class?
17	III	Yes	N/A	N/A

IPC Facilities/ Operations	Current / Proposed Operations		Full Pool/ Run-of-River
	Effects	Suggested PM&E	Effects
Line 906 (H-frame wood)	DF: Transmission line silhouetted on horizon (in flat landscape)	No specific measures are proposed. ¹	N/A

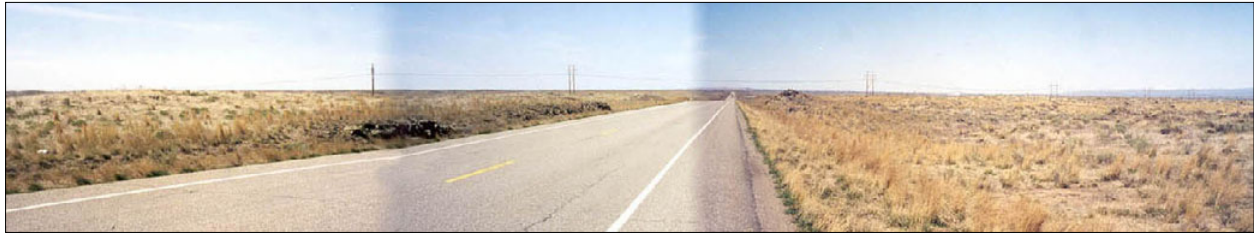
Viewpoint #8: ID SR 26 near Shoshone, Idaho (KOP)

Visual Contrast Rating	Existing VRM Class	Is contrast rating acceptable for VRM Class?	Proposed VRI Class	Is contrast rating acceptable for proposed VRI Class?
18	III	Yes	N/A	N/A
IPC Facilities/ Operations	Current / Proposed Operations			Full Pool/ Run-of-River
	Effects	Suggested PM&E		Effects
Line 912 (H-frame wood/laminate)	DF: Transmission line silhouetted on horizon	No specific measures are proposed. ¹		N/A
Comments	None

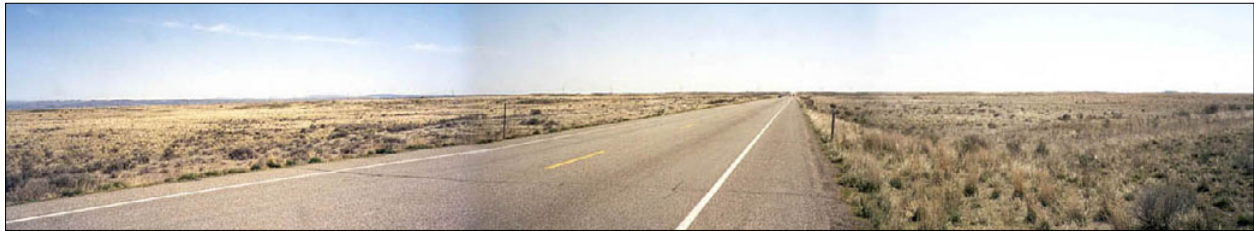
Viewpoint #9: ID SR 26 near Shoshone, Idaho (KOP)

Visual Contrast Rating	Existing VRM Class	Is contrast rating acceptable for VRM Class?	Proposed VRI Class	Is contrast rating acceptable for proposed VRI Class?
18	III	Yes	N/A	N/A
IPC Facilities/ Operations	Current / Proposed Operations		Full Pool/ Run-of-River	
	Effects	Suggested PM&E	Effects	
Line 912 (H-frame wood/laminate)	DF: Transmission line silhouetted on horizon	No specific measures are proposed. ¹	N/A	
Comments	None

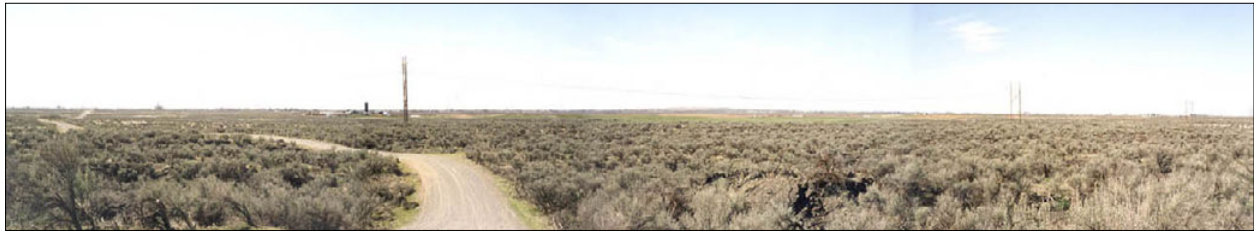
Viewpoint #10: Road 2300 (KOP)

Visual Contrast Rating	Existing VRM Class	Is contrast rating acceptable for VRM Class?	Proposed VRI Class	Is contrast rating acceptable for proposed VRI Class?
18	II	No	N/A	N/A

Comments	Effect most noticeable from northern approach and is visible for very short period of time as motorists approach and pass under line. Relocating towers is not reasonable.
-----------------	--

IPC Facilities/ Operations	Current / Proposed Operations		Full Pool/ Run-of-River
	Effects	Suggested PM&E	Effects
Line 912 (H-frame wood/laminate)	DF: Transmission line silhouetted on horizon	Replace lines with non-specular wire in normal maintenance cycle.	N/A

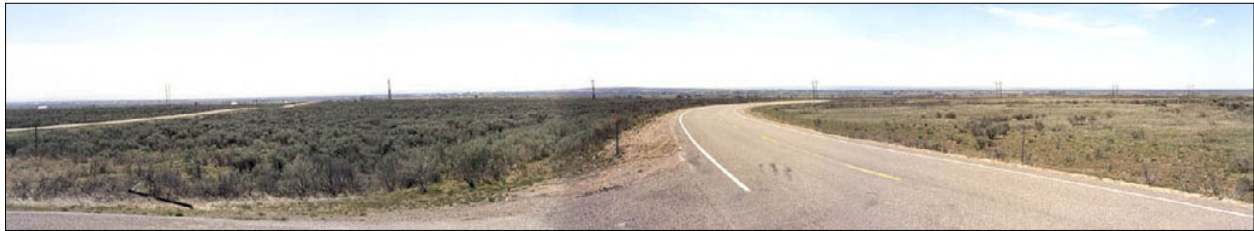
Viewpoint #11: ID SR 46 and Old Highway 46 (KOP)

Visual Contrast Rating	Existing VRM Class	Is contrast rating acceptable for VRM Class?	Proposed VRI Class	Is contrast rating acceptable for proposed VRI Class?
17	II	No	N/A	N/A
IPC Facilities/ Operations	Current / Proposed Operations		Full Pool/ Run-of-River	
	Effects	Suggested PM&E	Effects	
Line 912 (H-frame wood/laminate)	DF: Six towers silhouetted from southern approach	Replace lines with non-specular wire in normal maintenance cycle.	N/A	
Comments	Effect is visible for very short time period as motorists approach and pass under line. Relocating towers is not reasonable.

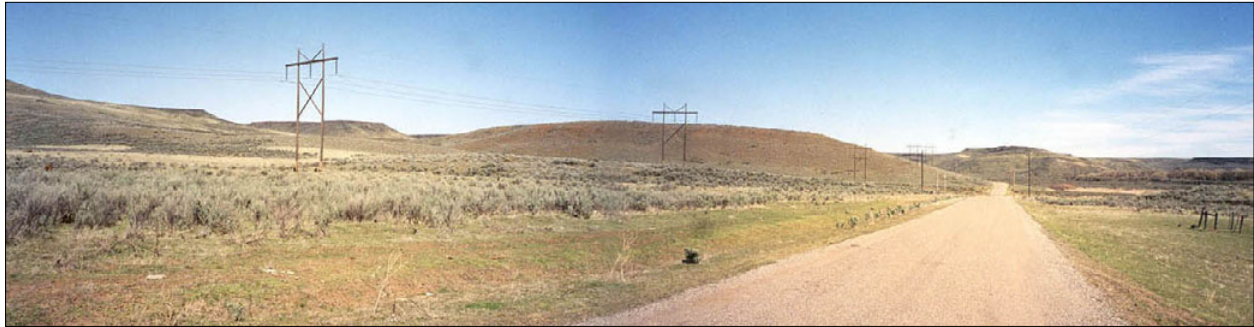
Viewpoint #13: Clover Creek Road (KOP)

Visual Contrast Rating	Existing VRM Class	Is contrast rating acceptable for VRM Class?	Proposed VRI Class	Is contrast rating acceptable for proposed VRI Class?
13	IV	Yes	N/A	N/A

IPC Facilities/ Operations	Current / Proposed Operations		Full Pool/ Run-of-River
	Effects	Suggested PM&E	Effects
Line 912 (H-frame wood/laminate)	DF: Four towers silhouetted on ridge to north in foreground/midground.	No specific measures are proposed. ¹	N/A

Comments	Gravel road parallels transmission line.
----------	--

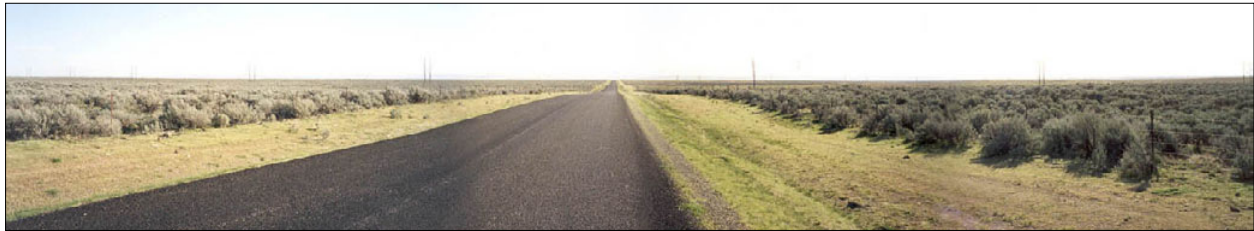
Viewpoint #15: Bennett Mountain Road – Line 906 (KOP)

Visual Contrast Rating	Existing VRM Class	Is contrast rating acceptable for VRM Class?	Proposed VRI Class	Is contrast rating acceptable for proposed VRI Class?
17	I	No	N/A	N/A
IPC Facilities/ Operations	Current / Proposed Operations		Full Pool/ Run-of-River	
	Effects	Suggested PM&E	Effects	
Line 906 (H-frame wood)	DF: Transmission line crosses Bennett Mountain Road.	Replace lines with non-specular wire in normal maintenance cycle.	N/A	
Comments	Effect is visible for very short time period as motorists approach and pass under line. Relocating towers is not reasonable.

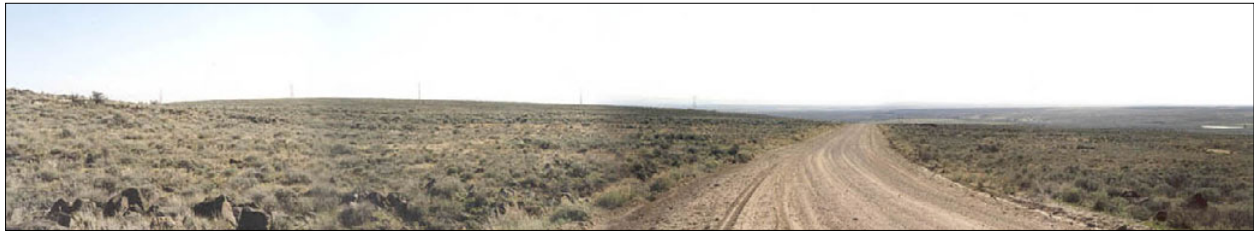
Viewpoint #16: Bennett Mountain Road – Line 912 (KOP)

Visual Contrast Rating	Existing VRM Class	Is contrast rating acceptable for VRM Class?	Proposed VRI Class	Is contrast rating acceptable for proposed VRI Class?
17	III	Yes	N/A	N/A
IPC Facilities/ Operations	Current / Proposed Operations		Full Pool/ Run-of-River	
	Effects	Suggested PM&E	Effects	
Line 912 (H-frame wood/laminate)	DF: Five towers silhouetted on horizon.	No specific measures are proposed. ¹	N/A	
Comments	Effect is visible for very short time period as motorists approach and pass under line.

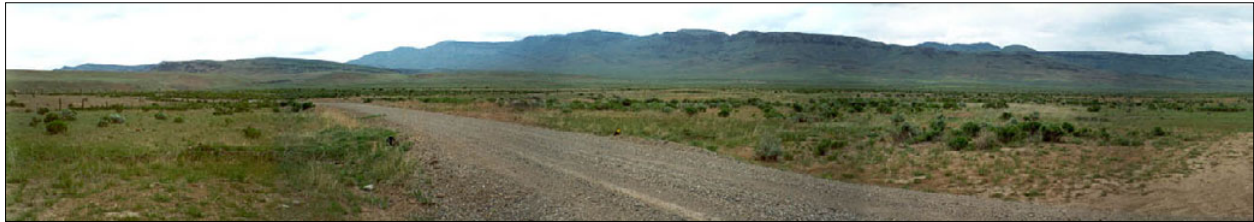
Viewpoint #17: Centennial Trail (KOP)

Visual Contrast Rating	Existing VRM Class	Is contrast rating acceptable for VRM Class?	Proposed VRI Class	Is contrast rating acceptable for proposed VRI Class?
8	II	Yes	N/A	N/A
IPC Facilities/ Operations	Current / Proposed Operations		Full Pool/ Run-of-River	
	Effects	Suggested PM&E	Effects	
Line 912 (H-frame wood/Laminate)	DF: Transmission line in middle-ground and well below ridgeline; towers mimic patterns of fence posts.	No specific measures are proposed. ¹	N/A	
Comments	None

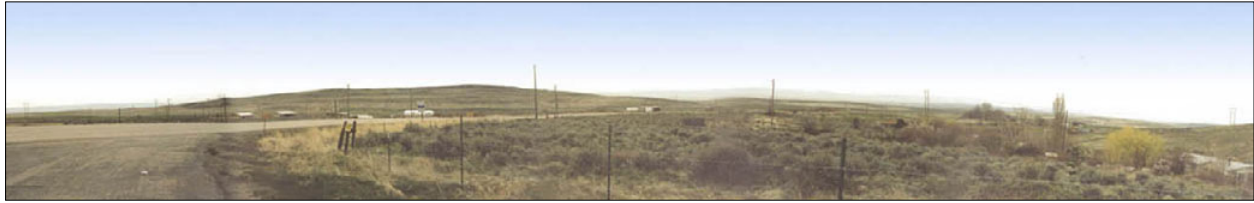
Viewpoint #18: Rattlesnake Station Historical Site and US 20 (KOP)

Visual Contrast Rating	Existing VRM Class	Is contrast rating acceptable for VRM Class?	Proposed VRI Class	Is contrast rating acceptable for proposed VRI Class?
14	I	No	N/A	N/A

Comments	Road crossing is good example of reduced effect with long span. Relocating towers is not reasonable.
-----------------	--

IPC Facilities/ Operations	Current / Proposed Operations		Full Pool/ Run-of-River
	Effects	Suggested PM&E	Effects
Line 912 (H-frame wood/laminate)	DF: Three towers silhouetted.	Replace lines with non-specular wire in normal maintenance cycle.	N/A

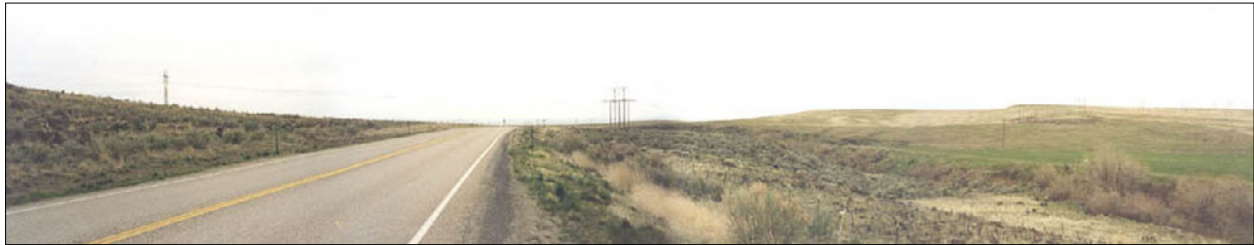
Viewpoint #19: US 20 (KOP)

Visual Contrast Rating	Existing VRM Class	Is contrast rating acceptable for VRM Class?	Proposed VRI Class	Is contrast rating acceptable for proposed VRI Class?
22	III	No	N/A	N/A

IPC Facilities/ Operations	Current / Proposed Operations		Full Pool/ Run-of-River
	Effects	Suggested PM&E	Effects
Line 906 (H-frame wood)	DF: Six towers silhouetted to west in middleground/ background.	Replace lines with non-specular wire in normal maintenance cycle.	N/A

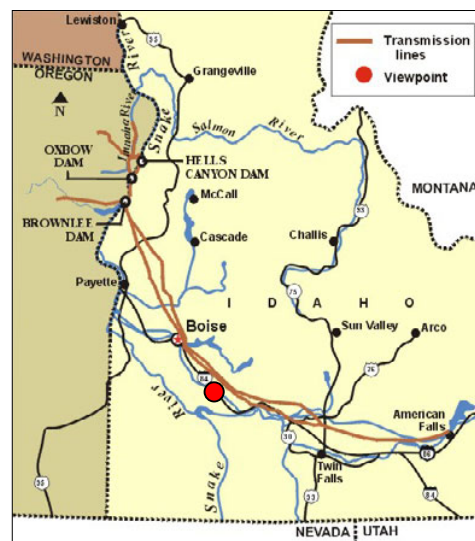
Viewpoint #20: Bonneville Point (KOP)

Visual Contrast Rating	Existing VRM Class	Is contrast rating acceptable for VRM Class?	Proposed VRI Class	Is contrast rating acceptable for proposed VRI Class?
17	I	No	N/A	N/A
IPC Facilities/ Operations	Current / Proposed Operations		Full Pool/ Run-of-River	
	Effects	Suggested PM&E	Effects	
Line 906 (H-frame wood); Line 912 (H-frame wood/laminate, steel lattice)	DF: Four steel lattice towers silhouetted on adjacent ridge.	Replace lines with non-specular wire in normal maintenance cycle. ¹	N/A	
Comments	<p>NP: Multiple non-subject lines in valley and nearby radio towers moderate effect. Because IPC's line is in the background view and many other lines are in the vicinity, the cumulative view would be improved little by the suggested mitigation. Viewpoint clearly occurs in Class I due to proximity to Oregon Trail. BLM mapping is unclear as to whether impact occurs in I, II, or III.</p>

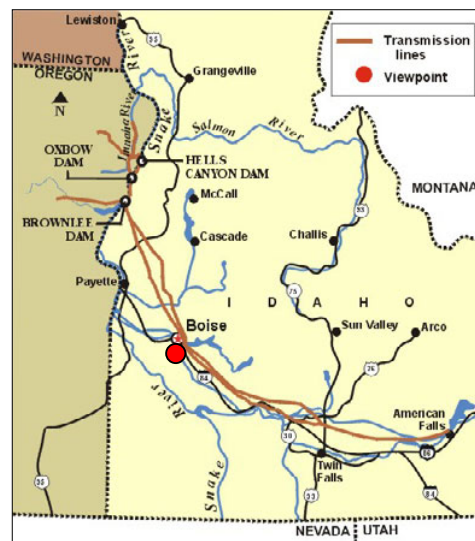
Viewpoint #21: Discovery Unit, Lucky Peak State Park (KOP)

Visual Contrast Rating	Existing VRM Class	Is contrast rating acceptable for VRM Class?	Proposed VRI Class	Is contrast rating acceptable for proposed VRI Class?
17	II	No	N/A	N/A
IPC Facilities/ Operations	Current / Proposed Operations		Full Pool/ Run-of-River	
	Effects	Suggested PM&E	Effects	
Line 912 (H-frame wood/laminate, steel lattice)	DF: Three steel lattice towers are silhouetted on adjacent ridge.	Replace lines with non-specular wire in normal maintenance cycle. ¹	N/A	
Comments	Impact occurs in Class I but is viewed from Class II. NP: The nearby dam and related facilities have much more significant aesthetic impact than the Project transmission line. The cumulative effect would not be substantially improved by the suggested mitigation measures.

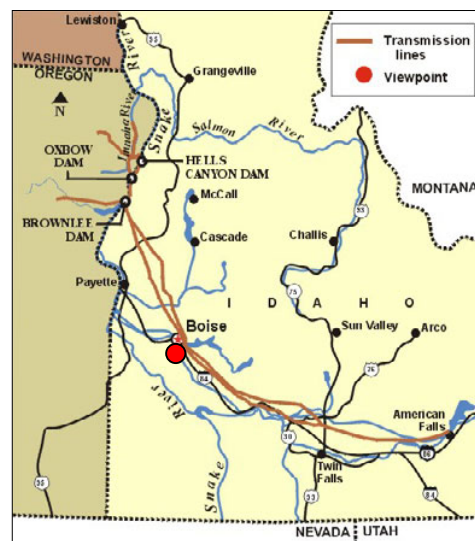
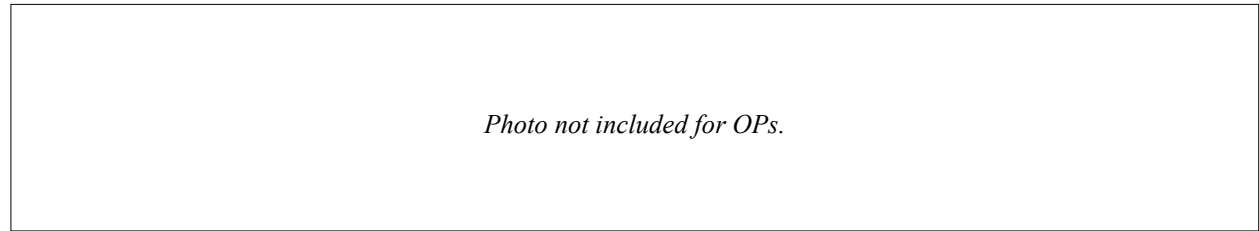
Viewpoint #22: Rocky Canyon Road (FR 360) (OP)

Visual Contrast Rating	Existing VRM Class	Is contrast rating acceptable for VRM Class?	Proposed VRI Class	Is contrast rating acceptable for proposed VRI Class?
Not rated	II	Yes	N/A	N/A
IPC Facilities/ Operations	Current / Proposed Operations		Full Pool/ Run-of-River	
	Effects	Suggested PM&E		Effects
Line 911 (steel lattice)	Negligible	No specific measures are proposed. ¹		N/A
Comments	Topography and vegetation screen the transmission line.

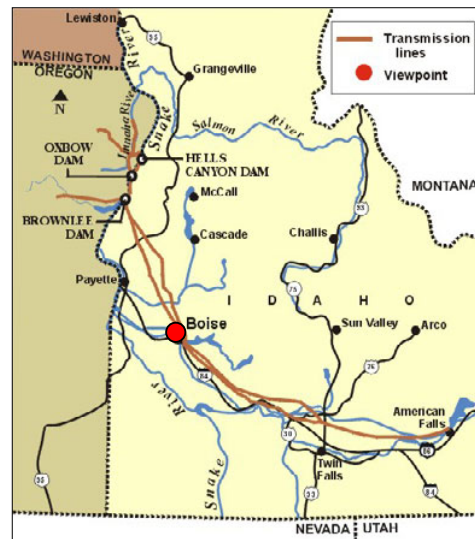
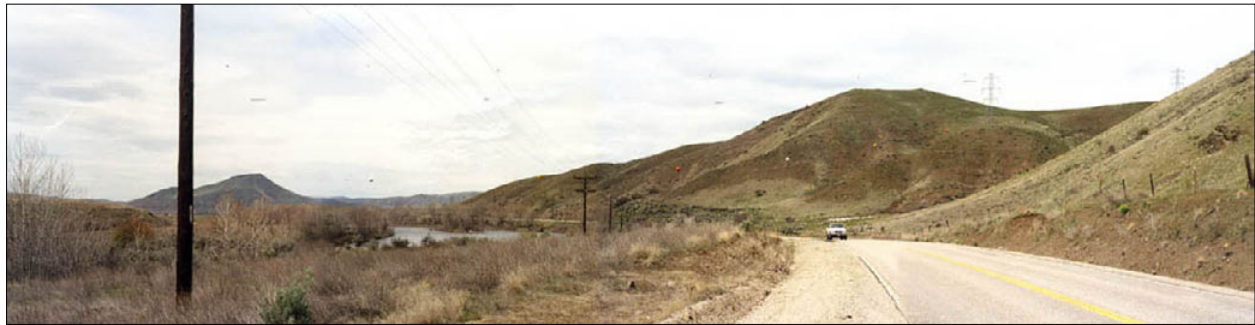
Viewpoint #23: Payette River and ID SR 52 (KOP)

Visual Contrast Rating	Existing VRM Class	Is contrast rating acceptable for VRM Class?	Proposed VRI Class	Is contrast rating acceptable for proposed VRI Class?
21	II	No	N/A	N/A
IPC Facilities/ Operations	Current / Proposed Operations		Full Pool/ Run-of-River	
	Effects	Suggested PM&E	Effects	
Line 911 (steel lattice)	DF: Steel lattice tower transmission line crosses Payette River and ID SR 52; towers silhouetted to south middle-ground/background.	Replace lines with non-specular wire in normal maintenance cycle.	N/A	
Comments	Effect is visible for very short time period as motorists approach and pass under line. Relocating towers is not reasonable.

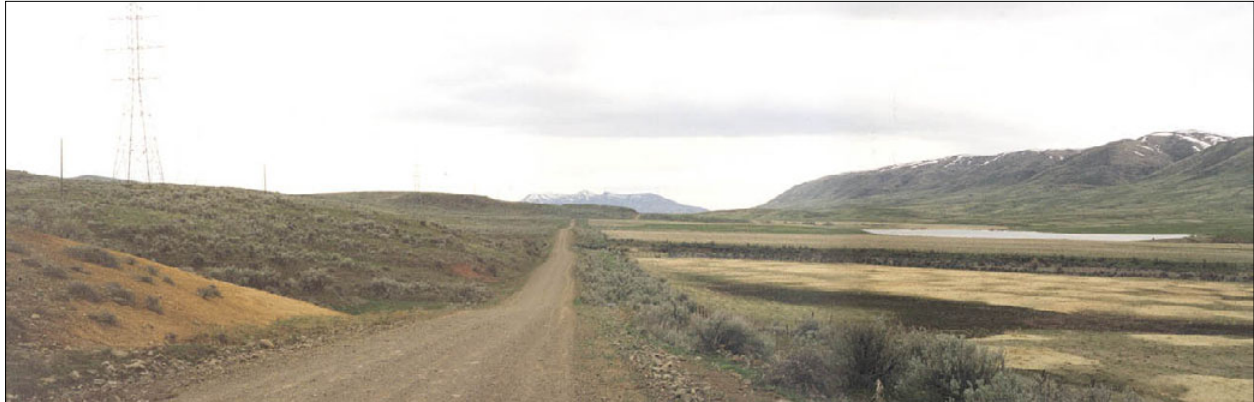
Viewpoint #24: North Crane Road (KOP)

IPC Facilities/ Operations	Current / Proposed Operations		Full Pool/ Run-of-River
	Effects	Suggested PM&E	Effects
Line 911 (steel lattice)	DF: Six steel lattice towers silhouetted from viewpoint.	Replace lines with non-specular wire in normal maintenance cycle.	N/A

Comments	Very low-usage travel route. Relocating towers not reasonable.
----------	--

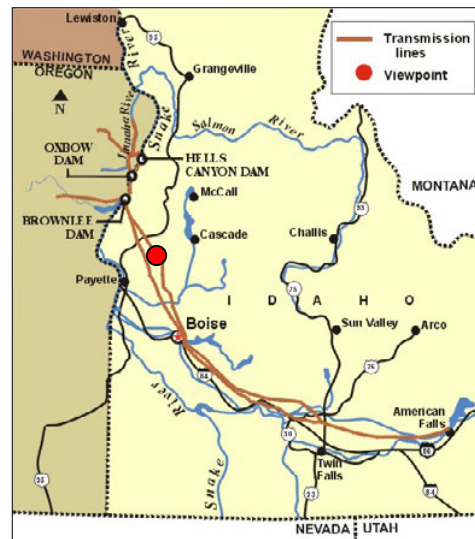
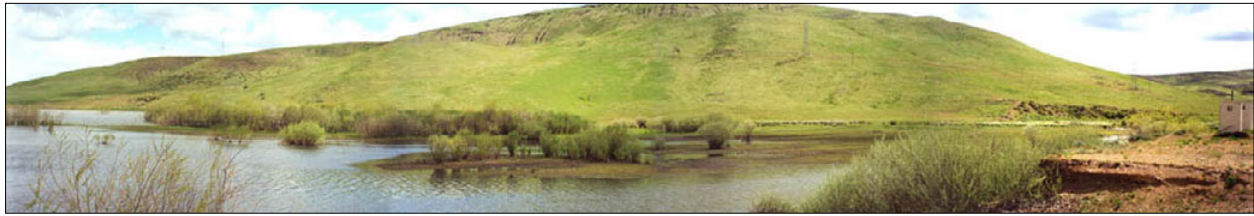
Viewpoint #25: Paddock Valley Reservoir (KOP)

Visual Contrast Rating	Existing VRM Class	Is contrast rating acceptable for VRM Class?	Proposed VRI Class	Is contrast rating acceptable for proposed VRI Class?
23	II	No	N/A	N/A
IPC Facilities/ Operations	Current / Proposed Operations		Full Pool/ Run-of-River	
	Effects	Suggested PM&E		Effects
Line 904 (steel lattice)	DF: Transmission line silhouetted along east side of reservoir. Maintenance road visible across slope.	Replace lines with non-specular wire in normal maintenance cycle. Paint towers below ridgeline to match landscape colors. Bring formal spur down from maintenance road to access reservoir. ¹ Prepare visual simulation to determine benefits of suggested PM&E.		N/A
Comments	Consider if user type (e.g., fishermen) warrants mitigation. BLM suggested road access spur would result in higher visual impact than existing conditions.

¹BLM Cascade Resource Area (now Four Rivers Resource Area) suggested improving informal reservoir access road and culverting through springs or bringing improved road spur down to reservoir from maintenance road.

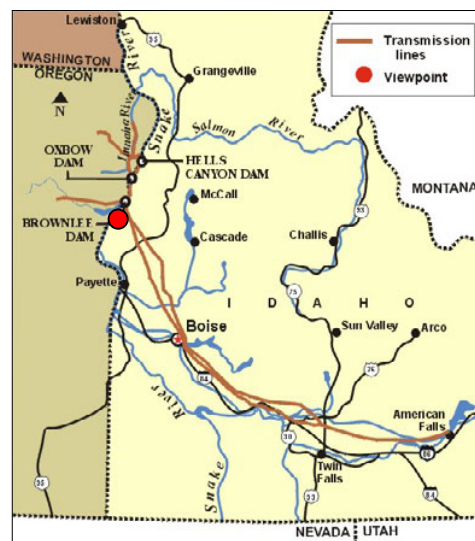
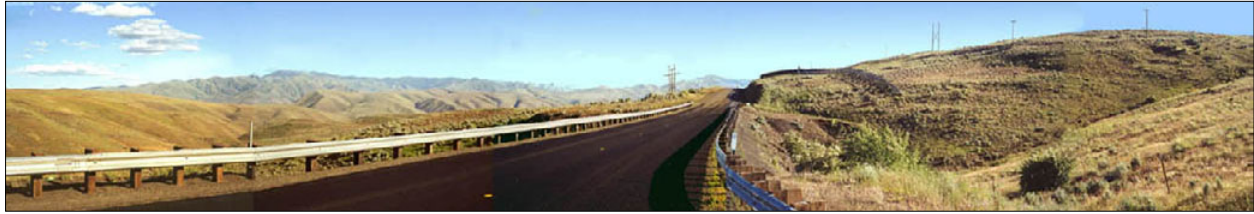
Viewpoint #30: OR SR 86 near Richland, Oregon (KOP)

Visual Contrast Rating	Existing VRM Class	Is contrast rating acceptable for VRM Class?	Proposed VRI Class	Is contrast rating acceptable for proposed VRI Class?
24	III	No	N/A	N/A
IPC Facilities/ Operations	Current / Proposed Operations		Full Pool/ Run-of-River	
	Effects	Suggested PM&E	Effects	
Line 903 (H-frame wood)	DF: Transmission line crosses Scenic Byway at right angle. Major structural tower silhouetted immediately adjacent to road.	Replace line with non-specular wire in normal maintenance cycle.	N/A	
Comments	No visual standards exist for Scenic Byway. Site conditions limit ability to modify location and type of tower. Effect is visible for very short time period as motorists approach and pass under line.

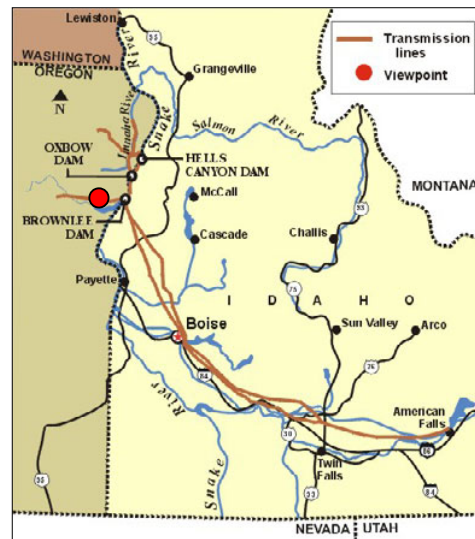
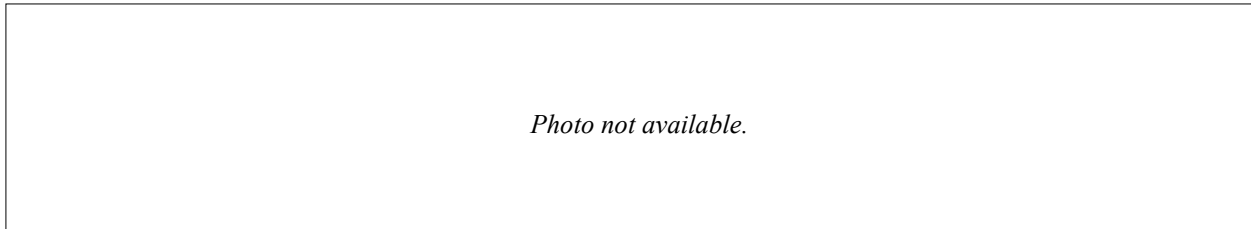
Viewpoint #31: OR SR 86 and Hole-in-the-Wall Interpretive Site (KOP)

IPC Facilities/ Operations	Current / Proposed Operations		Full Pool/ Run-of-River
	Effects	Suggested PM&E	Effects
Line 903 (H-frame wood)	DF: Two towers silhouetted on ridge in background.	No specific measures are proposed. ¹	N/A

Comments	Distance to transmission line minimizes effect. Viewpoint is within public right-of-way; impact is on private land. There is no VRM Class assigned to this area.
----------	--

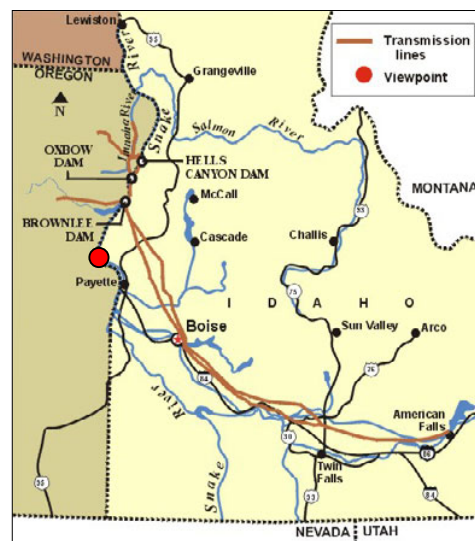
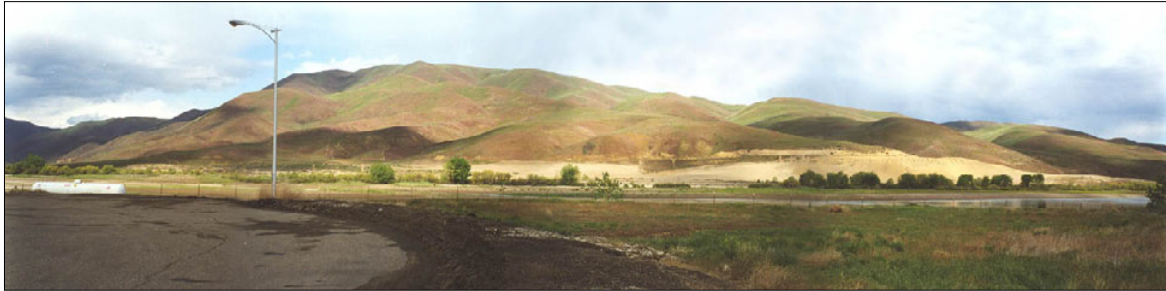
Viewpoint #34: Weiser Dunes (KOP)

IPC Facilities/ Operations	Current / Proposed Operations		Full Pool/ Run-of-River
	Effects	Suggested PM&E	Effects
Brownlee Reservoir	DF: High level of noxious weeds present in drawdown zone. Drawdown effect not obtrusive at time of contrast rating (May 2000).	None required (see comments).	Noxious weeds and drawdown effect eliminated by full pool.

Comments
Drawdown effect may increase contrast at lower water levels. Trail network highly visible resulting from high contrast between vegetation and bare ground. IPC not responsible for trail network impacts at this site. Although no PM&E is required, opportunity exists to coordinate with the BLM to manage weeds at this site.

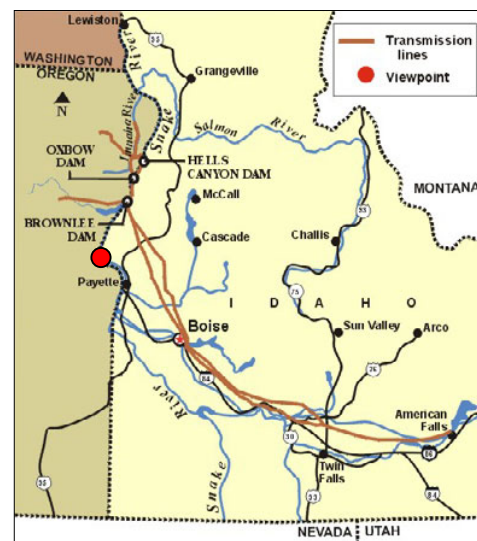
Viewpoint #36: Burnt River Confluence/Steck Park (KOP)

Visual Contrast Rating	Existing VRM Class (Oregon/Idaho)	Is contrast rating acceptable for VRM Class?	Proposed VRI Class	Is contrast rating acceptable for proposed VRI Class?
17	IV / II	No	III	Yes
IPC Facilities/ Operations	Current / Proposed Operations		Full Pool/ Run-of-River	
	Effects	Suggested PM&E	Effects	
Brownlee Reservoir	DF: Drawdown effect creates high contrast.	Moderate water level fluctuations to reduce drawdown effect.	Drawdown effect eliminated by full pool.	
Comments	NP: BLM facilities (access, parking, and ramp) across river at Steck Park create high contrast. IPC not responsible for BLM facilities at this site. Opportunity exists to coordinate with BLM to develop master plan for this site.

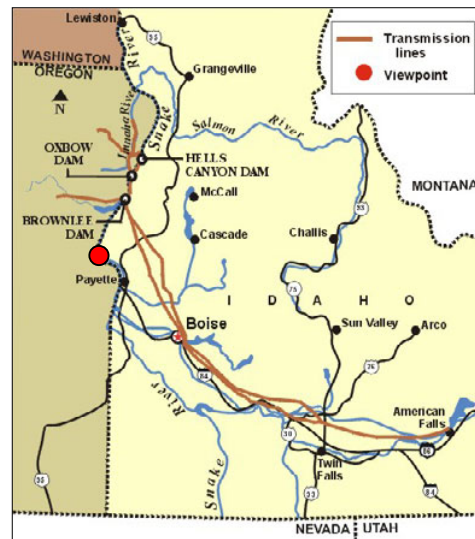
Viewpoint #37: Spring Recreation Site (KOP)

Visual Contrast Rating	Existing VRM Class (Oregon/Idaho)	Is contrast rating acceptable for VRM Class?	Proposed VRI Class	Is contrast rating acceptable for proposed VRI Class?
15	II / II	No	III	Yes
IPC Facilities/ Operations	Current / Proposed Operations		Full Pool/ Run-of-River	
	Effects	Suggested PM&E	Effects	
Brownlee Reservoir	DF: Drawdown effect creates high contrast.	Moderate water level fluctuations to reduce drawdown effect.	Drawdown effect eliminated by full pool.	
Comments	Vehicle control well suited to site. Opportunity exists to coordinate with BLM to develop master plan using desirable plants (native species if feasible) to provide screening.

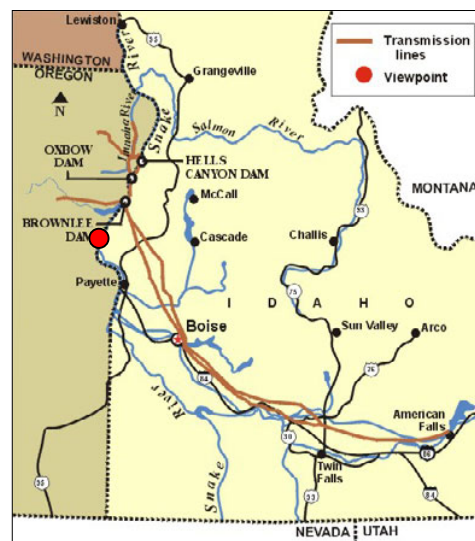
Viewpoint #38: Railroad Tunnel Historical Site (KOP)

IPC Facilities/ Operations	Current / Proposed Operations		Full Pool/ Run-of-River
	Effects	Suggested PM&E	Effects
Brownlee Reservoir	DF: Reservoir color is unsightly brown. Drawdown effect creates high contrast. Nearby dock is white and produces high contrast.	Moderate water level fluctuations to reduce drawdown effect. Incorporate compliance with the proposed aesthetic and design standards and guidelines into IPC permit system. Require color change of nearby dock to blend with natural surroundings when permits are renewed.	Drawdown effect eliminated by full pool.

Comments	This site is typical for river corridor between Cool Cabin and Spring Recreation Site. Reduced water temperature would improve water color but is an overall water-quality problem, not solely IPC's.
-----------------	---

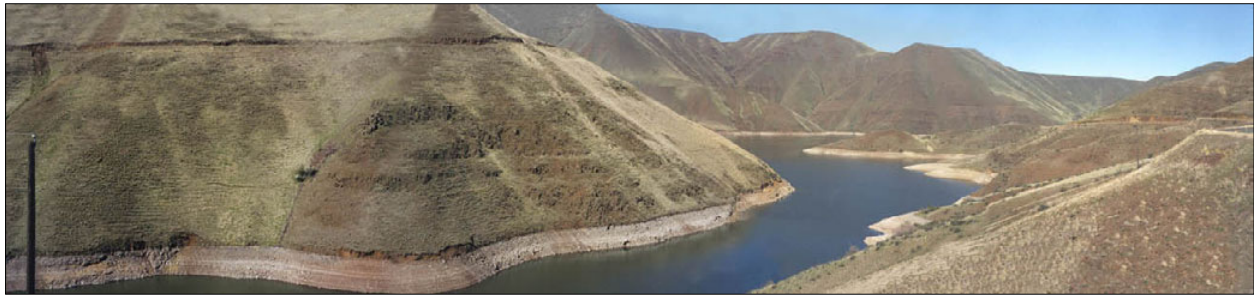
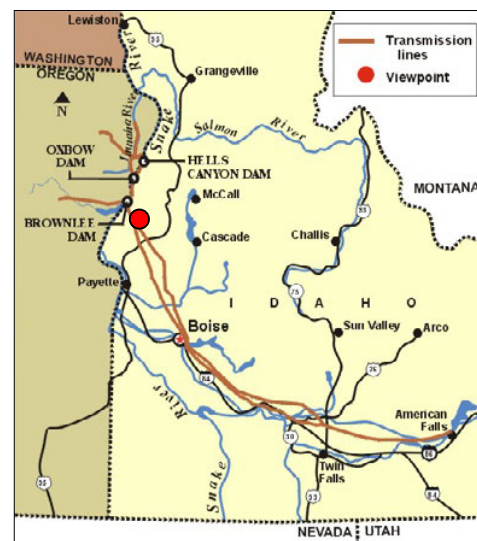
Viewpoint #43: Brownlee Creek Arm (KOP)

Visual Contrast Rating	Existing VRM Class (Oregon/Idaho)	Is contrast rating acceptable for VRM Class?	Proposed VRI Class	Is contrast rating acceptable for proposed VRI Class?
15	II / II	No	III	Yes

IPC Facilities/ Operations	Current / Proposed Operations		Full Pool/ Run-of-River
	Effects	Suggested PM&E	Effects
Brownlee Reservoir	DF: Drawdown effect creates high contrast.	Moderate water-level fluctuations to reduce drawdown effect.	Drawdown effect eliminated by full pool.

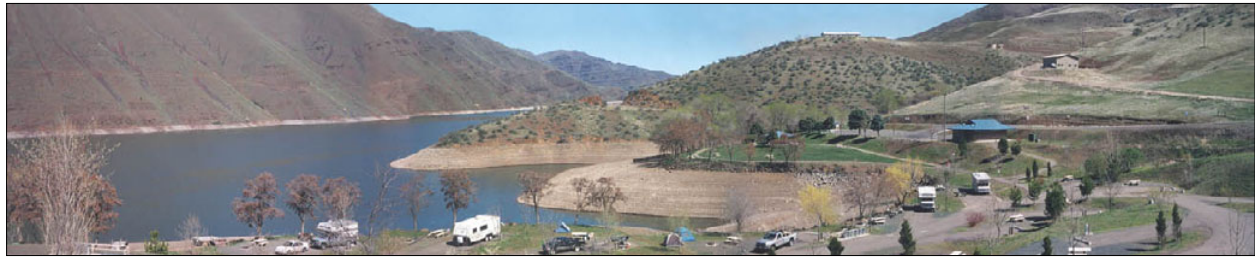
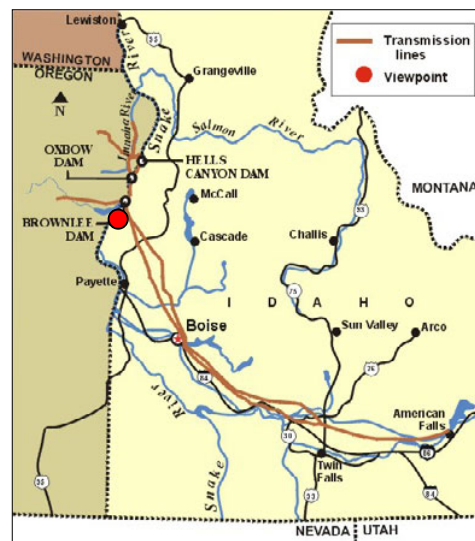
Viewpoint #44: Woodhead Park (KOP)

Visual Contrast Rating	Existing VRM Class (Oregon/Idaho)	Is contrast rating acceptable for VRM Class?	Proposed VRI Class	Is contrast rating acceptable for proposed VRI Class?
70	II / II	No	III	No

IPC Facilities/ Operations	Current / Proposed Operations		Full Pool/ Run-of-River
	Effects	Suggested PM&E	Effects
Brownlee Reservoir	DF: Drawdown effect creates high contrast as do forms and colors of hardscape elements.	Provide interpretive signage to explain drawdown effect and/or management strategy that results in water-level fluctuations. Moderate water-level fluctuations to reduce drawdown effect. Modify colors and dull reflective surfaces of hardscape elements including paving, roofs, and site furnishings. Modify species, location, and form of landscape planting to be more consistent with a natural community. Improve caretaker's residence and program elements (e.g., walls, walkways, shelters) to be more consistent in shape, form, and color with natural landform and vegetation.	DF: Forms and colors of hardscape elements create high contrast. Draw-down effect eliminated by full pool.

Comments	Modifications to landscape planting can still be functional — to provide shade, windbreaks, to screen, to direct viewsheds. Cumulative effects of many contrasts result in a very high contrast rating. Contrast varies based on viewer's position and therefore perspective of the impact.
----------	---

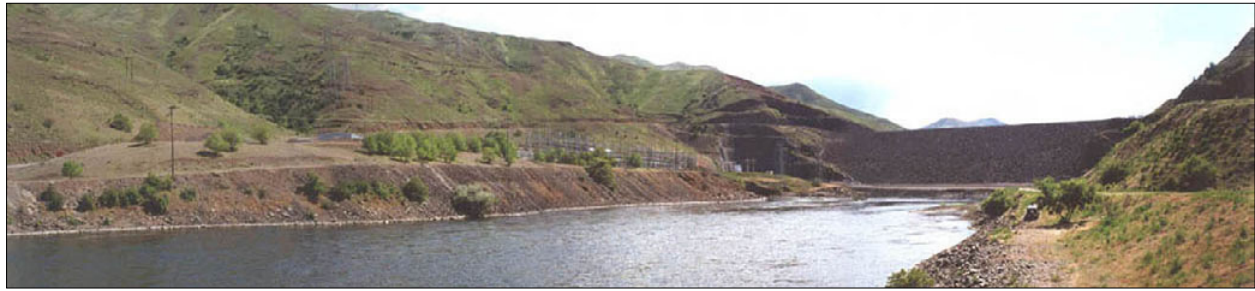
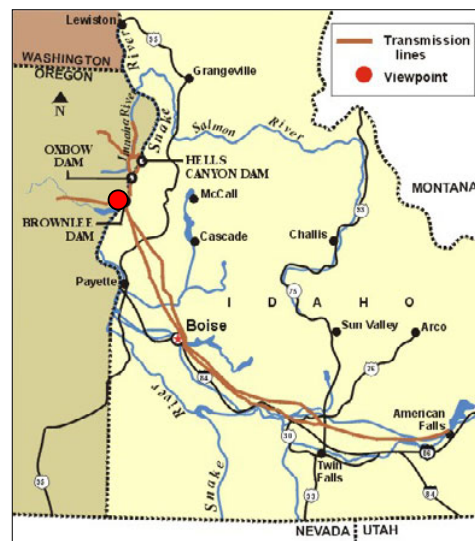
Viewpoint #46: Oxbow Bridge (KOP)

Visual Contrast Rating	Existing VRM Class (Oregon/Idaho)	Is contrast rating acceptable for VRM Class?	Proposed VRI Class	Is contrast rating acceptable for proposed VRI Class?
52	II / II	No	III	No

IPC Facilities/ Operations	Current / Proposed Operations		Full Pool/ Run-of-River
	Effects	Suggested PM&E	Effects
Brownlee Dam and substation; Line 904 (steel lattice); Line 905 (steel lattice); Line 911 (steel lattice)	DF: Approximately 30 towers and substation in view. Brownlee Dam, road cut, and “cage” to keep rocks off road and IPC property add to cumulative contrast.	Moderate water-level fluctuations to reduce drawdown effect. Develop aesthetic improvement plan for this site that will include improving the overall orderliness of yard area and modifying the road cut and “the cage” to reduce visual impacts. Screen facilities with desirable vegetation (native species if feasible) wherever possible. Replace lines with non-specular wire in normal maintenance cycle. Paint towers to match natural landscape. Prepare visual simulation to determine positive effects of suggested PM&E.	DF: Approximately 30 towers and substation in view. Brownlee Dam, road cut, and “cage” to keep rocks off road and IPC property add to cumulative contrast. Drawdown effect eliminated by full pool.

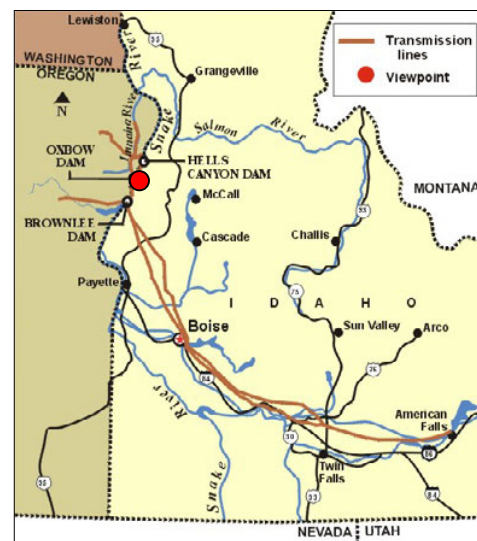
Viewpoint #47: McCormick Park (KOP)

IPC Facilities/ Operations	Current / Proposed Operations		Full Pool/ Run-of-River
	Effects	Suggested PM&E	Effects
Oxbow Reservoir; Line 905 (steel lattice), McCormick Park	DF: Drawdown effect creates contrast. Use of non-native vegetation in landscape, Jersey barriers, and rock berm along creek augment cumulative contrast. Entrance poorly defined and unattractive.	Provide interpretive signage to explain drawdown effect and water-level fluctuations. Develop aesthetic improvement plan for this site with special attention given to enhancing the entrance, eliminating the Jersey barriers, softening the flood control efforts to augment plantings with additional desirable vegetation (native species if feasible).	Drawdown effect eliminated by full pool. DF: Use of non-native vegetation in landscape, Jersey barriers, and rock berm along creek augment cumulative contrast.

Comments	Drawdown effect is noticeable. Although score is high, this site demonstrates generally good use of color and vegetation to blend site into landscape. Cumulative effects of many contrasts result in high contrast rating. Existing natural vegetation helps blend site into surrounding landscape. Use of gravel parking, as opposed to concrete, also reduces contrast.
----------	--
