Hells Canyon Complex Aesthetic Resource Inventory and Evaluation

TECHNICAL REPORT

**Technical Report
Appendix E.6-3**

Hells Canyon Complex
FERC No. 1971

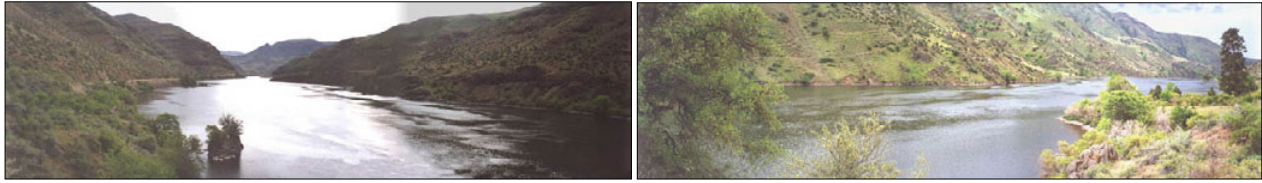
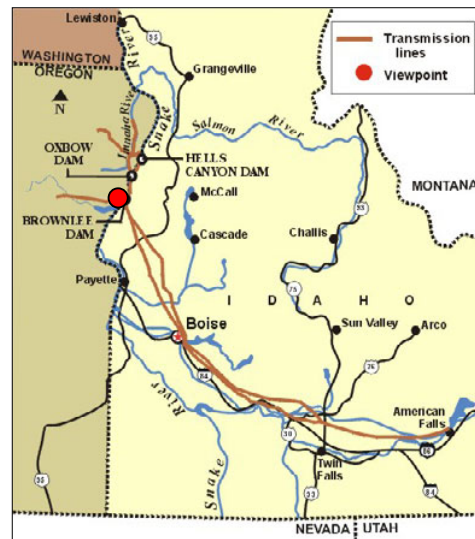
Viewpoint #48: Reflection Point (KOP)

Visual Contrast Rating	Existing VRM Class (Oregon/Idaho)	Is contrast rating acceptable for VRM Class?	Proposed VRI Class	Is contrast rating acceptable for proposed VRI Class?
34	II / II	No	III	No

IPC Facilities/ Operations	Current / Proposed Operations		Full Pool/ Run-of-River
	Effects	Suggested PM&E	Effects
Oxbow Reservoir; Line 905 (steel lattice)	DF: Drawdown effect, service road and lattice tower on east ridge create high contrast.	None proposed (see comments).	Drawdown effect eliminated by full pool. DF: Service road and lattice tower on east ridge creates high contrast.

Comments	Removed from consideration for mitigation and enhancement since not believed to be a significant viewpoint by Subgroup.
-----------------	---

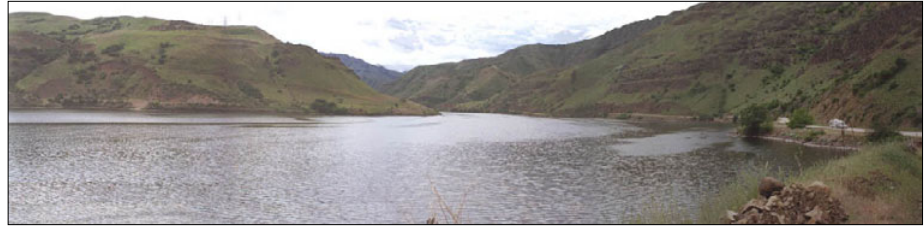
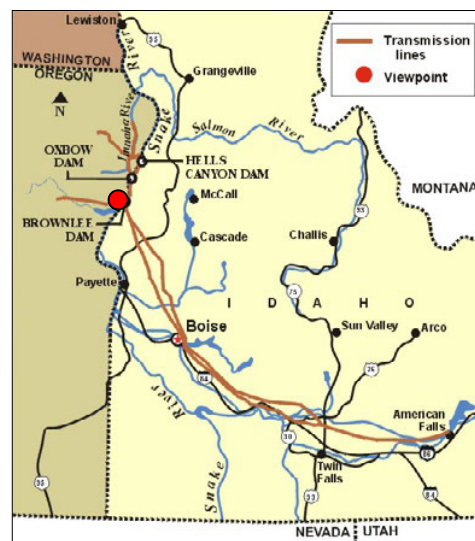
**Viewpoint #49:
Dead Man's Spot
(KOP)**

Visual Contrast Rating	Existing VRM Class (Oregon/Idaho)	Is contrast rating acceptable for VRM Class?	Proposed VRI Class	Is contrast rating acceptable for proposed VRI Class?
26	II / II	No	III	No
IPC Facilities/ Operations	Current / Proposed Operations		Full Pool/ Run-of-River	
	Effects	Suggested PM&E	Effects	
Oxbow Reservoir; Line 905 (steel lattice)	DF: Drawdown effect and road color create high contrast. Three towers are silhouetted.	None proposed (see comments).	Drawdown effect eliminated by full pool. DF: Road color and silhouetted towers create contrast.	
Comments	Removed from consideration for mitigation and enhancement since not believed to be a significant viewpoint by Subgroup.

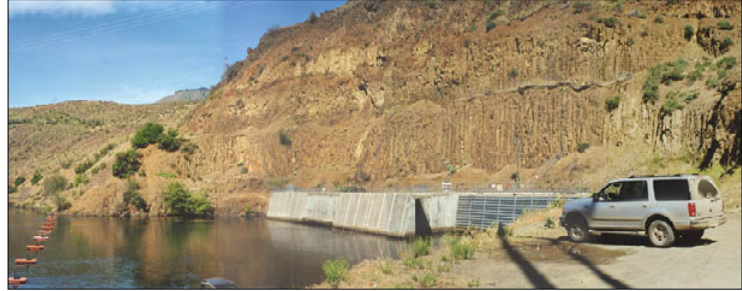
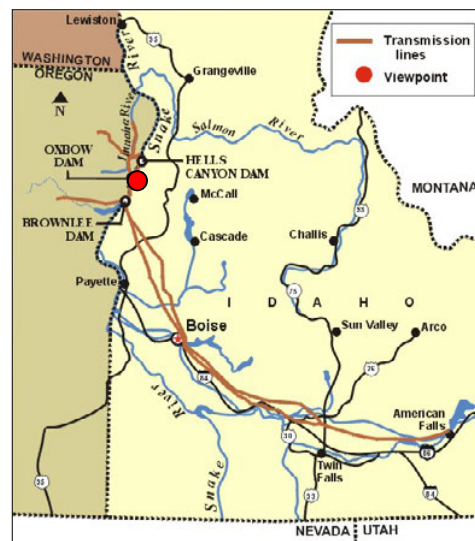
**Viewpoint #50:
Oxbow Dam (KOP)**

Visual Contrast Rating	Existing VRM Class	Is contrast rating acceptable for VRM Class?	Proposed VRI Class	Is contrast rating acceptable for proposed VRI Class?
38	II	No	III	No

IPC Facilities/ Operations	Current / Proposed Operations		Full Pool/ Run-of-River
	Effects	Suggested PM&E	Effects
Oxbow Reservoir, Oxbow Dam	DF: Dam, access road, light poles, and fencing creates high contrast. Drawdown effect creates minor contrast.	During normal maintenance cycle, modify colors and dull reflective surfaces of hardscape elements including concrete walls, to be consistent with the proposed aesthetic and design standards and guidelines. Modify road color to be consistent with surrounding landscape colors. Moderate water-level fluctuations to reduce drawdown effect. Replace lines with non-specular wire in normal maintenance cycle.	Drawdown effect eliminated by full pool. DF: Dam, access road, light poles, and fencing creates high contrast.
Comments	None

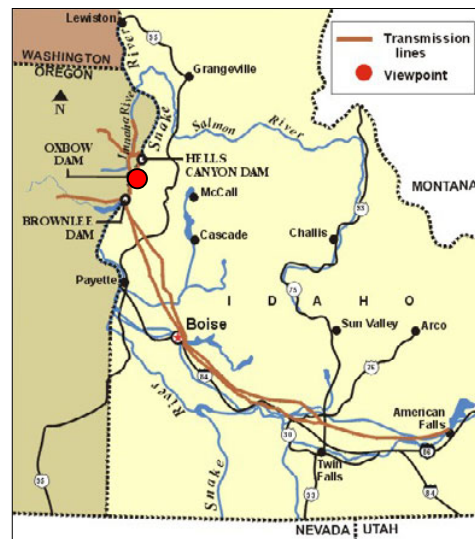
Viewpoint #51: Oxbow Spillway (KOP)

Visual Contrast Rating	Existing VRM Class	Is contrast rating acceptable for VRM Class?	Proposed VRI Class	Is contrast rating acceptable for proposed VRI Class?
43	II	No	III	No
IPC Facilities/ Operations	Current / Proposed Operations		Full Pool/ Run-of-River	
	Effects	Suggested PM&E	Effects	
Oxbow Spillway	DF: Spillway, access road, and parking area create high contrast.	Modify color and texture of concrete spillway structure and color of access road to be more consistent with surrounding landscape. Prepare visual simulation to determine positive effects of suggested PM&E.	DF: Spillway, access road, and parking area create high contrast.	
Comments	None

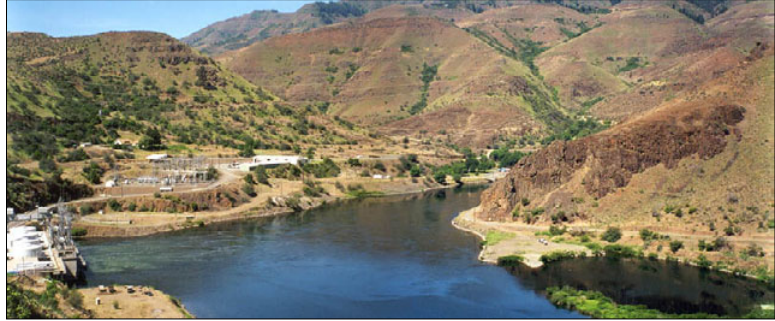
**Viewpoint #52:
Oxbow Plant (KOP)**

Visual Contrast Rating	Existing VRM Class	Is contrast rating acceptable for VRM Class?	Proposed VRI Class	Is contrast rating acceptable for proposed VRI Class?
39	II	No	III	No

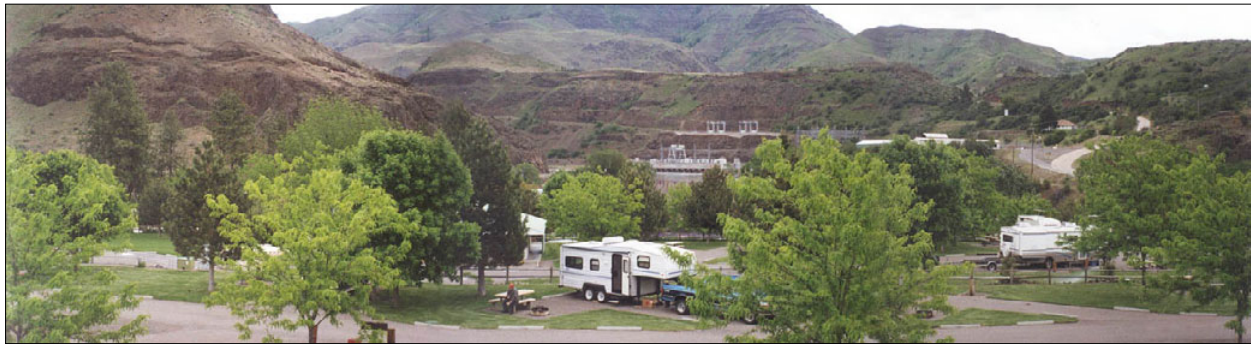
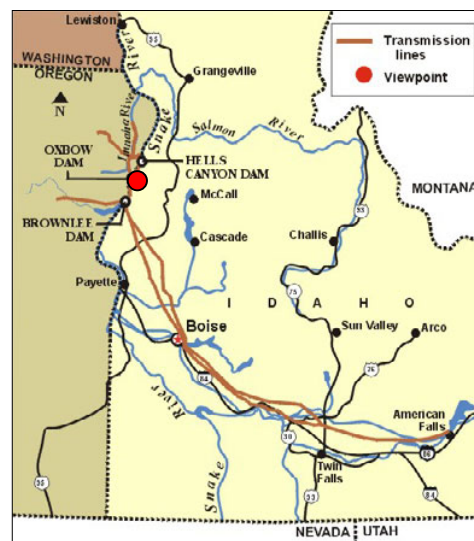
Viewpoint #53: Copperfield Park (KOP)

Visual Contrast Rating	Existing VRM Class	Is contrast rating acceptable for VRM Class?	Proposed VRI Class	Is contrast rating acceptable for proposed VRI Class?
32	II	No	III	No

IPC Facilities/ Operations	Current / Proposed Operations		Full Pool/ Run-of-River
	Effects	Suggested PM&E	Effects
Hells Canyon Reservoir, Copperfield Village, Oxbow Substation, Line 905 (steel lattice)	DF: Maintenance structures, employee housing, substation, and transmission line create high contrast.	During normal maintenance cycle, modify colors and dull reflective surfaces of hardscape elements including IPC housing, maintenance and appurtenant facilities, and access roads to be consistent with the proposed aesthetic and design standards and guidelines. Screen substation with desirable vegetation (native species if feasible). Replace lines with non-specular wire in normal maintenance cycles.	DF: Modular housing, substation, and transmission line all create high contrast.

Comments	Drawdown effect is negligible. Existing vegetation creates “oasis” from summer heat and screens certain undesirable views of project facilities. Opportunity exists to develop interpretive facility for hydropower generation.
----------	---

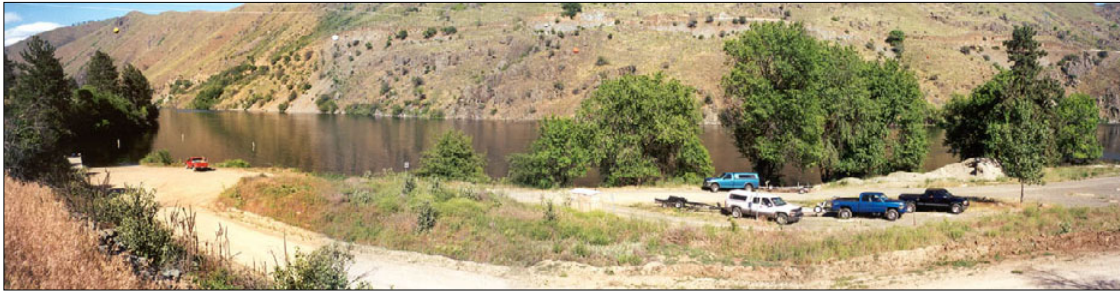
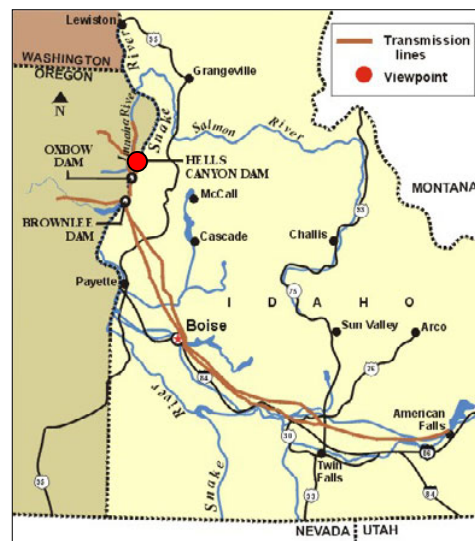
Viewpoint #54: Boat Launch Dispersed Recreation Site (KOP)

Visual Contrast Rating	Existing VRM Class	Is contrast rating acceptable for VRM Class?	Proposed VRI Class	Is contrast rating acceptable for proposed VRI Class?
15	II	No	II	No
IPC Facilities/ Operations	Current / Proposed Operations		Full Pool/ Run-of-River	
	Effects	Suggested PM&E	Effects	
Hells Canyon Reservoir	DF: Drawdown effect creates minor contrast.	Moderate water-level fluctuations to reduce drawdown effect.	Drawdown effect eliminated by full pool.	
Comments	None

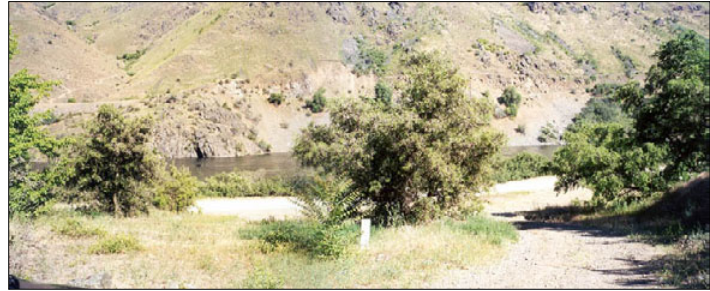
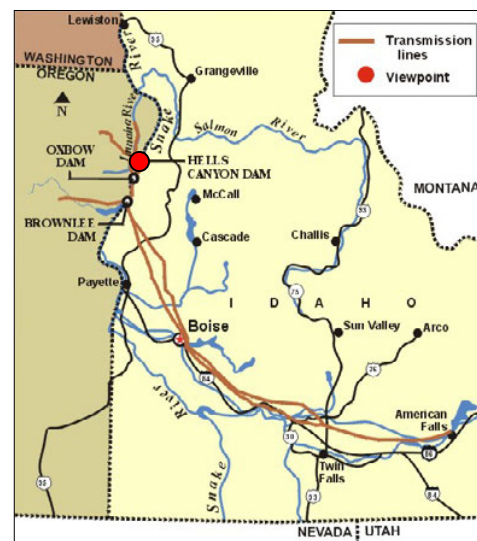
**Viewpoint #55:
Westfall Dispersed
Recreation Site (KOP)**

Visual Contrast Rating	Existing VRM Class	Is contrast rating acceptable for VRM Class?	Proposed VRI Class	Is contrast rating acceptable for proposed VRI Class?
20	II	No	II	No
IPC Facilities/ Operations	Current / Proposed Operations		Full Pool/ Run-of-River	
	Effects	Suggested PM&E	Effects	
Hells Canyon Reservoir; Line 905 (steel lattice)	DF: Three towers silhouetted. Drawdown effect creates minor contrast.	Replace lines with non-specular wire in normal maintenance cycle. Moderate water-level fluctuations to reduce drawdown effect.	Drawdown effect eliminated by full pool. DF: Three towers silhouetted.	
Comments	Relocating towers is not reasonable.

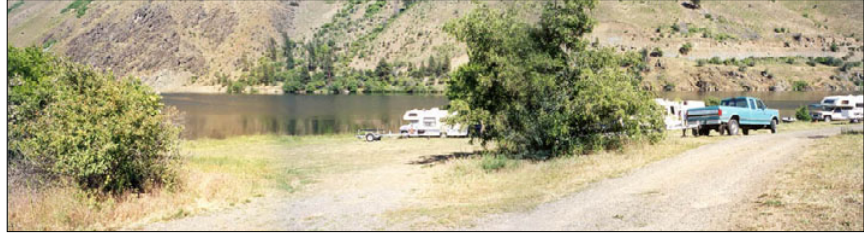
**Viewpoint #56:
Bob's Creek (KOP)**

Visual Contrast Rating	Existing VRM Class	Is contrast rating acceptable for VRM Class?	Proposed VRI Class	Is contrast rating acceptable for proposed VRI Class?
23	II	No	II	No

IPC Facilities/ Operations	Current / Proposed Operations		Full Pool/ Run-of-River
	Effects	Suggested PM&E	Effects
Hells Canyon Reservoir; Line 905 (steel lattice); airfield	DF: Three towers silhouetted. Drawdown effect creates minor contrast. Airfield fencing creates moderate contrast.	Replace lines with non-specular wire in normal maintenance cycle. Moderate water-level fluctuations to reduce drawdown effect. Paint or replace airfield fencing with color better suited to surroundings.	Drawdown effect eliminated by full pool. DF: Airfield fencing creates moderate contrast. Three towers silhouetted.

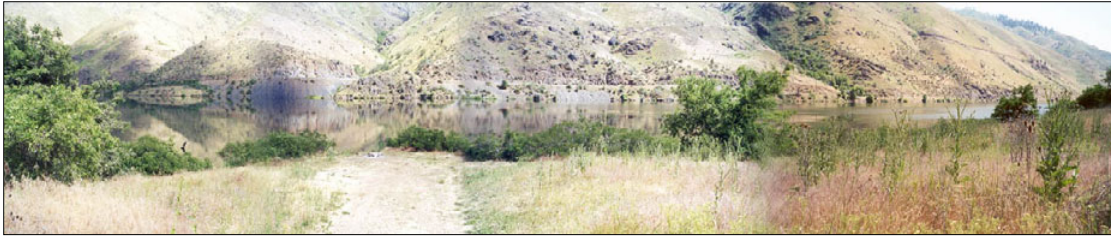
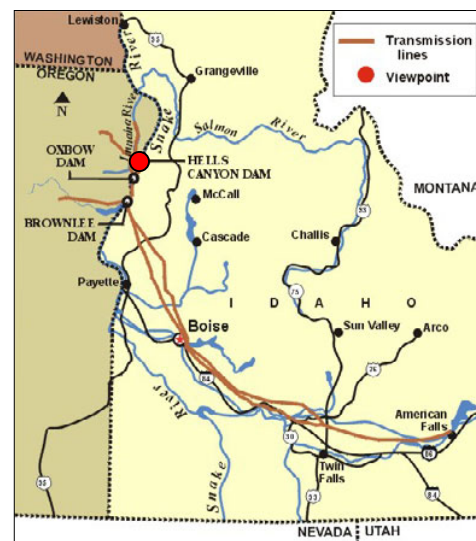
Viewpoint #57: Sixteen West Dispersed Recreation Site (KOP)

Visual Contrast Rating	Existing VRM Class	Is contrast rating acceptable for VRM Class?	Proposed VRI Class	Is contrast rating acceptable for proposed VRI Class?
15	II	No	II	No
IPC Facilities/ Operations	Current / Proposed Operations		Full Pool/ Run-of-River	
	Effects	Suggested PM&E	Effects	
Hells Canyon Reservoir	DF: Drawdown effect creates minor contrast.	Moderate water-level fluctuations to reduce drawdown effect.	Drawdown effect eliminated by full pool.	
Comments	None

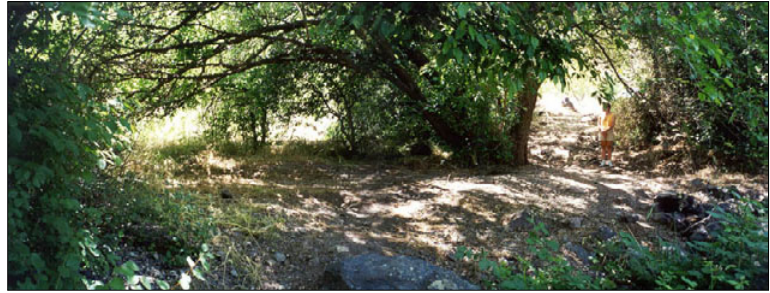
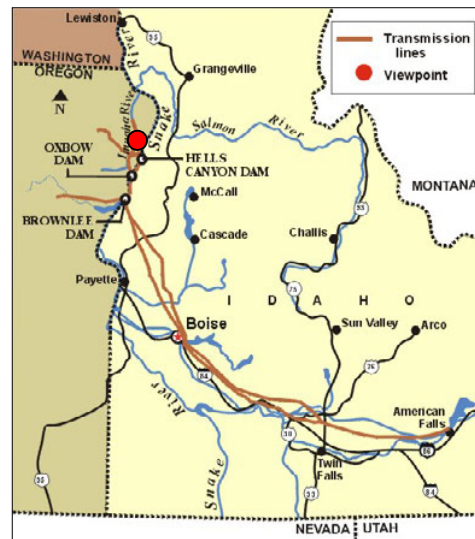
**Viewpoint #58:
Ashby Creek Dispersed
Recreation Site (KOP)**

Visual Contrast Rating	Existing VRM Class	Is contrast rating acceptable for VRM Class?	Proposed VRI Class	Is contrast rating acceptable for proposed VRI Class?
15	II	No	II	No
IPC Facilities/ Operations	Current / Proposed Operations		Full Pool/ Run-of-River	
	Effects	Suggested PM&E		Effects
Hells Canyon Reservoir	DF: Drawdown effect creates minor contrast.	Moderate water-level fluctuations to reduce drawdown effect.		Drawdown effect eliminated by full pool.
Comments	None

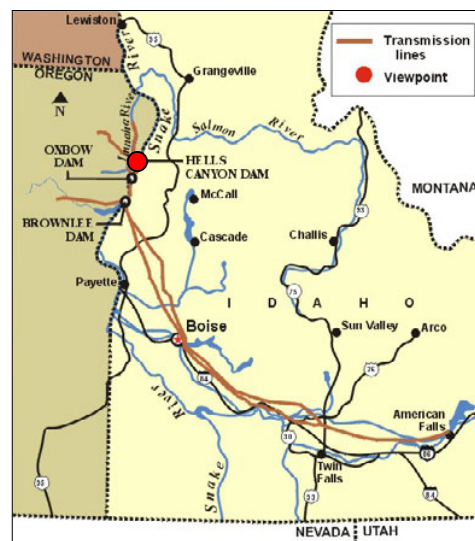
Viewpoint #59: Copper Creek Trailhead Park (KOP)

Visual Contrast Rating	Existing VRM Class	Is contrast rating acceptable for VRM Class?	Proposed VRI Class	Is contrast rating acceptable for proposed VRI Class?
15	II	No	II	No
IPC Facilities/ Operations	Current / Proposed Operations			Full Pool/ Run-of-River
	Effects	Suggested PM&E		Effects
Hells Canyon Reservoir	DF: Drawdown effect creates minor contrast.	Moderate water-level fluctuations to reduce drawdown effect.		Drawdown effect eliminated by full pool.
Comments	<p>NP: Restroom buildings' color, line, and form create contrast and are BLM facilities. Parking and day-use area are not well defined.</p> <p>Opportunity exists to coordinate with BLM on master plan to be compatible with the proposed aesthetic and design standards and guidelines.</p>

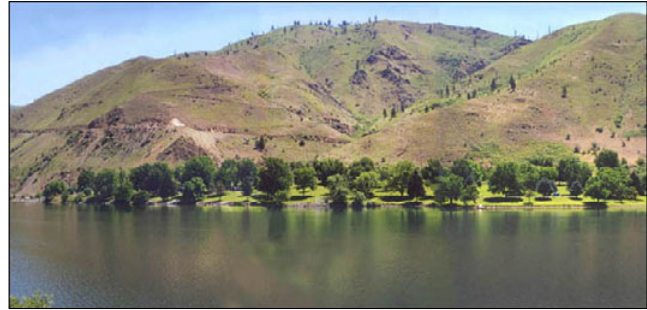
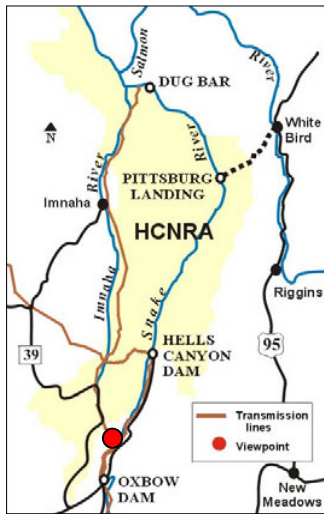
Viewpoint #101: Hells Canyon Park (SP)

Scenic integrity: Low – The color and reflectivity of the campground buildings and boat docks and the security fence are all negative elements to most people. The irrigated lawn and ornamental plantings are inconsistent with the surroundings to some but a welcome relief to others.

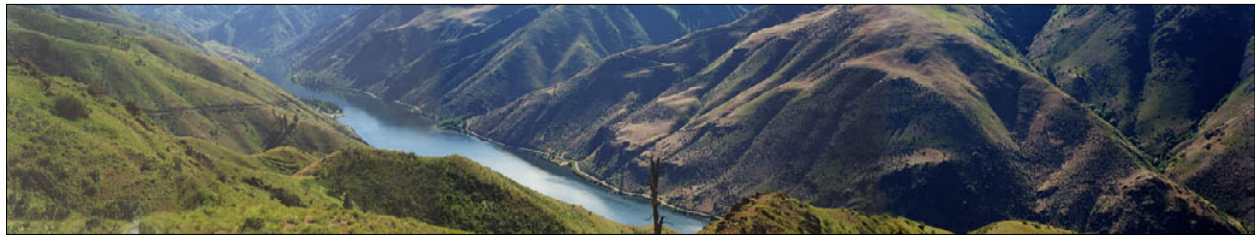
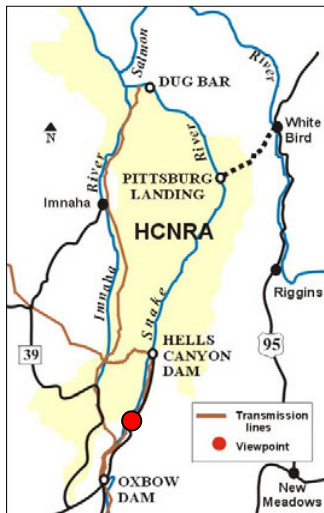
Viewpoint #102: Kleinschmidt Grade Overlook (SP)

IPC Facilities/ Operations	Current / Proposed Operations		Full Pool/ Run-of-River
	Effects	Suggested PM&E	Effects
Line 945 (Single pole, wood)	DF: Form, line and color inconsistent; uppermost tower sky-lined	Screen views of transmission line. Replace lines with non-specular wire during normal maintenance cycle.	Same
Transmission line service roads	DF: Line, color	Darken road surface and road cuts.	Same
Hells Canyon Reservoir	DF: Drawdown effect	Moderate water-level fluctuations.	Drawdown effect eliminated by full pool.
Comments	Opportunity exists to coordinate with USFS to construct interpretive viewpoint and turn-around.

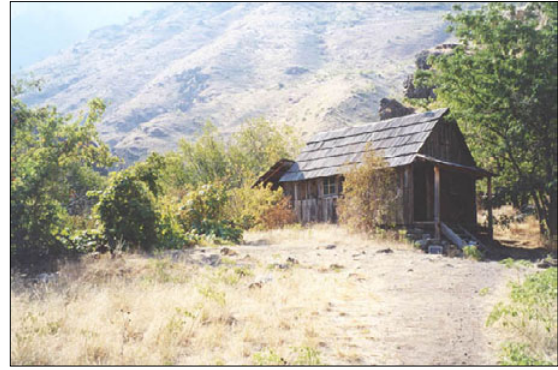
Viewpoint #118: McGaffee Cabin (SP)

Landscape character: The historic cabin remains as described below. It sits on a grassy river bench with remnants of the stone root cellar, water ditch, orchard and rusted farm implements. Black locust trees, grape vines and cherry trees remain from the days of occupancy. The unique interior wall paper is a wonderful aesthetic and nostalgic treat. Increased visitor use has had minimal impact. An established trail and bridge cross the creek.

IPC Facilities/ Operations	Current / Proposed Operations		Full Pool/ Run-of-River
	Effects	Suggested PM&E	Effects
Snake River fluctuation	DH: River water-level fluctuation	Moderate water-level fluctuations to reduce effect.	Daily fluctuations eliminated. Seasonal fluctuation increased.
Comments	<p>IF: Impacts to vegetation resulting from recreational use are minimal and focused on the trail to the cabin.</p> <p>NP: Construction debris from recent cabin rehabilitation remains on site and detracts from scenic integrity.</p>

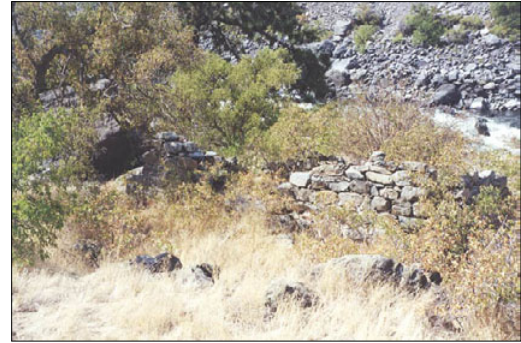
**Viewpoint #120:
Bill's Creek (SP)**

Si Bullock Cabin remnants at Bill's Creek

Landscape character: The skilled work of Si Bullock can be seen in the remnant rock walls of his cabin which still stand on the river side of the trail. The other rock structure along the path is the remnants of his corral. His garden was 50 feet down river from the house. Vegetation on the site is primarily cheatgrass-bluebunch wheat grass with islands of cliff talus slopes. The riparian area of Bill's Creek includes net leaf hack berry, common choke cherry, poison ivy and syringa.

Desired landscape character: The remains of Si Bullock's homestead should be stabilized. Ecologically the site is currently in a desirable condition. Protect the site from and limit recreation use to reduce visitor pressure. Protect rare plants including bartonberry and shining flatsedge.

IPC Facilities/ Operations	Current / Proposed Operations		Full Pool/ Run-of-River
	Effects	Suggested PM&E	Effects
Snake River fluctuation	DH: River water-level fluctuation	Moderate water-level fluctuations to reduce effect.	Daily fluctuations eliminated. Seasonal fluctuation increased.
Comments	IF: Impacts to vegetation resulting from recreational use are minimal. Opportunity exists to coordinate with USFS to develop interpretive program for Si Bullock cabin remnants.

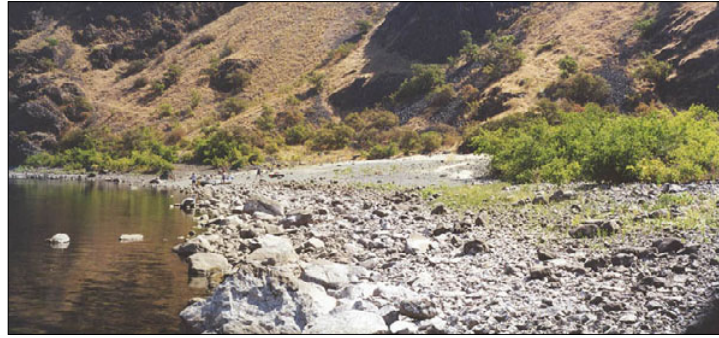
Viewpoint #123: Johnson Bar and Barton Bullock House (SP)

Johnson Bar

Landscape character: The ruins of the Barton Bullock house can still be seen on the bar, as well as the cellar hole for the Glenn Hibbs house. A campsite at the river bend north of the beach is used by boaters. It is bounded by steep slopes covered in cheatgrass-bluebunch wheat grass. Large areas of net leaf hackberry in shrub form make the latter appear to be dominant. Riparian areas along the river have net leaf hackberry and Eaton’s aster.

Desired landscape character: Consider design and construction of an interpretive trail to access historic remnants mentioned above. Stabilize the remnants for interpretive purposes. Manage noxious weeds found in shrubland and protect rare plants including bartonberry. Screen the gauging station across the river with native vegetation.

IPC Facilities/ Operations	Current / Proposed Operations		Full Pool/ Run-of-River
	Effects	Suggested PM&E	Effects
Snake River fluctuation	DH: River water-level fluctuation	Moderate water-level fluctuations to reduce effect.	Daily fluctuations eliminated. Seasonal fluctuation increased.
Snake River fluctuation	DH: Possible loss of sandy beach	If loss is documented and is Project effect, coordinate appropriate mitigation with USFS.	Unknown
Comments	<p>NP: The weather station located across the river is inconsistent with architectural character of the canyon and should be screened.</p> <p>Opportunity exists to coordinate with USFS to develop interpretive program for Barton Bullock house.</p>

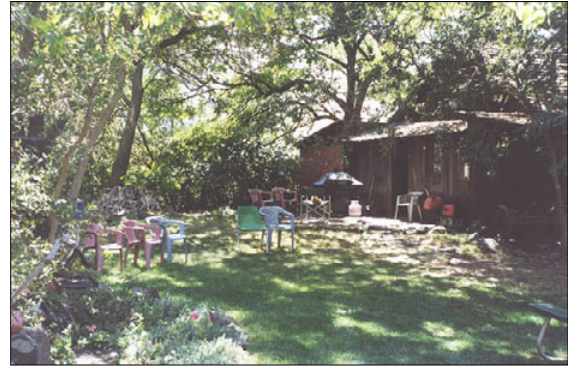
**Viewpoint #124:
Sheep Creek Ranch (OP)**

Landscape character: Bill and Mabel McGaffee’s cabin is located on an irrigated grassy bench amongst mature poplars. It is used as a historical rental facility. Bill McLeod’s stone house, cut out of the river bank, was later converted to a blacksmith shop. It still exists just above Sheep Creek on the north side.

IPC Facilities/ Operations	Current / Proposed Operations		Full Pool/ Run-of-River
	Effects	Suggested PM&E	Effects
No Project effects visible from site.	N/A	N/A	N/A
Comments	NP: Lawn chairs, picnic tables and modern facilities detract from the historical setting. Not considered an SP because no Project effects are visible.

Desired landscape character: Consider retaining the cabin as an historical rental giving the renters the feel of being immersed into the life during the late 19th century and early 20th century. Remove modern obtrusive facilities. Limit ornamental landscaping or reduce its negative effect as much as possible. Manage noxious weeds found on the site. USFS should examine its administration of the cabin permit in terms of the non-historical yard furnishings.

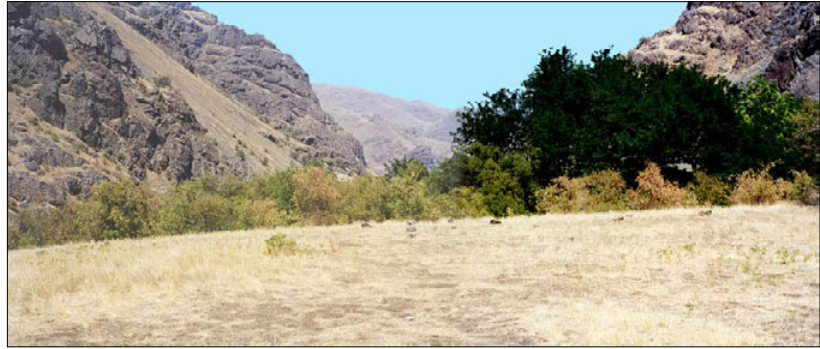
**Viewpoint #125:
Sheep Creek Campsite
(SP)**

Landscape character: The group campsite above the cabin provides shelter for the camp kitchen and a large high bench for tents. There is little shelter on the bench, but the view up river to Johnson Bar is spectacular. Other characteristics include angular rock faces, grasses, and rushing water sounds.

Scenic integrity: Moderate – Negative elements include denuded sites with trampled grass cover. Fluctuation effect can be seen at times.

Desired landscape character: Develop the role of this site in concert with the cabin site. Decisions about the interrelationships between these two sites need to be made before desired character statements can be developed. Include solving recreation impact problems and eradication of noxious weeds found on the site.

IPC Facilities/ Operations	Current / Proposed Operations		Full Pool/ Run-of-River
	Effects	Suggested PM&E	Effects
Snake River fluctuation	DH: River water-level fluctuation	Moderate water-level fluctuations to reduce effect.	Daily fluctuations eliminated. Seasonal fluctuation increased.
Comments	IF: User impacts consist of trampled vegetation on the bench and at cooking sites. Develop management controls and improve designated trail.

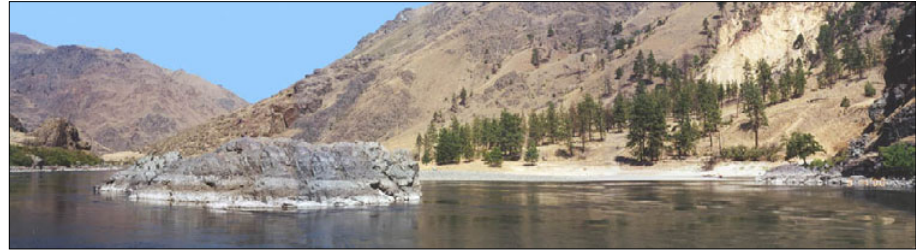
**Viewpoint #128:
Pine Bar (SP)**

Landscape character: This site provides a sheltered eddy that is an excellent swimming area with a sandy bottom. The large grove of Ponderosa Pine to the east is rare along the river corridor and creates an oasis in a linear landscape of rugged rock outcrops, grass, shrubs and churning water. Grassy areas are mostly cheatgrass-bluebunch wheat grass. The forested upland is Ponderosa Pine with common snow berry and a few stands of net leaf hackberry.

Desired landscape character: It is highly desirable to maintain and/or replace the sand beach. Explore options within the limitations of the Wild and Scenic River designation and sustainable ecology for the site. Limit recreation use as necessary to solve the user impact problems. Manage noxious weeds. Ensure that there are enough different age classes of Ponderosa Pine on the site to sustain the open park like character over time. Stabilize erodible soils to the degree feasible.

IPC Facilities/ Operations	Current / Proposed Operations		Full Pool/ Run-of-River
	Effects	Suggested PM&E	Effects
Snake River fluctuation	DH: Possible loss of sandy beach	If loss is documented and is Project effect, coordinate appropriate mitigation with USFS.	Unknown
Snake River fluctuation	DH: River water-level fluctuation	Moderate water-level fluctuations to reduce effect.	Daily fluctuations eliminated. Seasonal fluctuation increased.
Comments	None

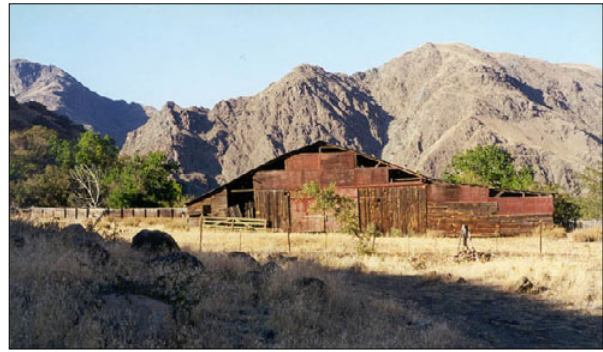
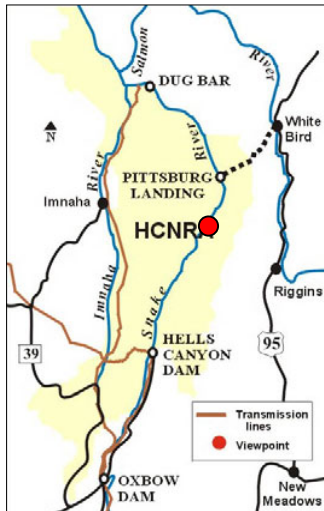
Viewpoint #130: Temperance Creek Ranch (SP)

Landscape character: A barn, shearing sheds, airstrip, and hangar stand on the upper bench. A modern frame house and several outbuildings area located below nearer the boat dock. The ranch is now used by an outfitter and guide for hunting and jet boat trips. The plant assemblages for the grassland include cheatgrass-bluebunch wheatgrass. There are several irrigated and non-irrigated pastures in the area. Many are weedy and include noxious weeds. Net leaf hackberry and bluebunch wheatgrass occur in the Shrub Savanna.

Ecological integrity: Low to Moderate – Due to the extensive grazing of cattle and sheep in the early years, and pack stock more recently. Many noxious weeds are found in the riparian areas.

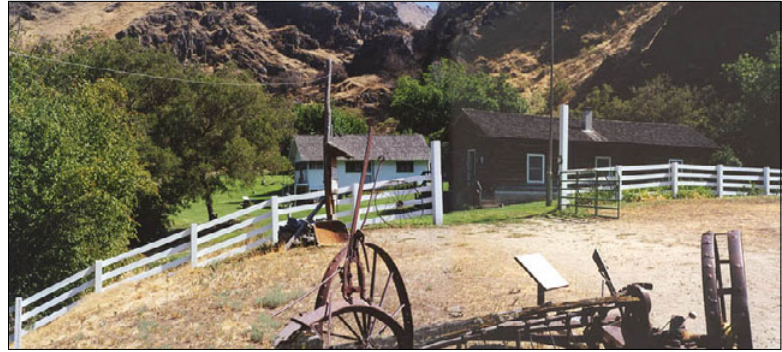
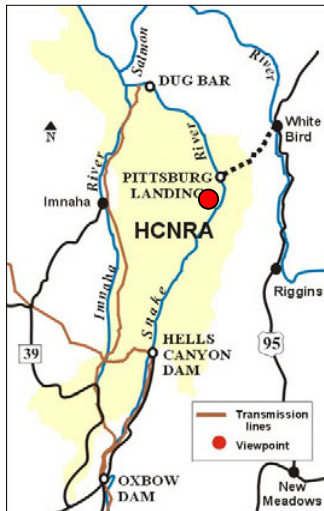
**Viewpoint #133:
Kirkwood Ranch (OP)**

Landscape character: This much-visited site is one of the most important, historically, in the canyon. Len Jordon’s house is very much intact on the bar. Sterling’s impressive bunkhouse has become a museum and Carl Hanna’s house is just across the creek in the middle of a small corral. Surrounding these buildings is a Kentucky bluegrass lawn with irrigated ornamentals. Upland vegetation includes cheatgrass-bluebunch wheatgrass and net leaf hackberry. The riparian area along the river contains purslane, net leaf hackberry, Eaton’s astor, and hemp dog bane.

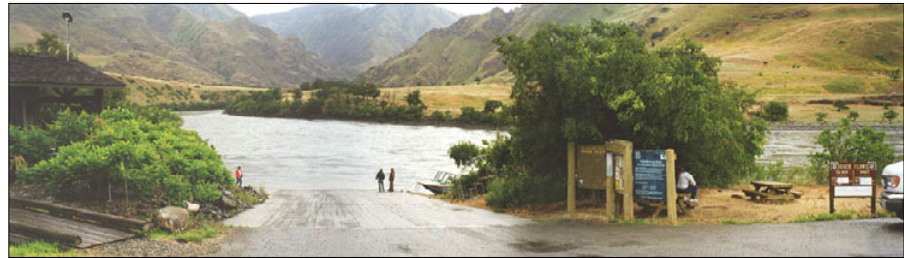
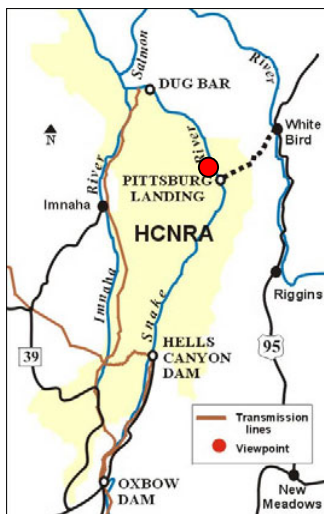
Viewpoint #136: Lower Pittsburg Landing and Campground (SP)

Lower Pittsburg Landing boat ramp

Landscape character: Dramatic granite slopes with grass surround this site. Shrubs and grasses dominate the middleground and lower and mid-slopes. Patches and stringers of evergreen trees dominate background and upperslopes with grasses and shrubs as an understory. The shoreline has a rocky/cobble edge with hackberry being the dominant vegetation. The recreation facility consists of a boat launch and associated parking facilities, campground and administration buildings. The rustic features and earthtones of the administrative building and restroom and their location within the tallest vegetation complements the landscape.

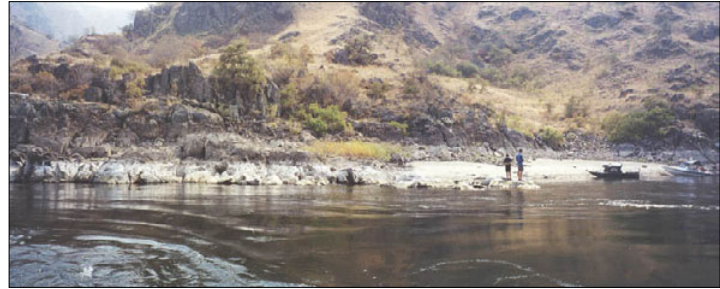
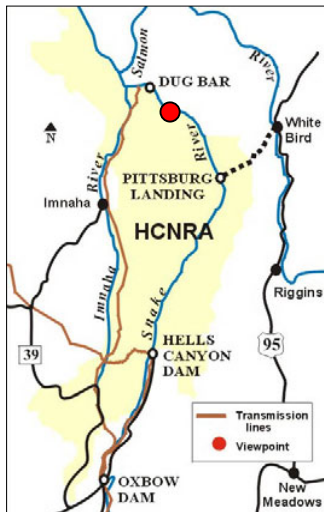
**Viewpoint #142:
Deep Creek (Chinese Miner
Massacre Site) (SP)**

Landscape character: Horizontal rock bluffs rise above the river from which the massacre occurred. This area is an important stage from which river users can re-live the tragic story described below. One of the few sandy beaches exists at this site. The plant assemblages include net leaf hackberry/bluebunch wheat grass. The riparian area along the river includes net leaf hackberry, Eaton’s astor and hemp dog bane.

Desired landscape character: This story should be told in the form of a brochure obtained at contact points outside Deep Creek. Do not encourage recreational visits on the site. Experience the drama from the river. Ecologically this site is in very good condition and the recommended approach of experiencing the site from the river should help maintain that condition.

IPC Facilities/ Operations	Current / Proposed Operations		Full Pool/ Run-of-River
	Effects	Suggested PM&E	Effects
Snake River fluctuation	DH: River water-level fluctuation	Moderate water-level fluctuations to reduce effect.	Daily fluctuations eliminated. Seasonal fluctuation increased
Comments	Opportunity exists to coordinate with appropriate party to develop interpretive program for this site.

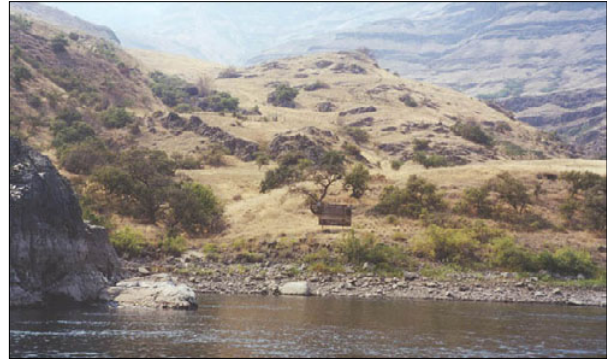
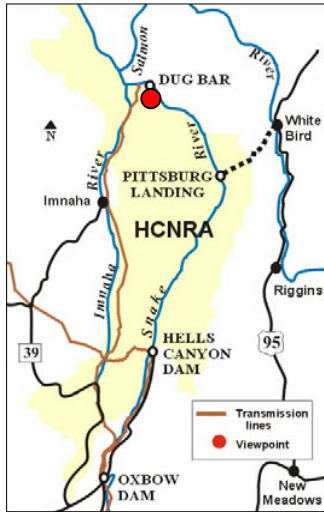
Viewpoint #143: Nez Perce Crossing Site (SP)

Landscape character: For many visitors, this is the most poignant historical site in the canyon. The existing landscape is one of dominant columnar basalt outcrops with grassland of cheatgrass-bluebunch wheat grass, shrubs of net leaf hackberry, and riparian area of net leaf hackberry, Eaton’s astor, coyote willow and hemp dogbane. A sign commemorating the Nez Perce crossing is located near the river. There is little else done to interpret the crossing.

IPC Facilities/ Operations	Current / Proposed Operations		Full Pool/ Run-of-River
	Effects	Suggested PM&E	Effects
Snake River fluctuation	DH: River water-level fluctuation	Moderate water-level fluctuations to reduce effect.	Daily fluctuations eliminated. Seasonal fluctuation increased.
Comments	Opportunity exists to coordinate with USFS to develop interpretive program for this site.

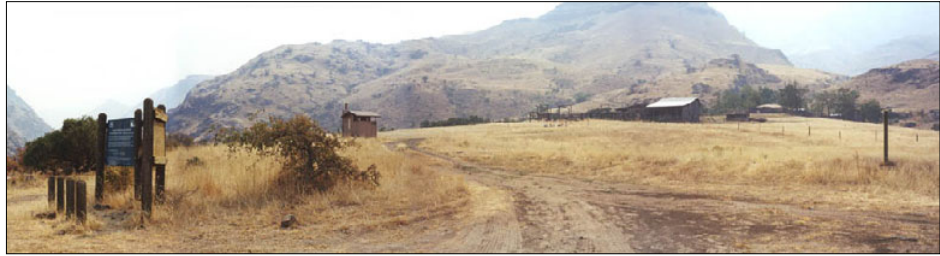
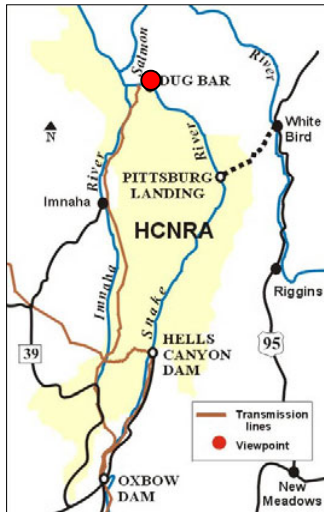
**Viewpoint #144:
Dug Bar Land-
ing (SP)**

Landscape character: On the east side of river, columnar basalt outcrops, a tall rock spire, and mixed vegetation near high water mark dominate the landscape Dug Bar Ranch is of early homestead architecture with a barn and corral. The plant assemblages include cheatgrass-bluebunch wheatgrass and net leaf hackberry. A very large area of cultivated crops defines the ranch with net leaf hackberry around the perimeter.

Ecological integrity: Low to Moderate – Disturbance from the vehicle traffic has destroyed much vegetation near the boat ramp and camping site. This has altered and degraded the ecological processes on the site.

Desired landscape character: The goal should be to provide a new site plan for the ranch and public area. It should be developed to provide a pleasant arrival for visitors by car and from the river and to solve some of the ecological problems outlined above. Define vehicle and pedestrian traffic and parking patterns. Redesign the signage to be more functional and attractive. Move existing degraded plant associations towards late seral or climax stage of succession. Manage noxious weeds and protect rare plants on the site.

IPC Facilities/ Operations	Current / Proposed Operations		Full Pool/ Run-of-River
	Effects	Suggested PM&E	Effects
Snake River fluctua- tion	DH: River water-level fluctuation	Moderate water-level fluctuations to reduce effect.	Daily fluctua- tions elimi- nated. Sea- sonal fluctua- tion increased.
Comments	<p>NP: Existing hardscape elements including parking and signage, and existing structures are not consistent with architectural character of the canyon.</p> <p>Opportunity exists to coordinate with USFS to develop an improvement plan for this site. Meeting a high scenic integrity level may be difficult due to impacts of non-Project effects.</p>

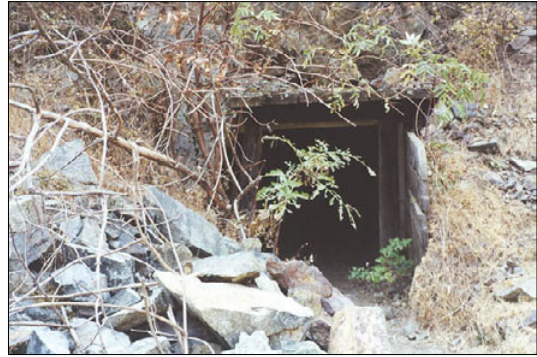
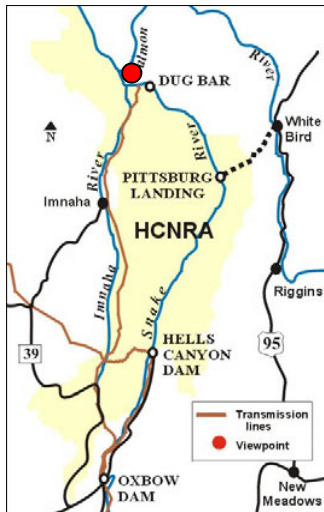
Viewpoint #145: Mountain Chief Mine Tunnel (SP)

Landscape character: In 1979 visitors could walk all the way through the tunnel, portal to portal, as long as they had good flashlights. Today one can only walk a short way in from each portal. The middle portions have become unsafe. Plant assemblages include cheatgrass-bluebunch wheatgrass and net leaf hackberry. There are scattered patches of cliff talus slopes.

Ecological integrity: High – Vegetation is not notably degraded by weedy annual plants or noxious weeds with the exception of a few sand bur plants which can be painful to recreationists.

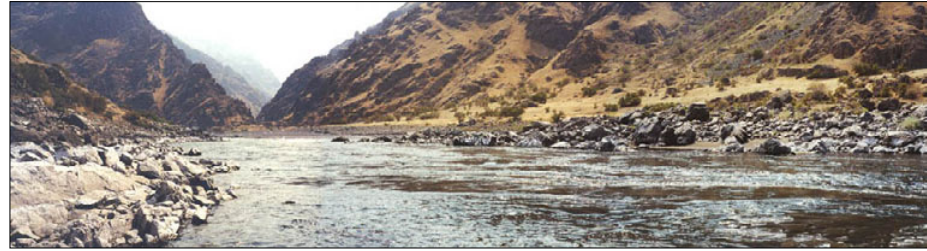
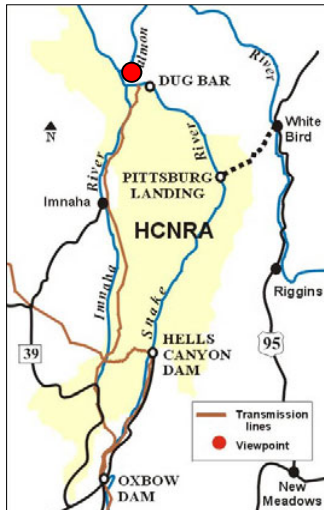
**Viewpoint #147:
Eureka Mine
(SP)**

Eureka Mine foundations (top right)

Landscape character: The massive rock mine foundations are all that is left of the Eureka mine in this landscape of rock outcrops and very steep grassy slopes. Boulder fields line the river bank. The plant cover matrix of this site is really a grassland of cheatgrass-bluebunch wheatgrass, but from the river appears to be a shrubland of net leaf hackberry and many rock outcrops of cliff talus slopes.

Scenic integrity: High	Ecological integrity: High – Vegetation is not notably degraded by undesirable species.
-------------------------------	--

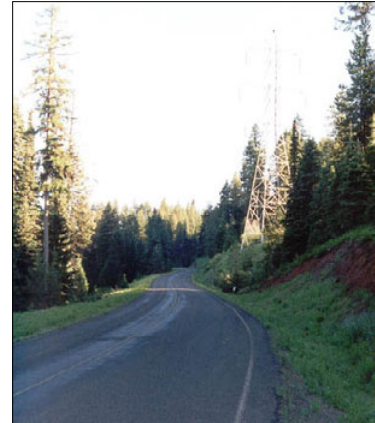
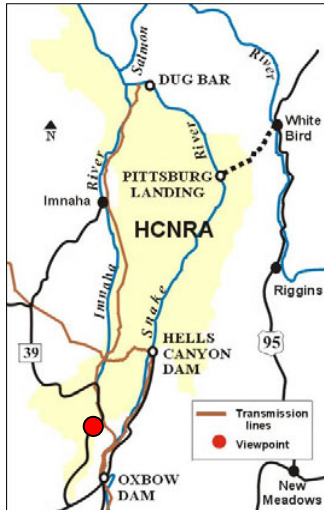
**Viewpoint #154:
Wallowa Mountain Loop Road #1 (SP)**

Scenic integrity: Low – Transmission line structure and conductors are strong negative elements in the foreground adjacent to the road shoulder and cross the Scenic Byway at a right angle.

Desired landscape character: The goal should be to provide mitigation of negative elements described in summary of effects. Recreate the long stretches of open, park-like, large diameter ponderosa pine stands with forest floor of sedges and pine grasses. Pockets of dense stands of Douglas fir and grand fir would break up these long stretches where seeps or north aspects create cool/moist biophysical conditions. At the edges of these stands, shrubs and forbs would add variety to color and texture.

IPC Facilities/ Operations	Current / Proposed Operations		Full Pool/ Run-of-River
	Effects	Suggested PM&E	Effects
Line 907, steel lattice	DF – Conductor has contrasting form, line and color	Replace lines with non-specular wire in normal maintenance cycle.	Same
Line 907, steel lattice	DF – Lattice tower has contrasting form, line and color	Screen views of tower structures with vegetation where practical. Paint/dull tower structures to minimize the visual contrasts. Modify vegetation management within right-of-way to achieve additional screening and softening.	Same
Comments	Tower is immediately adjacent to roadside and dominates view. Effect is visible for a short period of time as motorists approach and pass under line.

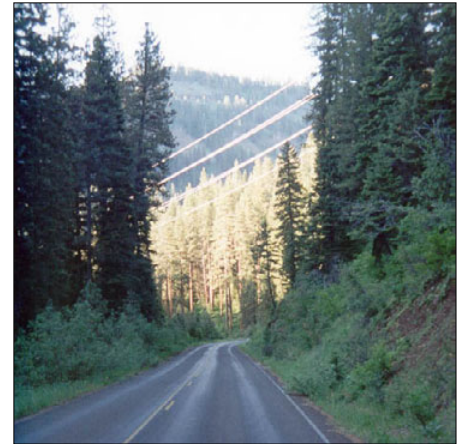
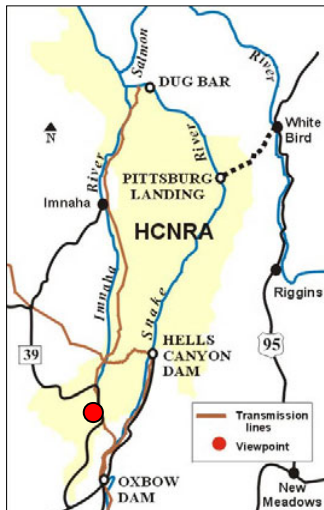
**Viewpoint #155:
Wallowa Mountain Loop Road #2 (SP)**

Scenic integrity: Moderate – Transmission conductors cross Scenic Byway at right angle. The highly reflective conductors create contrast in form, line, and color in the foreground and are negative elements.

Desired landscape character: The goal should be to provide mitigation of negative elements described in summary of effects. Recreate the long stretches of open, park-like, large diameter ponderosa pine stands with forest floor of sedges and pine grasses. Pockets of dense stands of Douglas fir and grand fir would break up these long stretches where seeps or north aspects create cool/moist biophysical conditions. At the edges of these stands, shrubs and forbs will add variety to color and texture.

IPC Facilities/ Operations	Current / Proposed Operations		Full Pool/ Run-of-River
	Effects	Suggested PM&E	Effects
Line 907, steel lattice	DF – Conductor has contrasting form, line and color	Replace lines with non-specular wire in normal maintenance cycle.	Same
Comments	Effect is visible for a short period of time as motorists approach and pass under line.

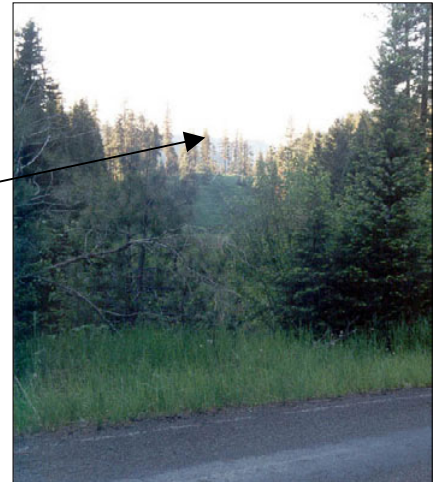
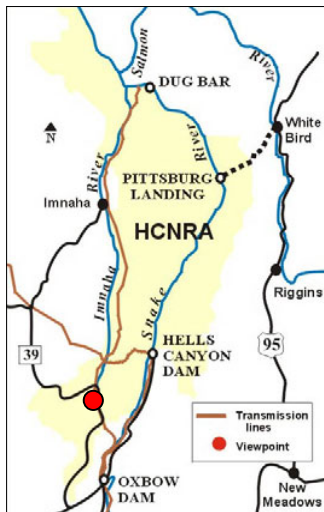
**Viewpoint #156:
Wallowa Mountain Loop Road #3 (SP)**

Transmission tower

Scenic integrity: Moderate – Transmission line structure and conductors are visible in the foreground and cross the Scenic Byway at a right angle. The lattice tower is set back from the shoulder and therefore less obtrusive.

Desired landscape character: The goal should be to provide mitigation of negative elements described in summary of effects. Recreate the long stretches of open, park-like, large diameter ponderosa pine stands with forest floor of sedges and pine grasses. Pockets of dense stands of Douglas fir and grand fir would break up these long stretches where seeps or north aspects create cool/moist biophysical conditions. At the edges of these stands, shrubs and forbs will add variety to color and texture.

IPC Facilities/ Operations	Current / Proposed Operations		Full Pool/ Run-of-River
	Effects	Suggested PM&E	Effects
Line 907, steel lattice	DF: Conductor has contrasting form, line and color	Replace lines with non-specular wire in normal maintenance cycle.	Same
Line 907, steel lattice	DF – Lattice tower has contrasting form, line and color	Screen views of tower structures with vegetation. Paint/dull tower structures to minimize the visual contrasts. Modify vegetation management within right-of-way to achieve additional screening and softening.	Same
Comments	Effect is visible for a short period of time as motorists approach and pass under line. Transmission tower is not readily visible in photograph.

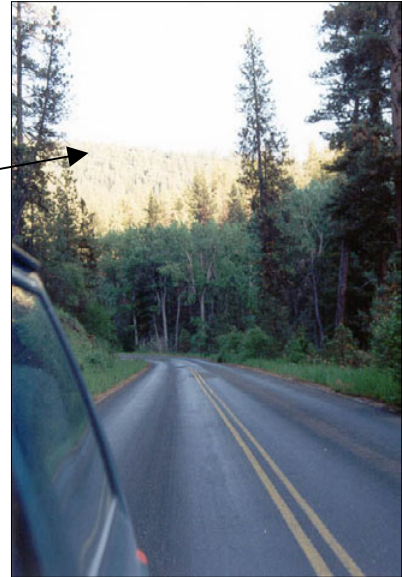
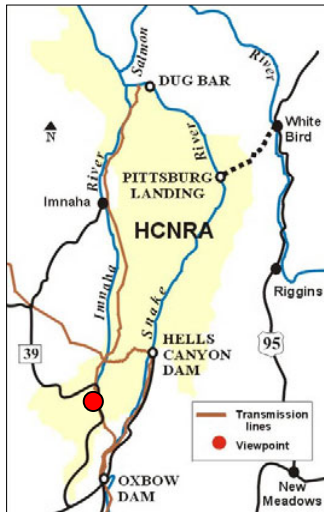
**Viewpoint #157:
Wallowa Mountain Loop Road #4 (SP)**

Conductors

Scenic integrity: Moderate – Transmission line crosses Scenic Byway in foreground at right angle. Conductors are highly reflective and create contrast in form, line, and color. Lattice tower is partially masked by existing vegetation.

Desired landscape character: The goal should be to provide mitigation of negative elements described in summary of effects. Recreate the long stretches of open, park-like, large diameter ponderosa pine stands with forest floor of sedges and pine grasses. Pockets of dense stands of Douglas fir and grand fir would break up these long stretches where seeps or north aspects create cool/moist biophysical conditions. At the edges of these stands, shrubs and forbs will add variety to color and texture.

IPC Facilities/ Operations	Current / Proposed Operations		Full Pool/ Run-of-River
	Effects	Suggested PM&E	Effects
Line 907, steel lattice	DF – Conductor has contrasting form, line and color	Replace lines with non-specular wire in normal maintenance cycle.	Same
Line 907, steel lattice	DF – Lattice tower has contrasting form, line and color	Screen views of tower structures. Paint/dull tower structures to minimize the visual contrasts. Modify vegetation management within right-of-way to achieve additional screening and softening.	Same

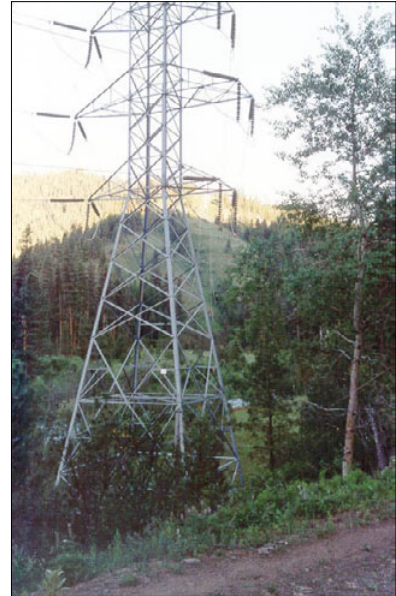
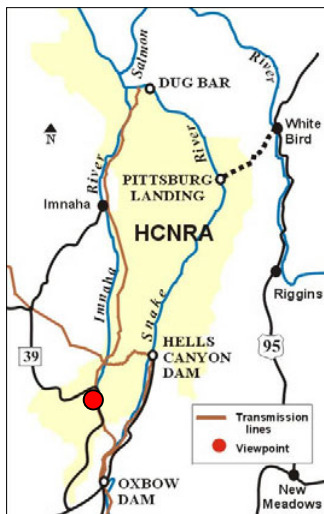
**Viewpoint #158:
Wallowa Mountain Loop Road #5 (SP)**

Scenic integrity: Low – Transmission line corridor is very visible, immediately adjacent to roadway. Conductors are in view at eye-level. Lattice tower is located adjacent to road shoulder and creates high contrast.

Desired landscape character: The goal should be to provide mitigation of negative elements described in summary of effects. Recreate the long stretches of open, park-like, large diameter ponderosa pine stands with forest floor of sedges and pine grasses. Pockets of dense stands of Douglas fir and grand fir would break up these long stretches where seeps or north aspects create cool/moist biophysical conditions. At the edges of these stands, shrubs and forbs will add variety to color and texture.

IPC Facilities/ Operations	Current / Proposed Operations		Full Pool/ Run-of-River
	Effects	Suggested PM&E	Effects
Line 907, steel lattice	DF – Conductor has contrasting form, line and color	Replace lines with non-specular wire in normal maintenance cycle.	Same
Line 907, steel lattice	DF – Lattice tower has contrasting form, line and color	Screen views of tower structures with vegetation. Paint/dull tower structures to minimize the visual contrasts. Modify vegetation management within right-of-way to achieve additional screening and softening.	Same
Comments	Transmission line corridor is very visible. Effects are visible for extended period upon approach.

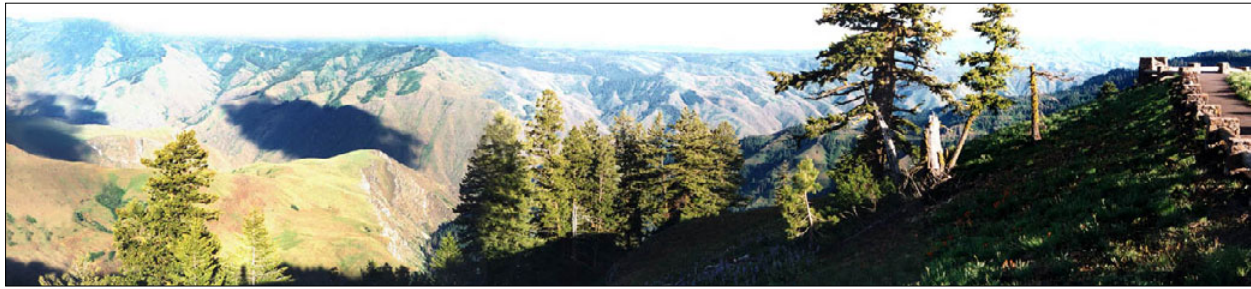
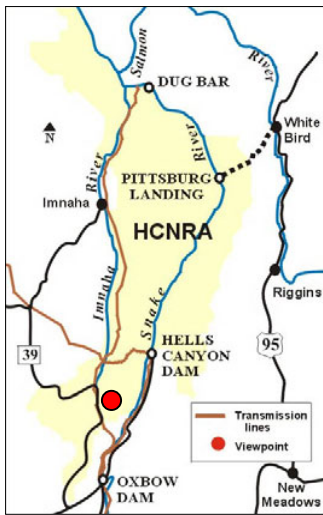
Viewpoint #159: Hells Canyon Overlook (SP)

Scenic integrity: High – Transmission line is located in the middleground/background and is relatively unobtrusive from this viewpoint.

IPC Facilities/ Operations	Current / Proposed Operations		Full Pool/ Run-of-River
	Effects	Suggested PM&E	Effects
Line 910, steel lattice	DF – Conductor has minimal contrast in middle-ground/background.	Replace lines with non-specular wire in normal maintenance cycle.	Same
Line 910, steel lattice	DF – Lattice tower has minimal contrast in middle-ground/background.	Paint/dull tower structures to minimize the visual contrasts.	Same
Comments	Lattice towers located on ridgeline are more visible when viewed under bright light conditions. They are not readily identified in the photograph.
