Hells Canyon Complex Aesthetic Resource Inventory and Evaluation

TECHNICAL REPORT

**Technical Report
Appendix E.6-3**

Hells Canyon Complex
FERC No. 1971

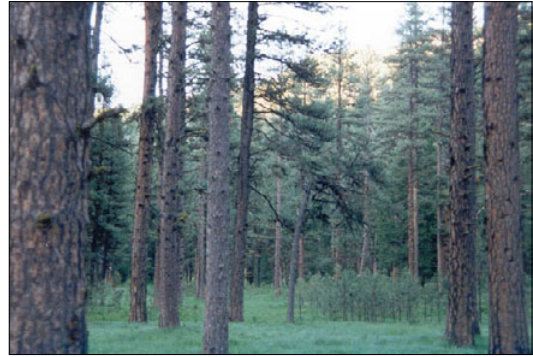
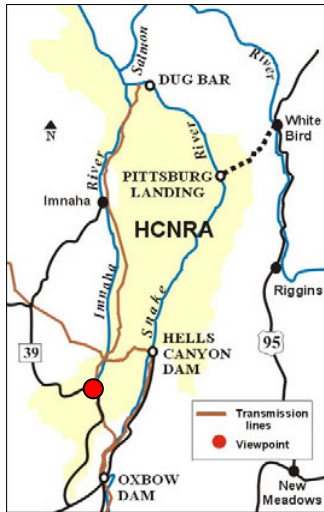
**Viewpoint #162:
Ollokot Campground (SP)**

Scenic integrity: Moderate – Transmission line structure and conductors create contrast in form, line, and color in the middleground. Vegetation and topography screen portions of the line and towers.

IPC Facilities/ Operations	Current / Proposed Operations		Full Pool/ Run-of-River
	Effects	Suggested PM&E	Effects
Line 907, steel lattice	DF – Conductor has contrasting form, line and color	Screen views of transmission lines with vegetation. Replace lines with non-specular wire in normal maintenance cycle.	Same
Line 907, steel lattice	DF – Lattice tower has contrasting form, line and color	Screen views of tower structures with vegetation. Paint/dull tower structures to minimize the visual contrasts.	Same
Comments	Transmission line is visible in middleground where ridgelines do not block views. Line is not visible in the photograph.

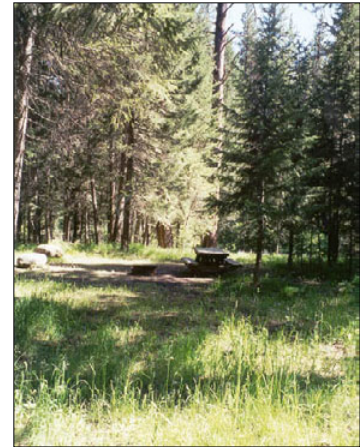
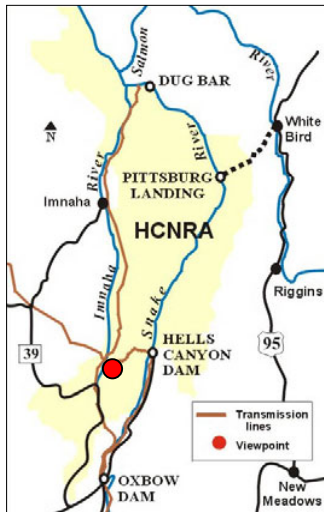
Viewpoint #163: Black Horse Campground (SP)

Scenic integrity: Moderate – Transmission line structure and conductors create contrast in form, line, and color in the middleground. Vegetation and topography screen portions of the line and towers.

IPC Facilities/ Operations	Current / Proposed Operations		Full Pool/ Run-of-River
	Effects	Suggested PM&E	Effects
Line 907, steel lattice	DF – Conductor has contrasting form, line and color	Screen views of transmission lines with vegetation. Replace lines with non-specular wire in normal maintenance cycle.	Same
Line 907, steel lattice	DF – Lattice tower has contrasting form, line and color	Screen views of tower structures with vegetation. Paint/dull tower structures to minimize the visual contrasts.	Same
Comments	Transmission line is visible in middleground where ridgelines do not block views. Line is not visible in the photograph.

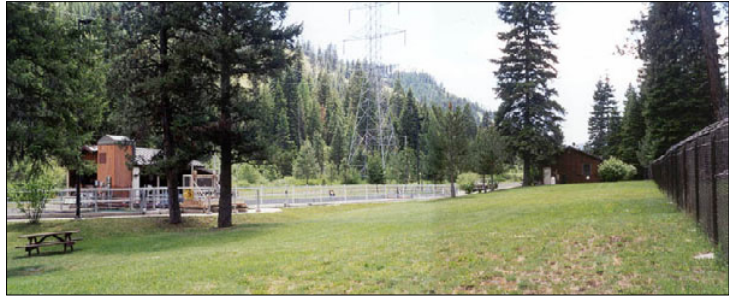
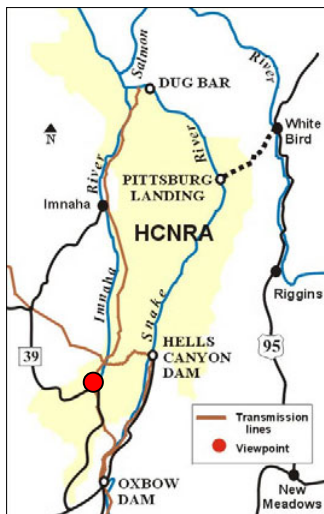
**Viewpoint #164:
Ollokot Fish Trap (SP)**

Scenic integrity: Very low – The lattice towers and reflective conductors dominate the foreground, immediately adjacent to the river. The fish trap facility is industrial in appearance and has a negative effect on scenic quality.

IPC Facilities/ Operations	Current / Proposed Operations		Full Pool/ Run-of-River
	Effects	Suggested PM&E	Effects
Line 907, steel lattice	DF: Conductor has contrasting form, line and color	Replace lines with non-specular wire in normal maintenance cycle.	Same
Line 907, steel lattice	DF: Lattice tower has contrasting form, line and color	Screen views of tower structures. Paint/dull tower structures to minimize the visual contrasts. Modify vegetation management within right-of-way to achieve additional screening and softening.	Same
Comments	On-site personnel are very effective in explaining the story of the salmon’s yearly journey. They are interested in providing information to visitors regarding the positive contributions by IPC. Opportunity exists to develop an interpretive and education program at this site.

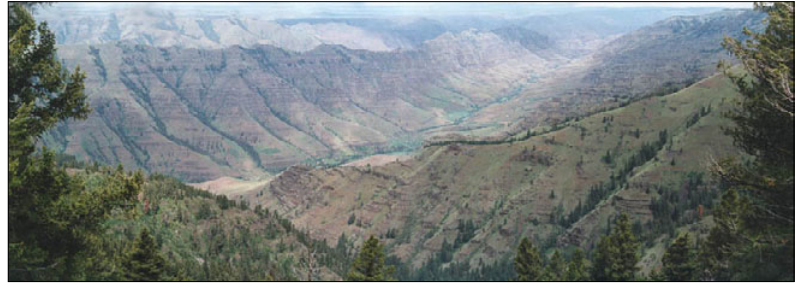
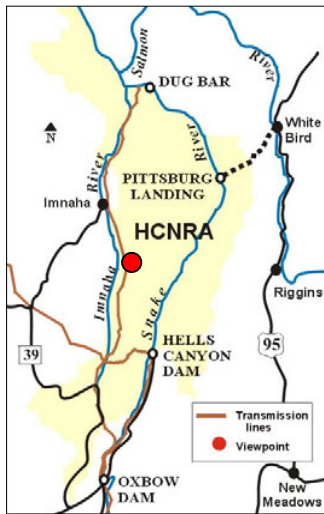
**Viewpoint #174:
Granny Viewpoint (SP)**

Scenic integrity: Moderate – Transmission line conductors in middleground are highly reflective in bright conditions.

IPC Facilities/ Operations	Current / Proposed Operations		Full Pool/ Run-of-River
	Effects	Suggested PM&E	Effects
Line 908, H- Frame Wood	DF – Conductor has contrasting form, line and color	Replace lines with non-specular wire in normal maintenance cycle.	Same
Comments	The line is not evident in the photograph but is located on the valley floor.

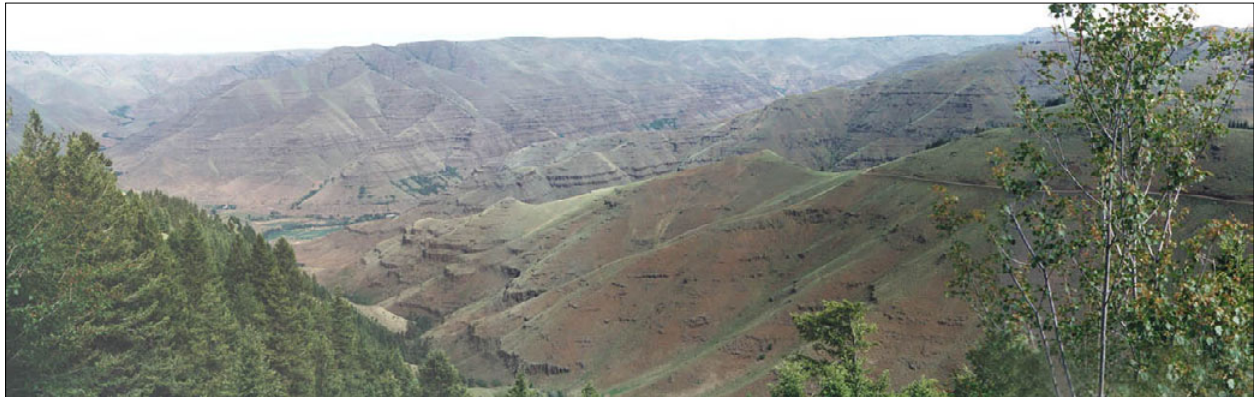
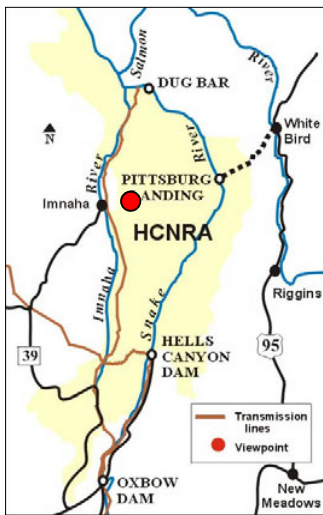
Viewpoint #182: Five Mile Viewpoint (SP)

Scenic integrity: Moderate – Transmission conductors are visible in middleground and highly reflective in bright conditions. Wood towers are less obtrusive than lattice. Topography screens the line in several places along the canyon floor.

IPC Facilities/ Operations	Current / Proposed Operations		Full Pool/ Run-of-River
	Effects	Suggested PM&E	Effects
Line 908, H-Frame Wood	DF: Conductor has contrasting form, line and color	Replace lines with non-specular wire in normal maintenance cycle.	Same
Line 908, H-Frame Wood	DF: Wood tower has contrasting form, line and color	Paint/dull tower hardware to minimize the visual contrasts.	Same
Comments	NP: Hat Point Road is visible with contrasting line and color across landscape. Opportunity exists to coordinate with USFS to treat road and road cuts to reduce color and line contrasts. The line is not evident in the photograph but is located on the valley floor.

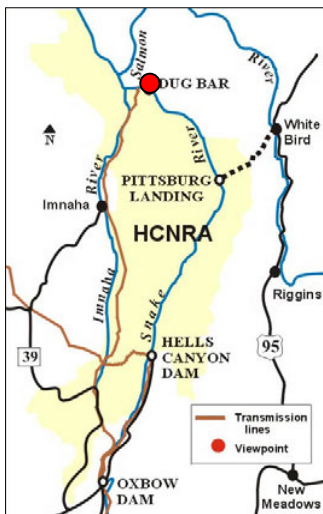
Landscape character: Travel along Dug Bar Road provides many vistas overlooking the Snake River Canyon and large open ridges. Powerline towers and lines dominate the foreground with grasses on steep slopes. Landforms with grasses dominate the middleground. Large open ridges with some stringers and grasses dominate the background.

Scenic integrity: Low	Ecological integrity: N/A
------------------------------	----------------------------------
